"2002" SEMINAR INFORMATION

"What's New for '2002' Technical Seminar"

AUTOMATIC TRANSMISSION SERVICE GROUP

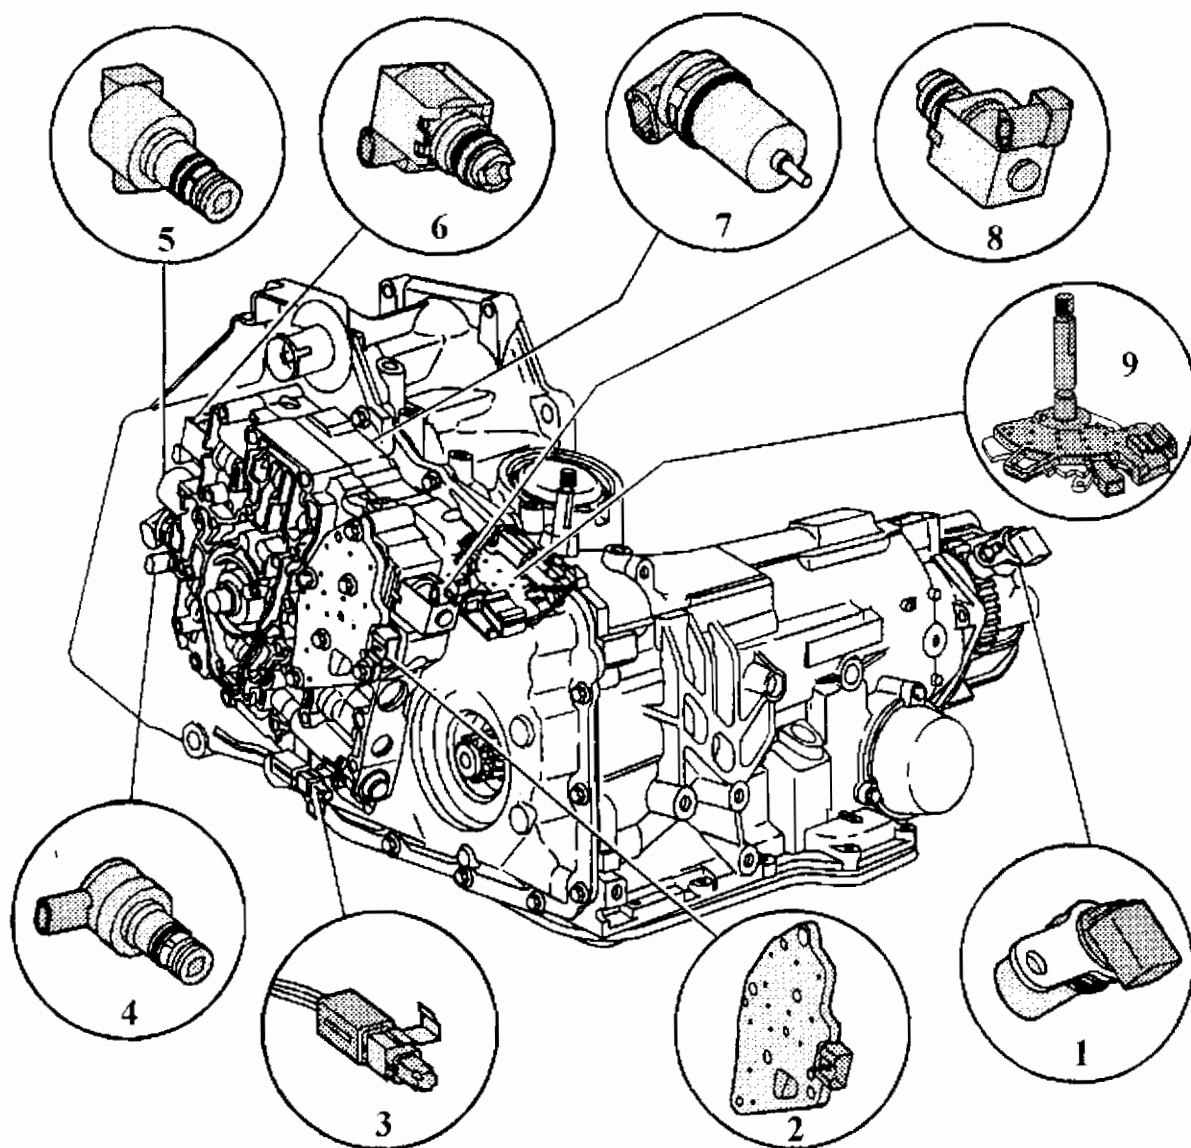
THM 4T65E INTERNAL MODE SWITCH LOCATION

- 1. OUTPUT SPEED SENSOR
- 2. TRANSMISSION FLUID PRESSURE SWITCH ASSEMBLY
- 3. TRANSMISSION FLUID TEMPERATURE SENSOR
- 4. TCC PWM SOLENOID

- 5. PRESSURE CONTROL SOLENOID
- 6. 1-2/3-4 SHIFT SOLENOID
- 7. INPUT SPEED SENSOR
- 8. 2-3 SHIFT SOLENOID
- 9. INTERNAL MODE SWITCH

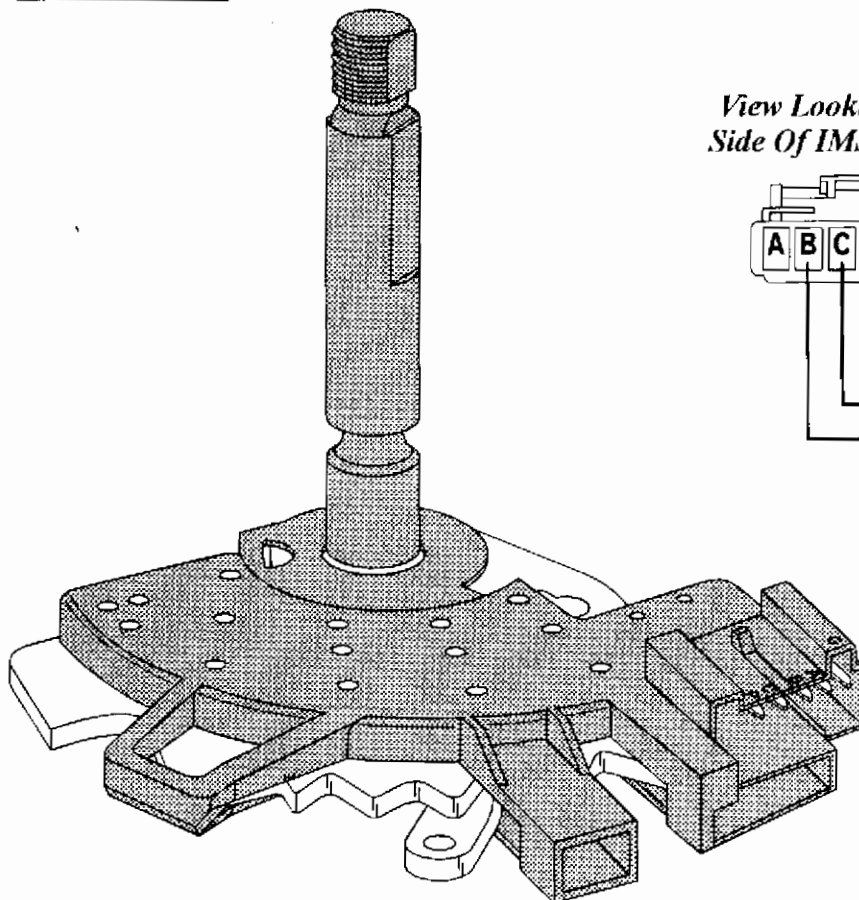
INTERNAL MODE SWITCH (IMS) CONNECTOR			
PIN	WIRE COLOR	CIRCUIT NO.	FUNCTION
A	—	—	NOT USED
B	GRAY/WHT	776	IMS MODE P
C	YEL/BLK	773	IMS MODE C
D	DK GRN/WHT	772	IMS MODE B
E	RED/BLK	771	IMS MODE A
F	BLK/WHT	1050	GROUND

View Looking At Wire
Side Of IMS Connector

- (4) *Refer to Figure 4 for identification of the transaxle case connector terminals that were added to accommodate the new IMS, and the wire colors and functions. We have also included a resistance chart for the internal transaxle components.*
- (5) *Refer to Figure 5 for identification of the PCM connector terminals, both Blue and the Clear connectors for the transaxle related components.*
- (6) *Refer to Figure 6 for an Internal Mode Switch Logic chart that will provide you with the proper readings for all four input parameters for the IMS. These can be viewed from the appropriate scan tool.*
- (7) *Figure 7 provides you with the information to bench check the Internal Mode Switch for the proper continuity at the Internal Mode Switch connector, and Figure 8 provides you the same information to check the switch at the transaxle case connector terminals.*

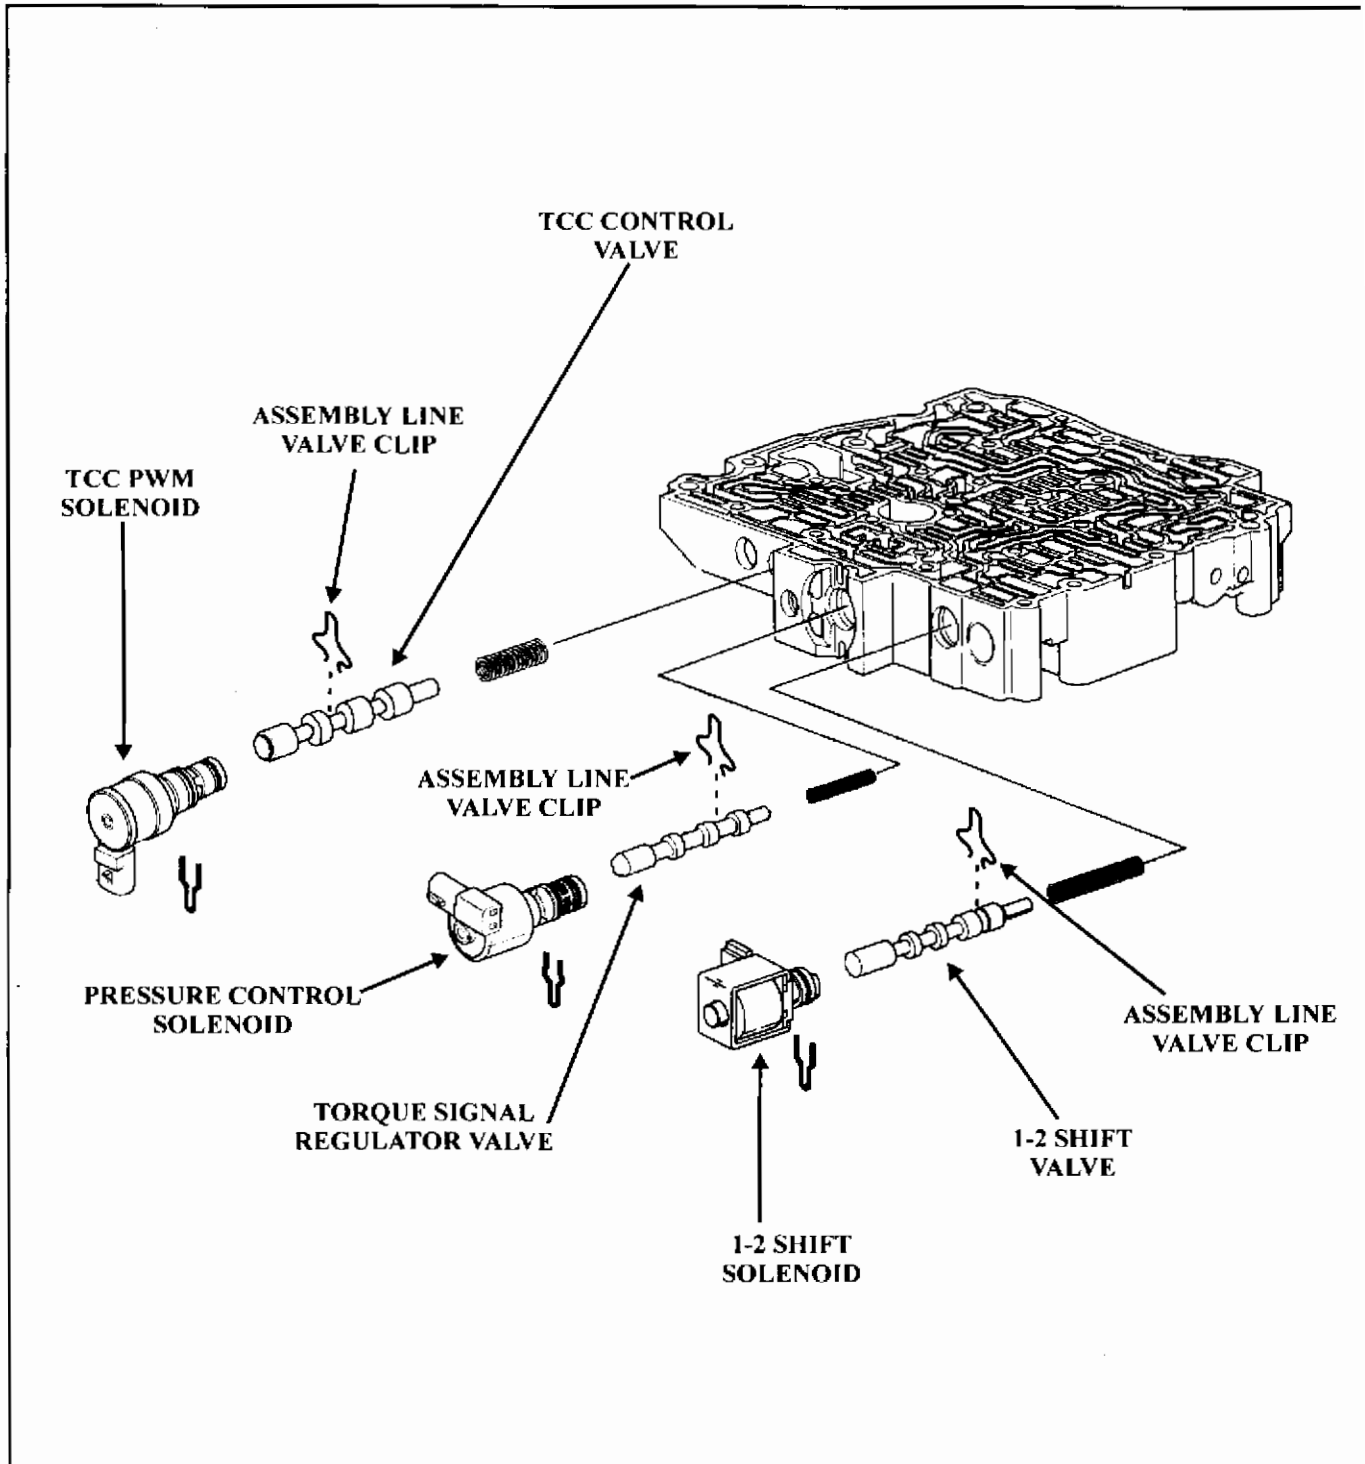
Figure 1

- COMPLAINT:** When the transmission pan is removed, one or more of what appears to be broken valve retainer clips are found. Upon inspection of the valve body, everything seems to be in order as all valve and solenoid retainers are present.
- CAUSE:** These retainer clips are used to hold these valves in place as seen in figure 1, during the assembly line process. They serve no function concerning transmission operation. These clips are barely noticeable unless you know they are there or you are trying to remove one of these valves. The location of these retainer clips are shown in figure 2.
- CORRECTION:** Since these retainer clips have no functional purpose, they can be omitted and therefore need not be replaced.

**THM 4T65E
ASSEMBLY LINE VALVE CLIPS**

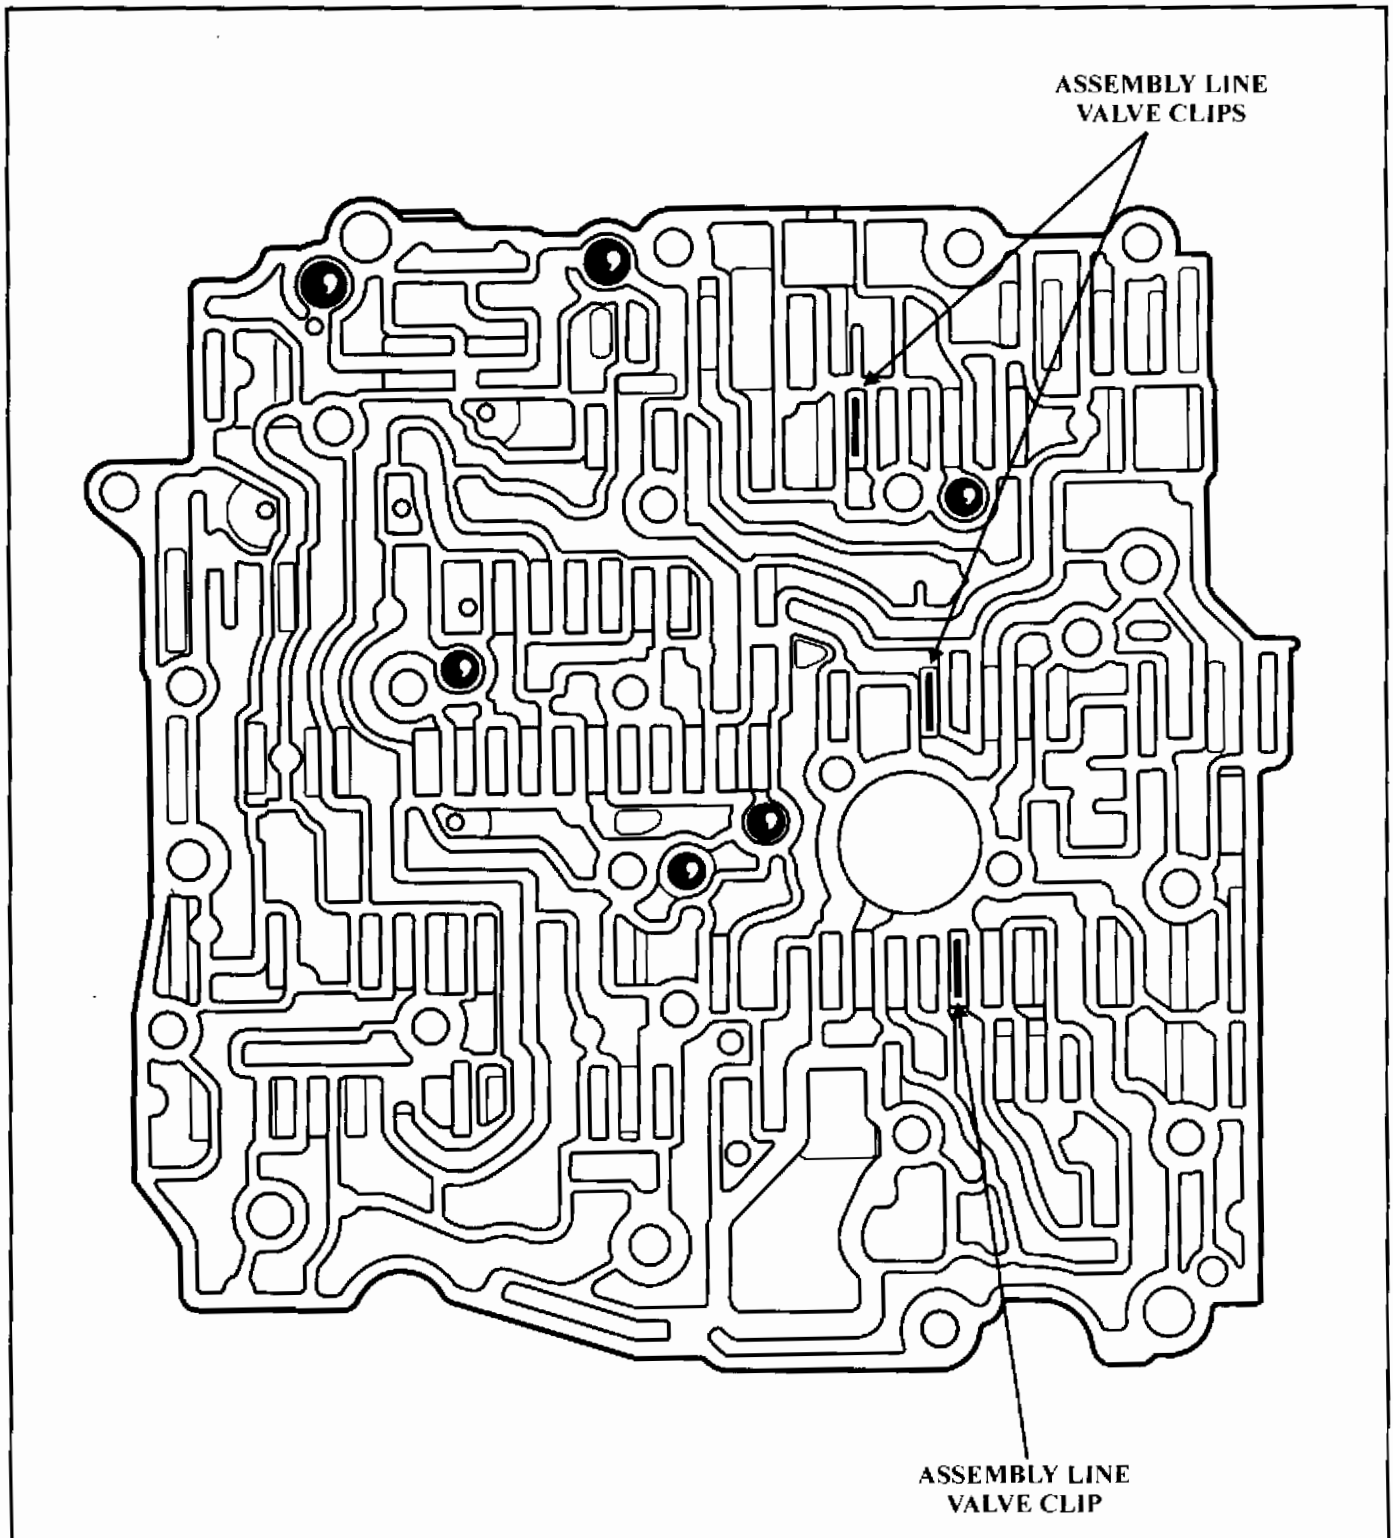
Figure 2

**THM 4T65E
ASSEMBLY LINE VALVE CLIPS**

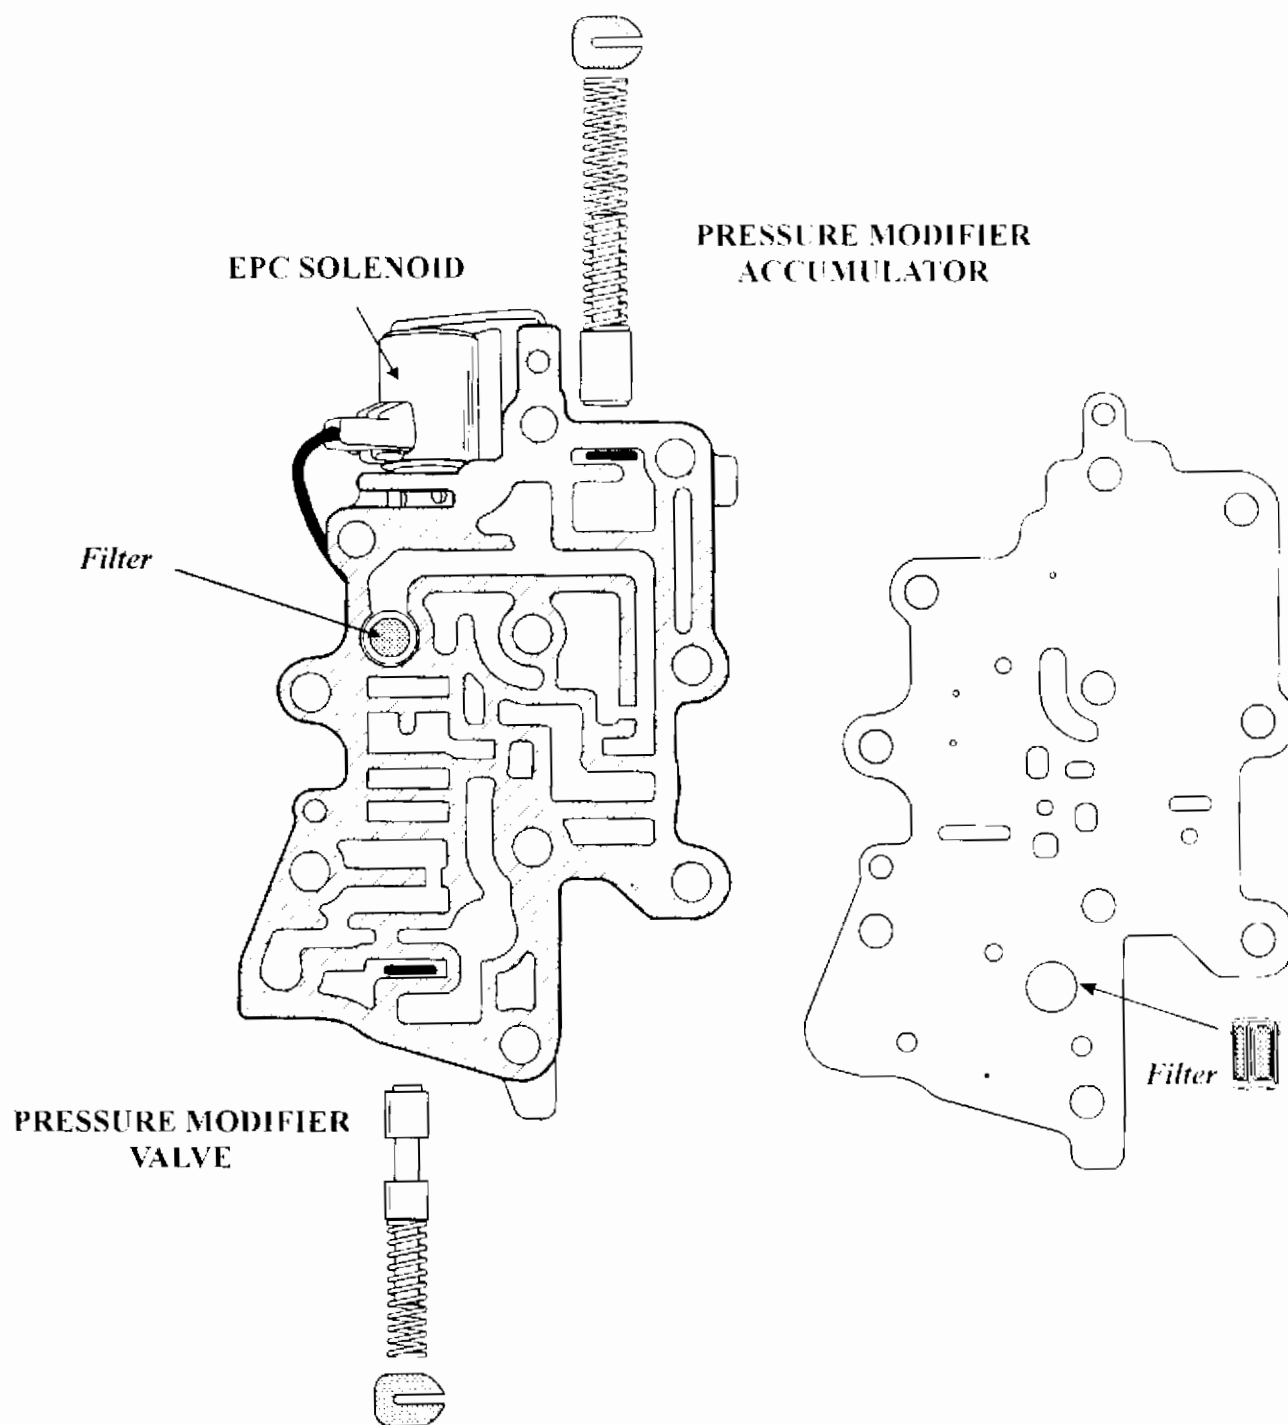
Figure 1

**"97" PRESSURE CONTROL SOLENOID BODY
AND SPACER PLATE**

None of the parts listed above can be used in any previous models. However, when using the complete valve body as a service package, it will retro-fit back to previous models.

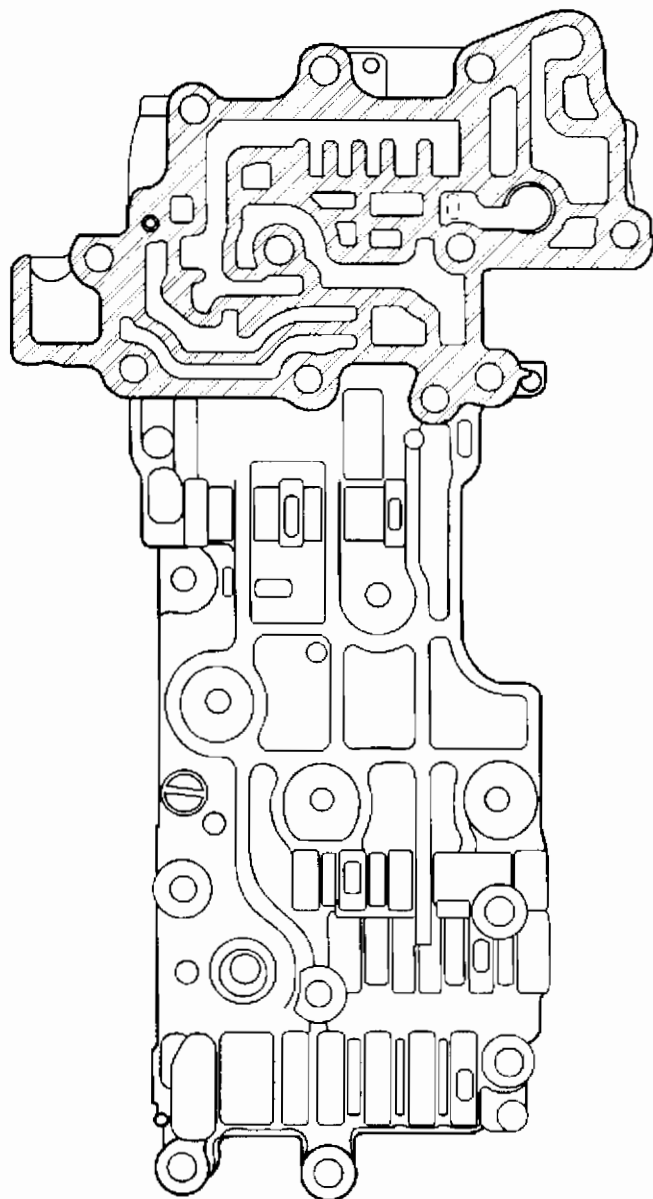
"97" MAIN VALVE BODY (UPPER)

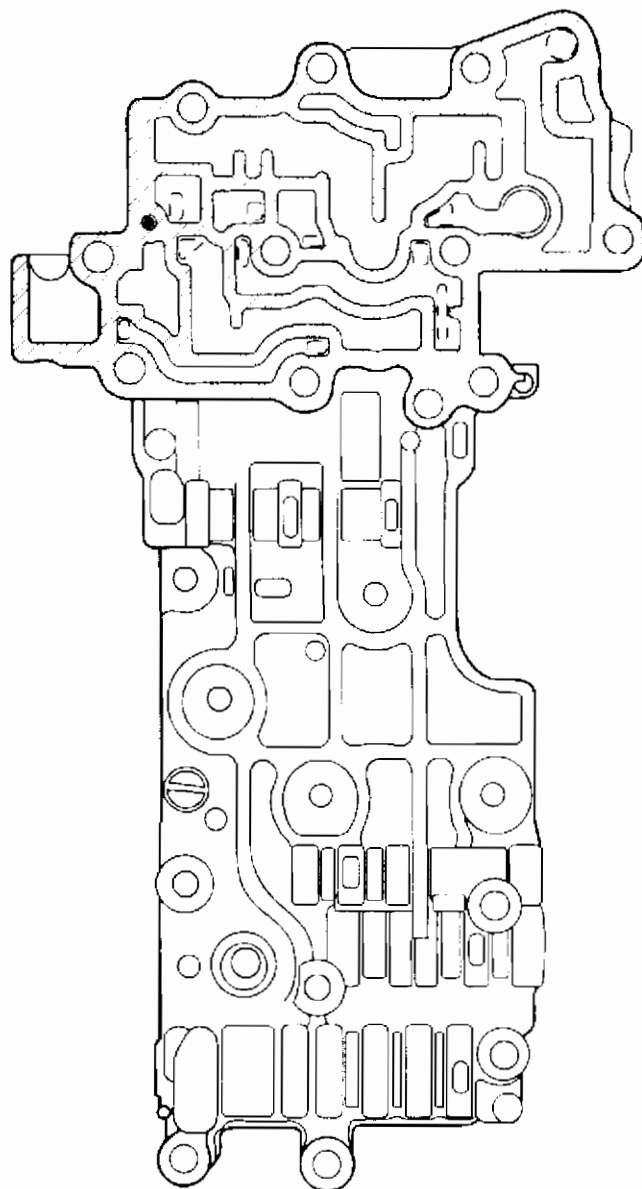
Figure 3

"98" MAIN VALVE BODY (UPPER)

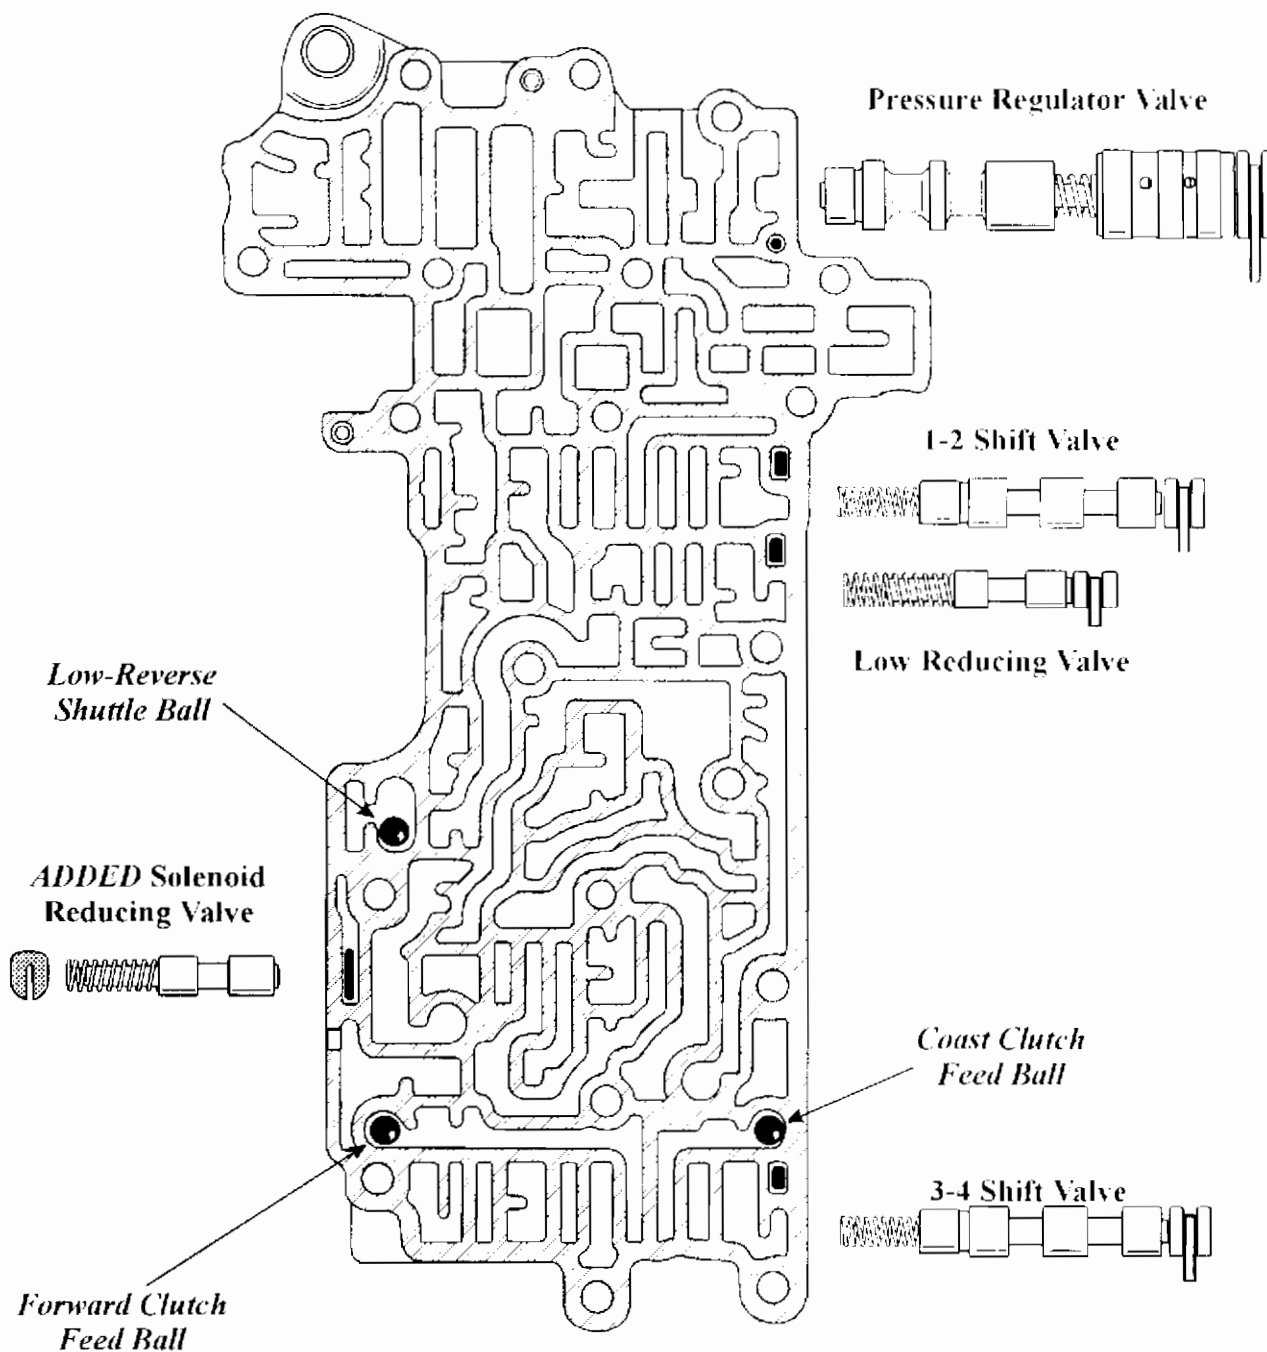
Figure 5

"98" MAIN VALVE BODY (LOWER)

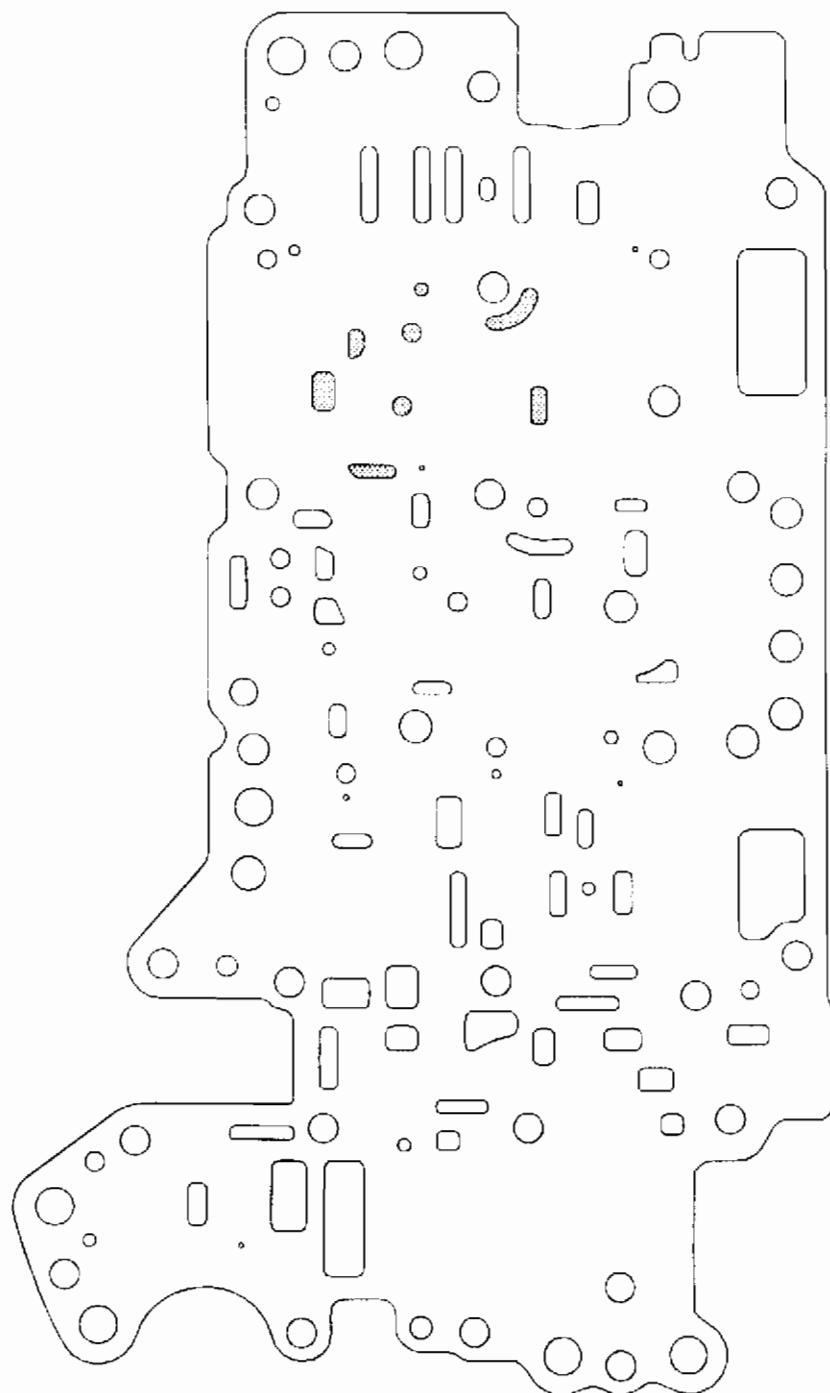
Figure 6

"97" MAIN VALVE BODY SPACER PLATE

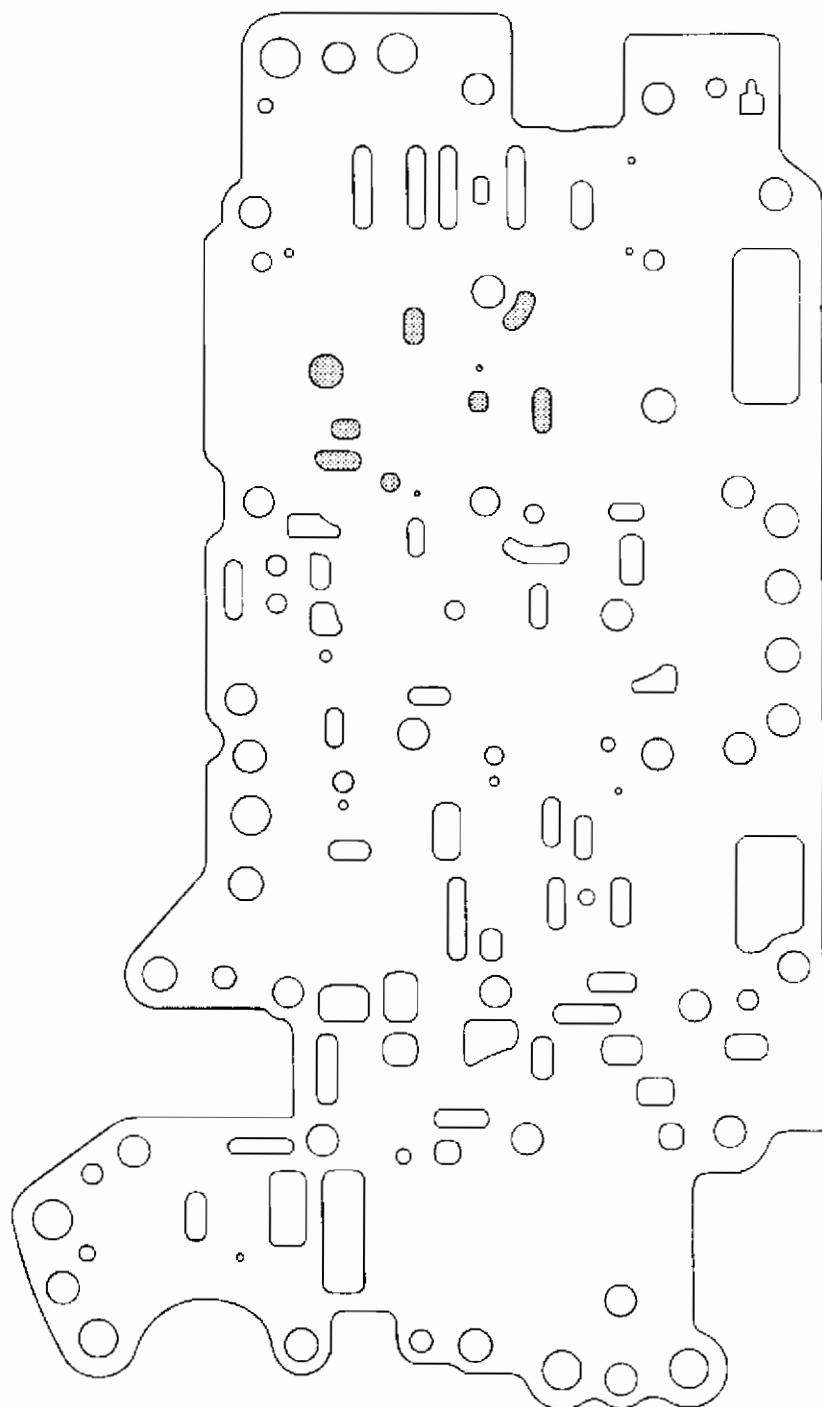
Figure 7

"98" MAIN VALVE BODY SPACER PLATE

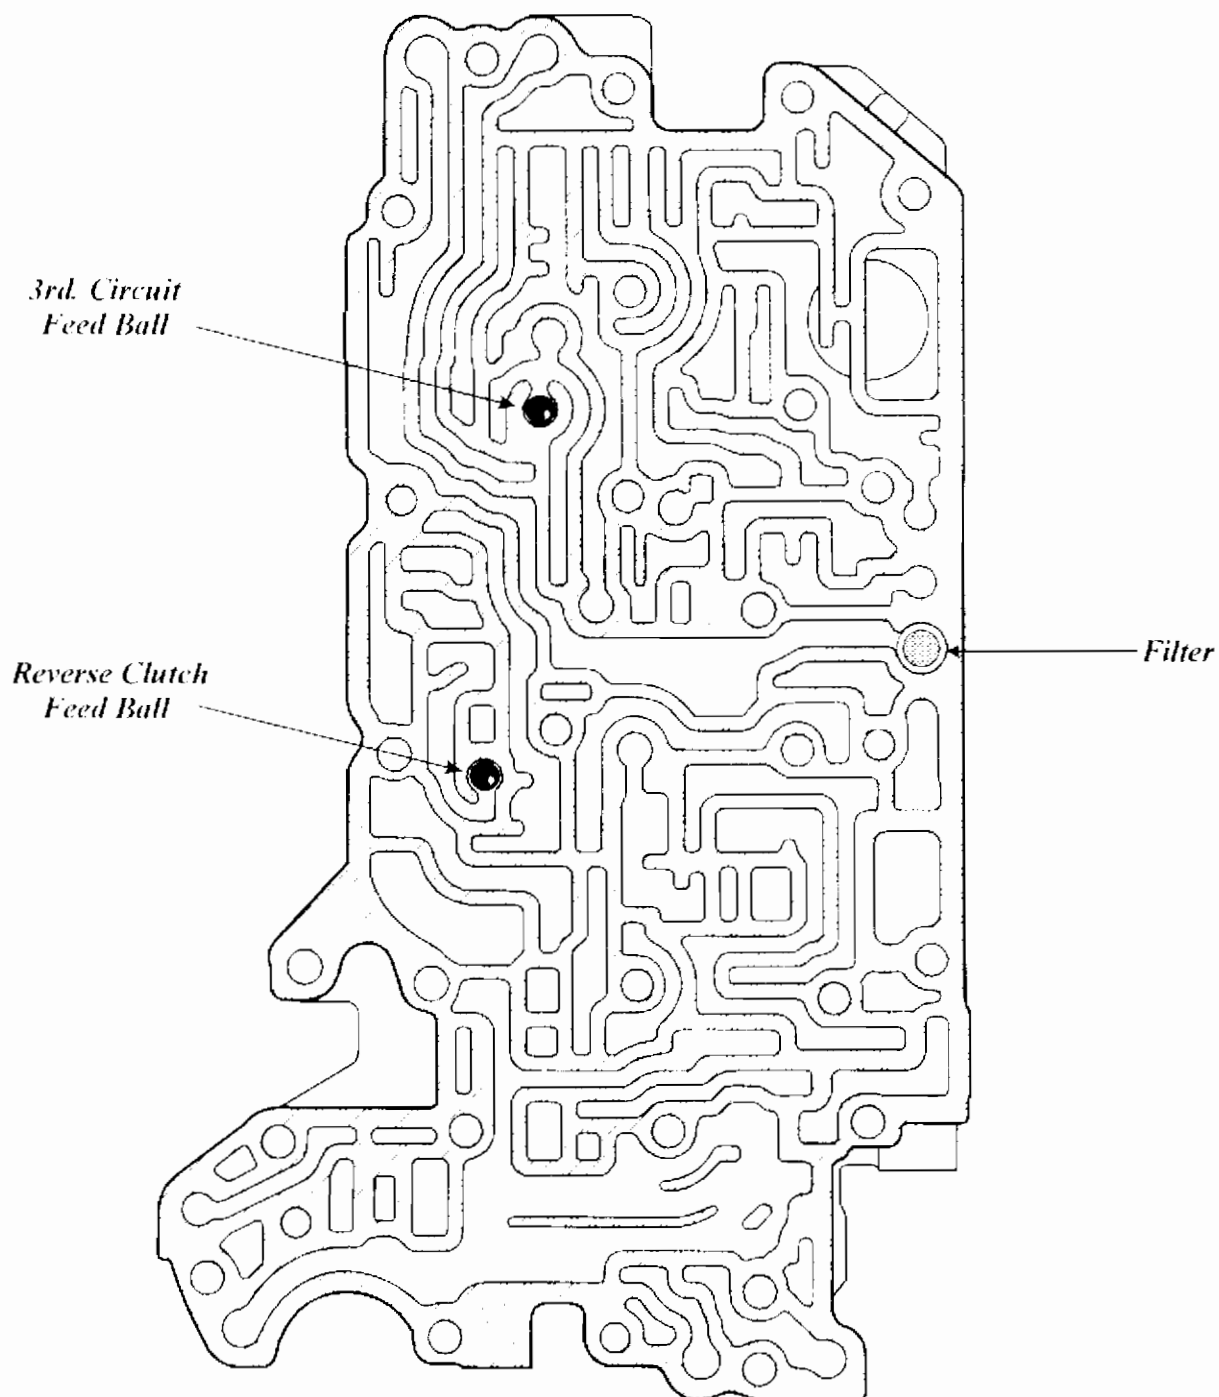
Figure 8

"97" PREMAIN VALVE BODY (UPPER)

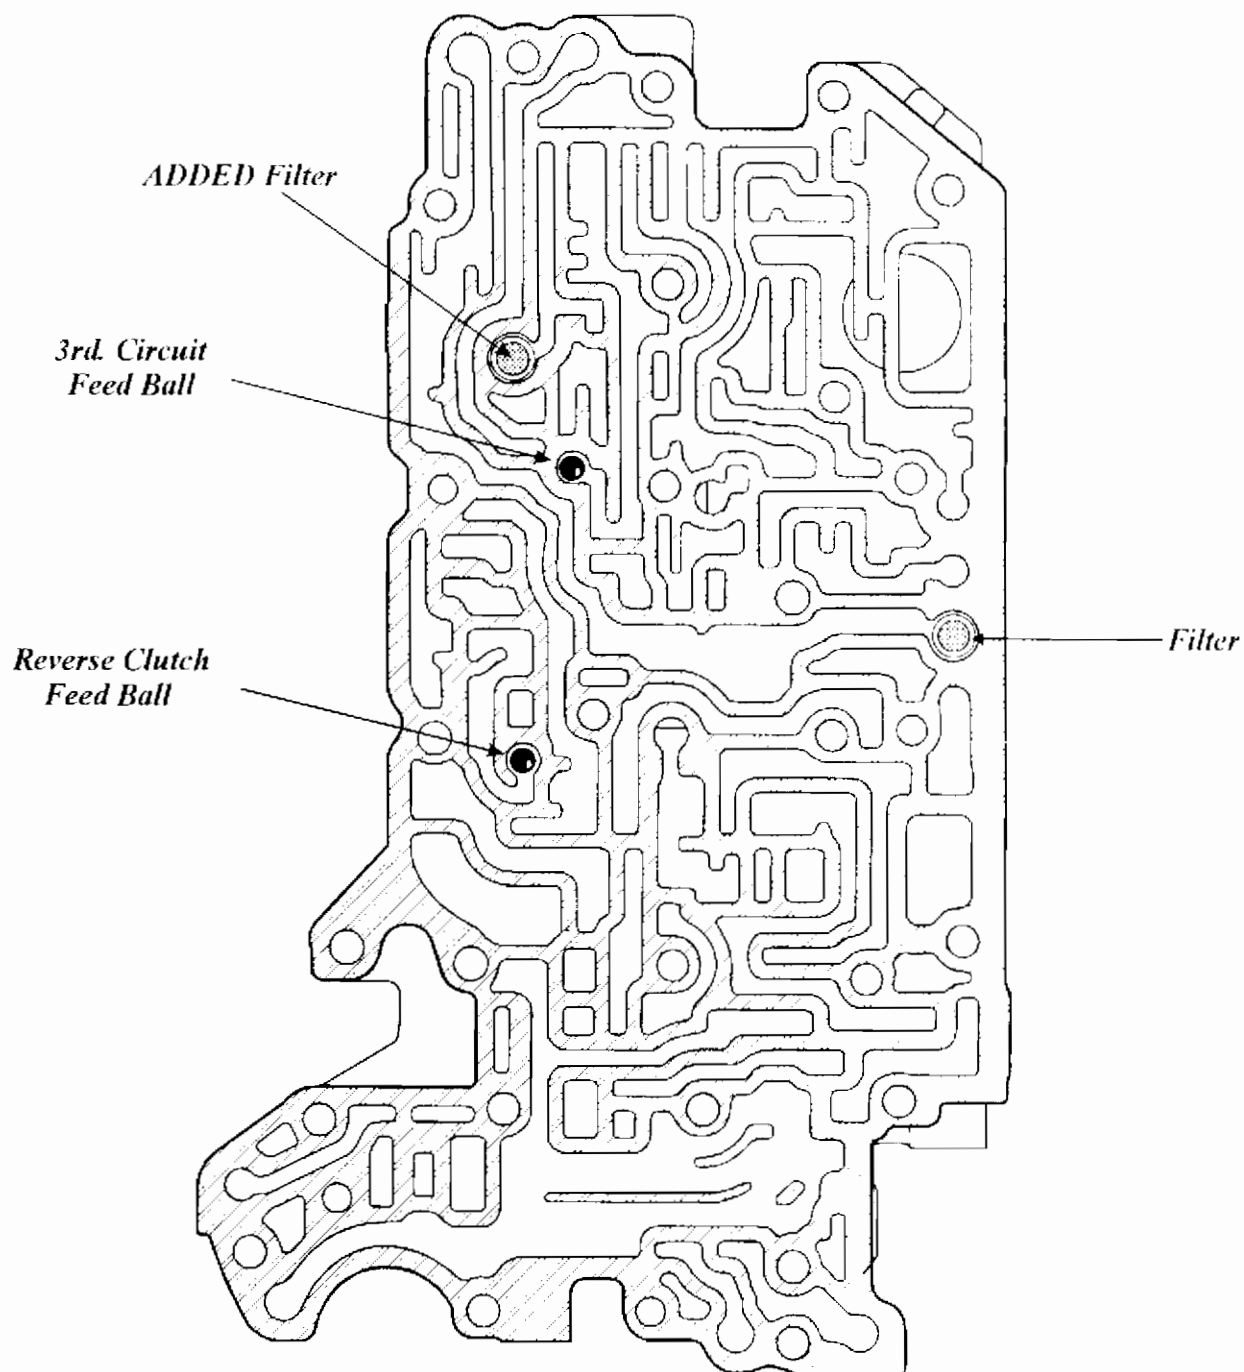
Figure 9

"98" PREMAIN VALVE BODY (UPPER)

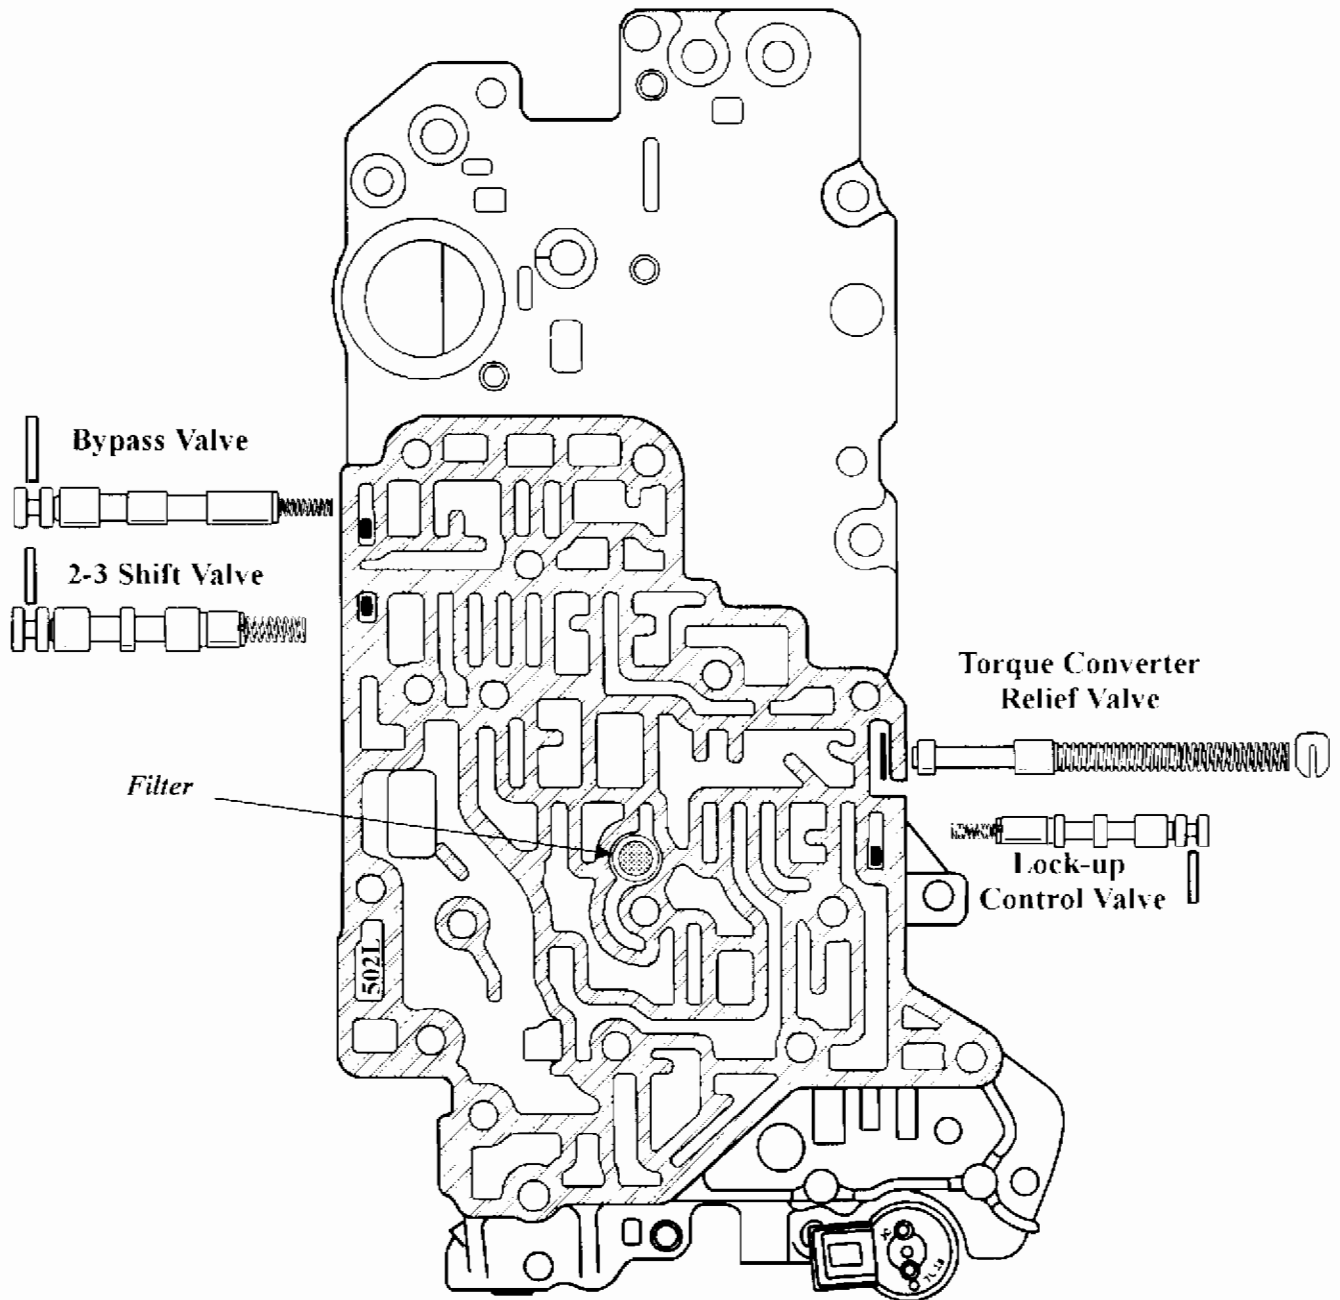
Figure 10

"97" PREMAIN VALVE BODY (LOWER)

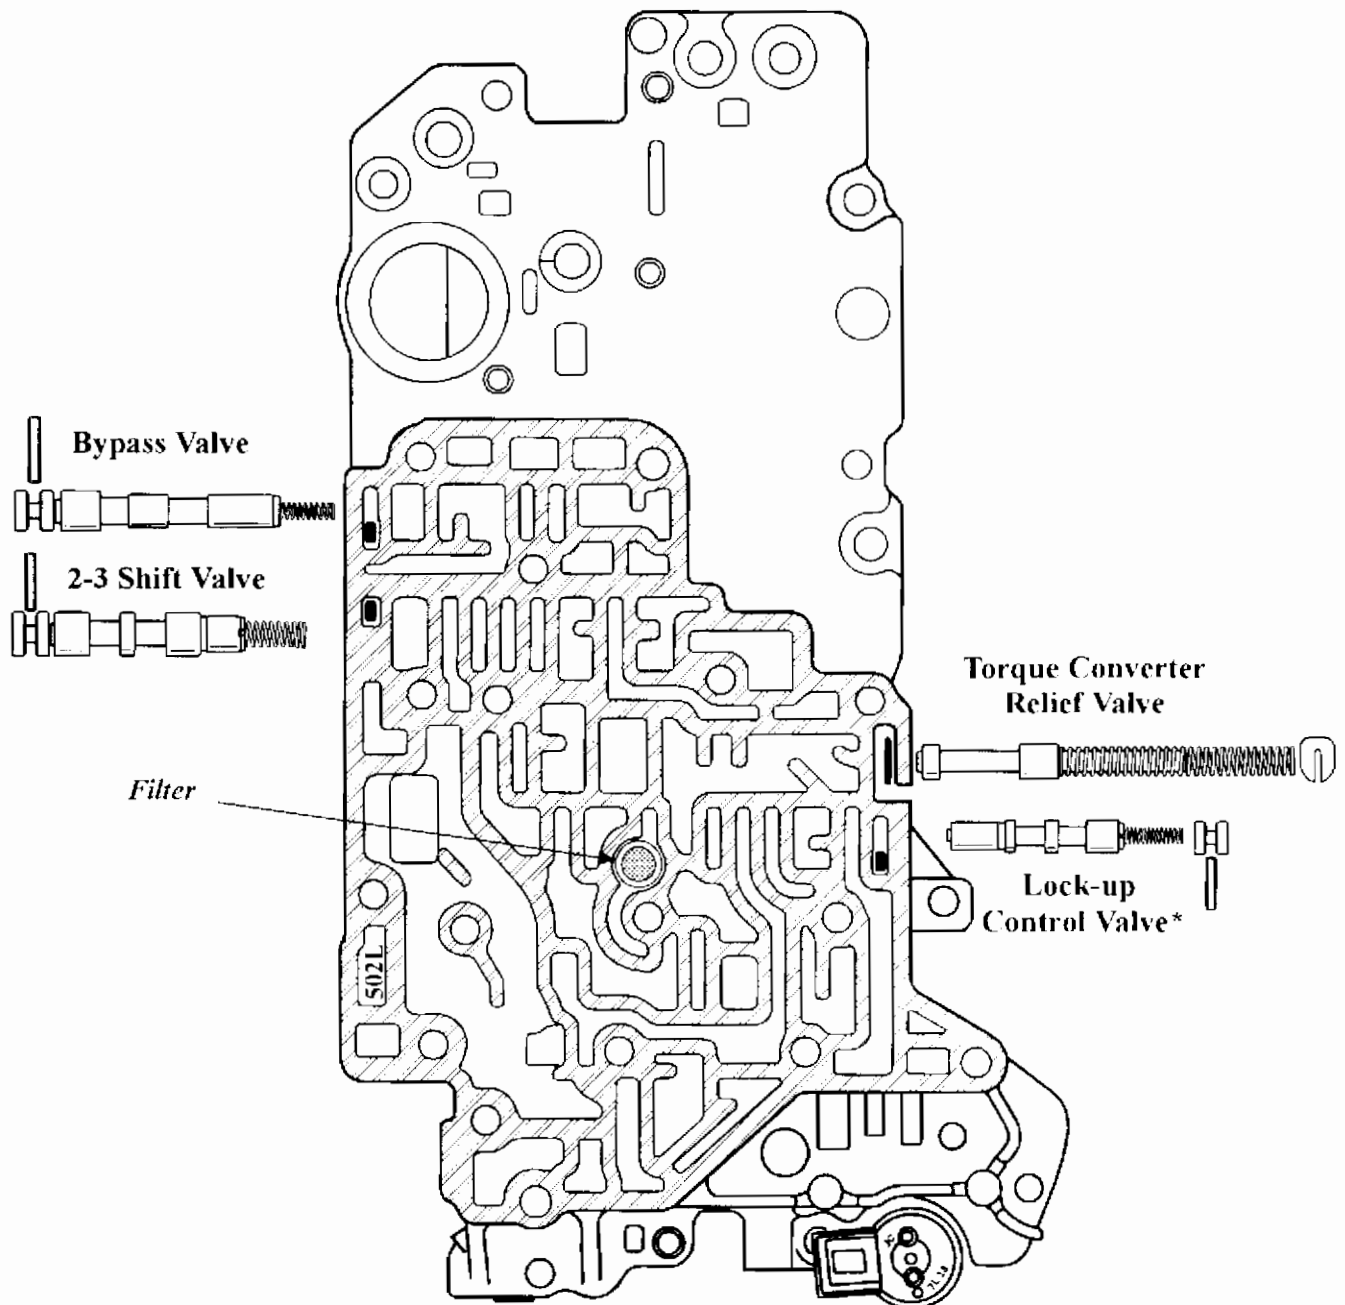
"98" PREMAIN VALVE BODY (LOWER)

*** NOTE: THE VALVE HAS THE HOLE AND THE SPRING
 AT THE OPPOSITE END OF THE VALVE**

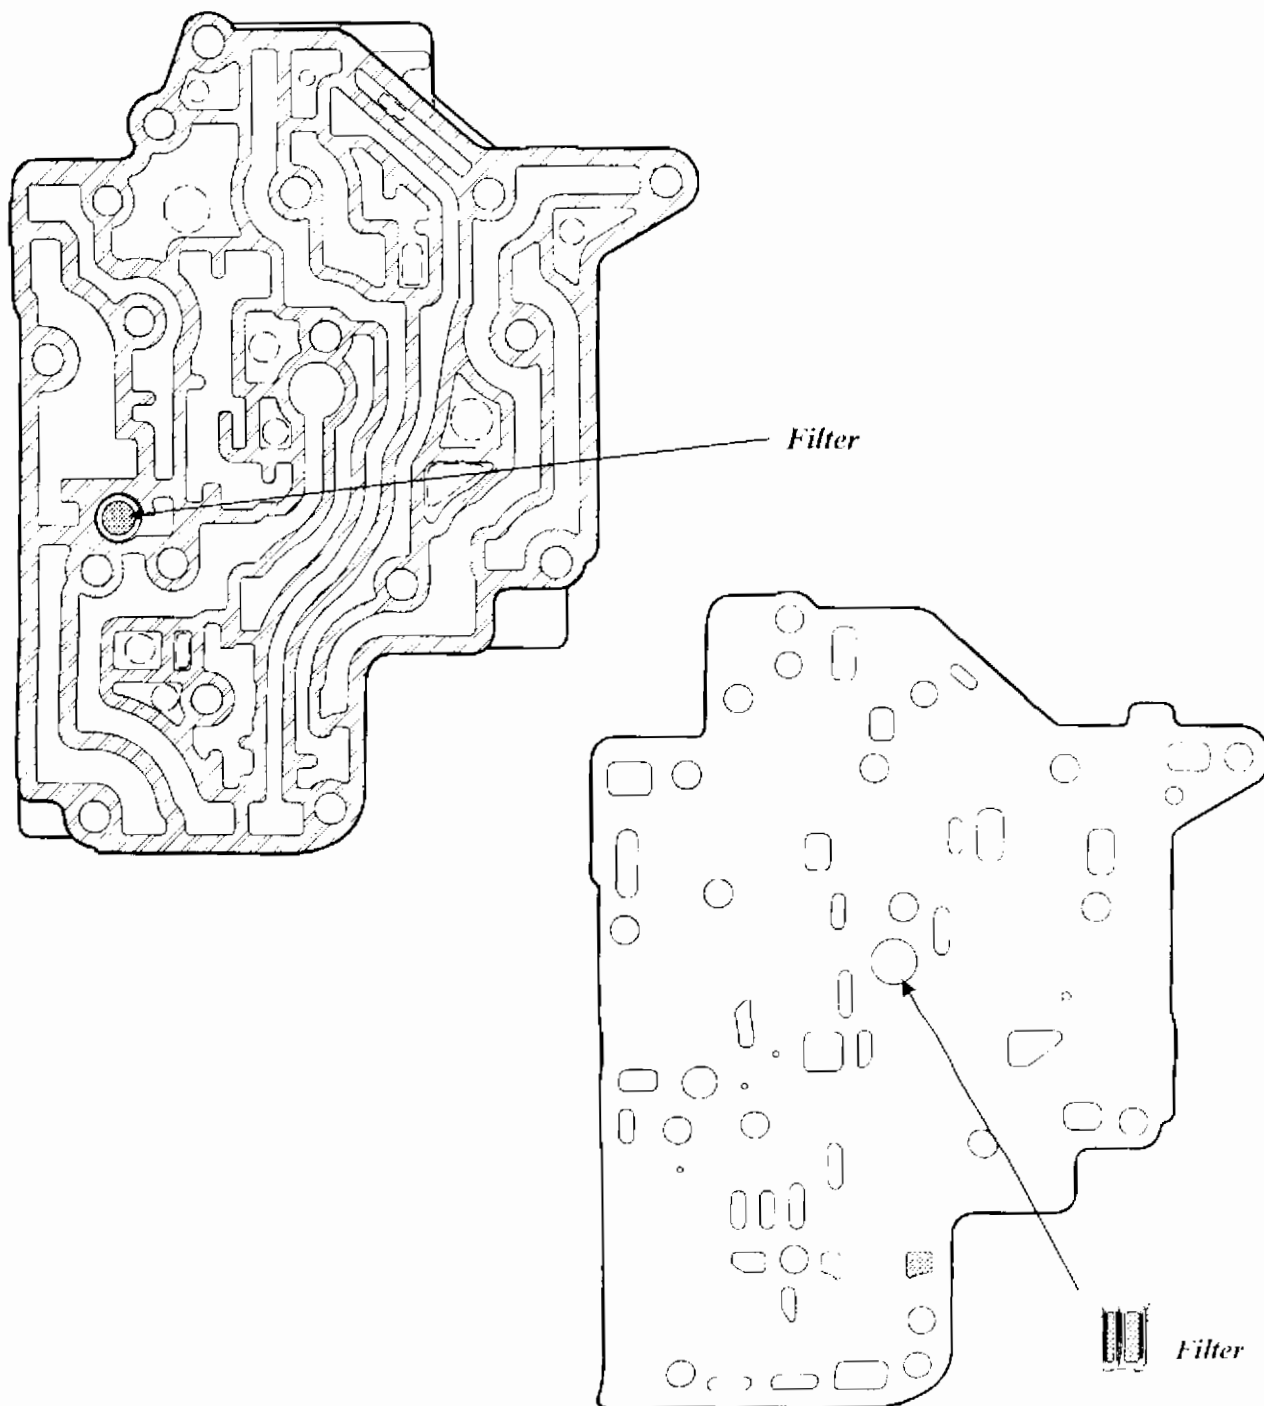
Figure 13

"98" PREMAIN COVER AND SPACER PLATE
