"2002" SEMINAR INFORMATION

"What's New for '2002' Technical Seminar"

AUTOMATIC TRANSMISSION SERVICE GROUP

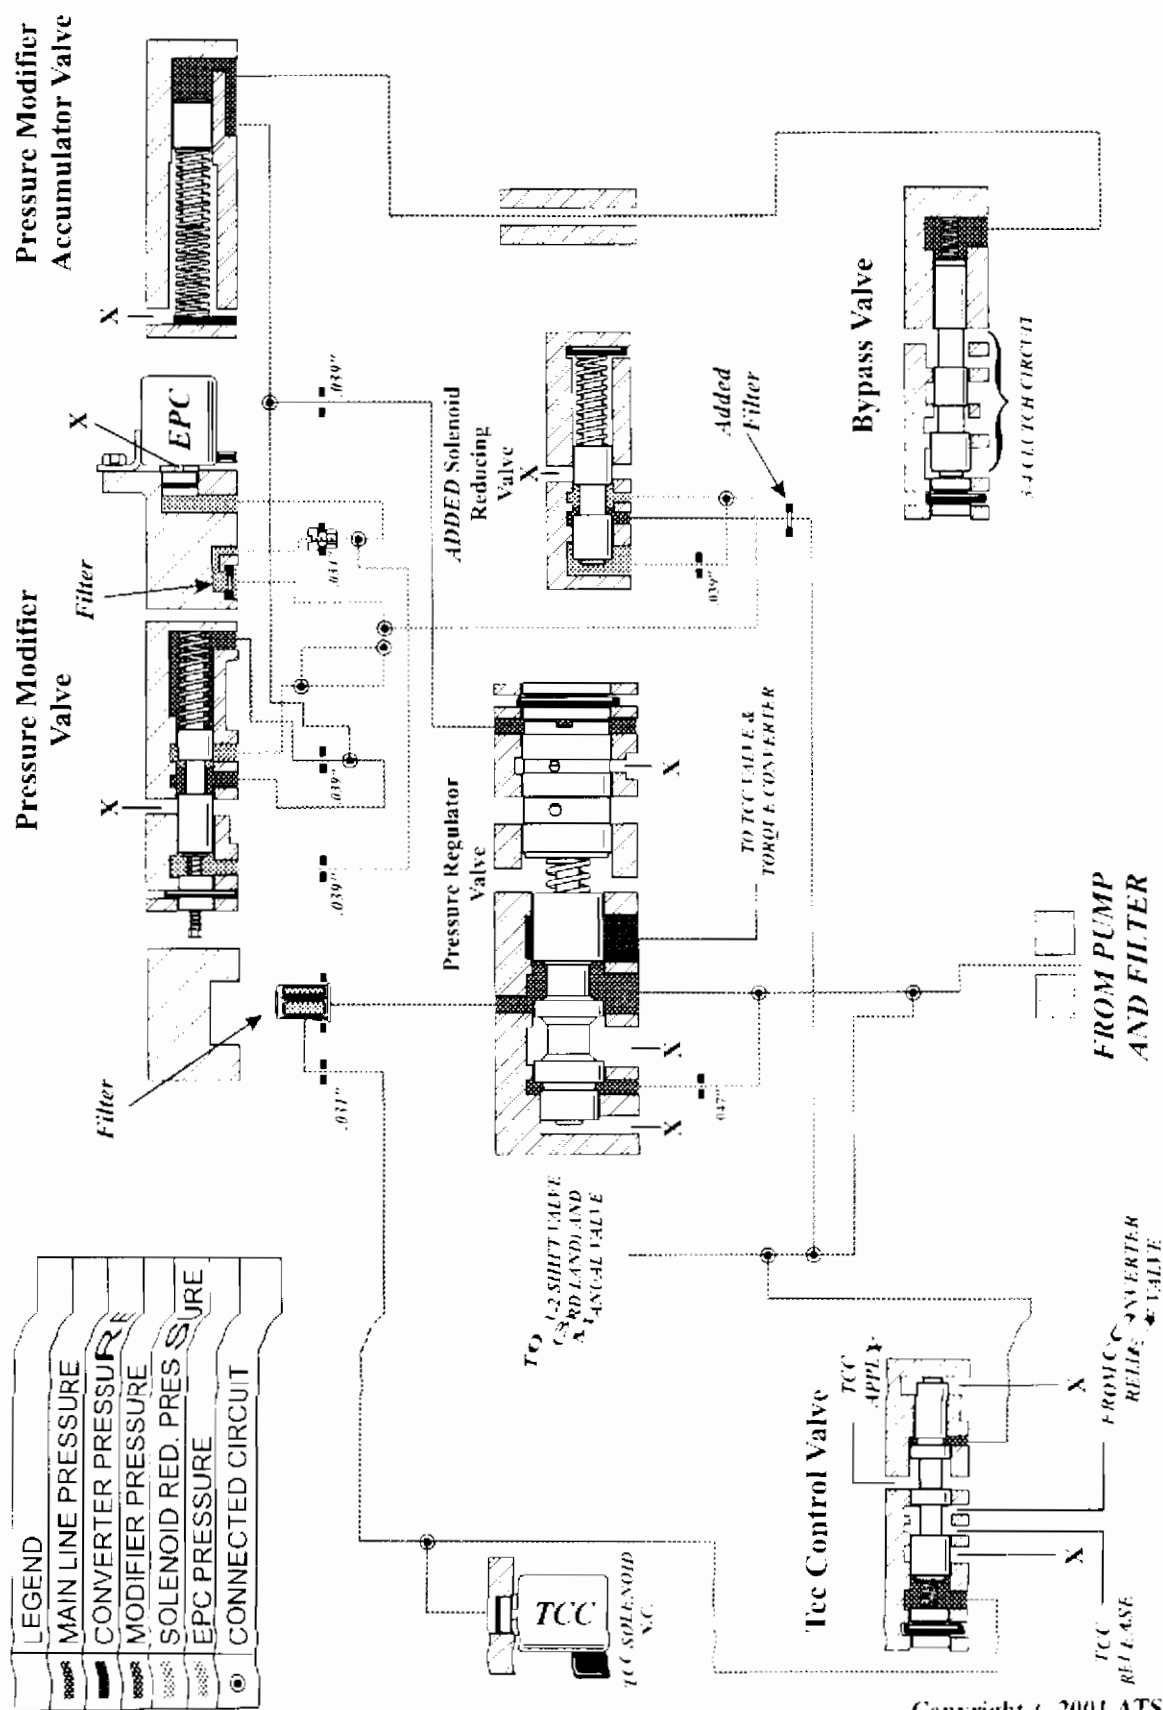
Figure 15

"9" F4E-III ELECTRONIC PRESSURE CONTROL HYDRAULIC CIRCUIT

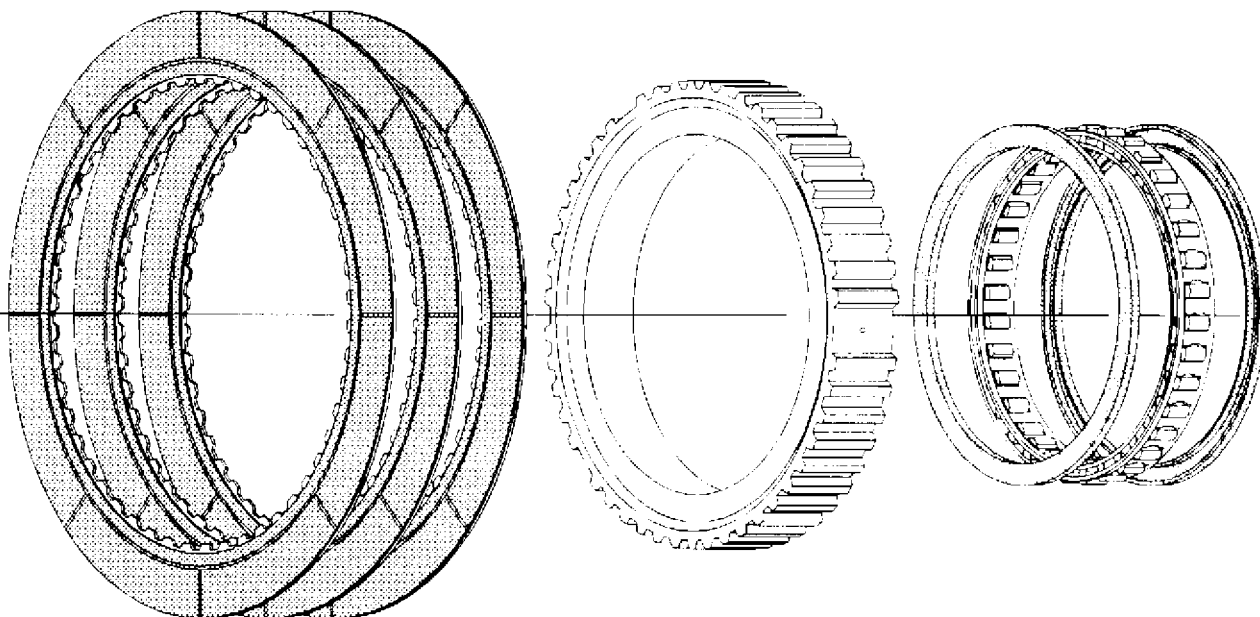
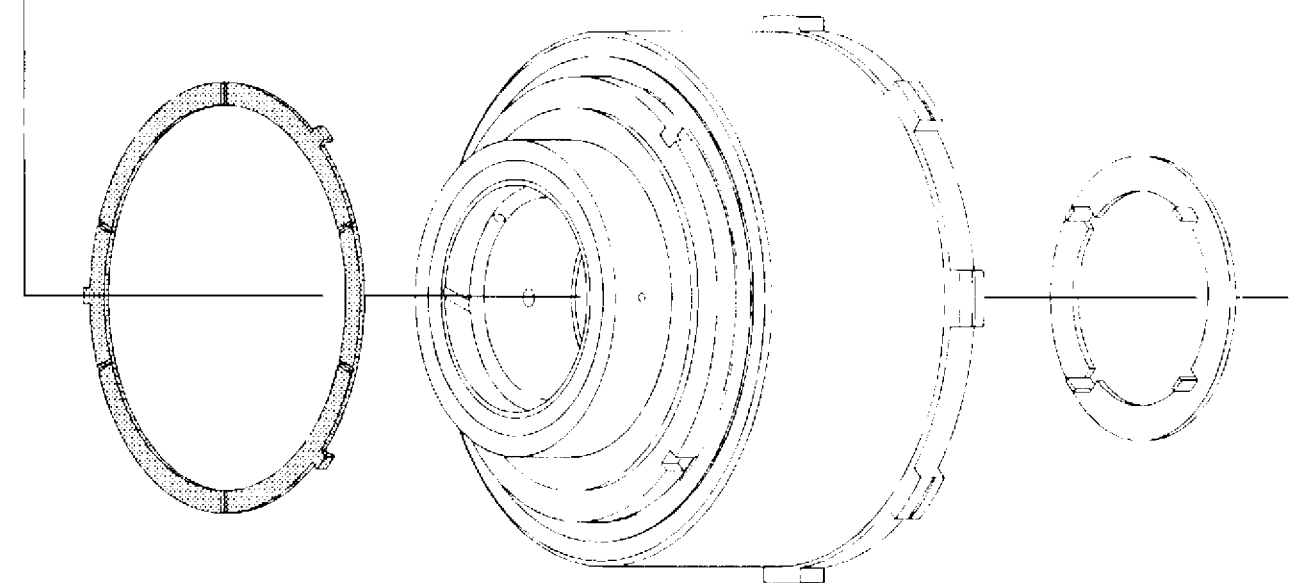
FORD 4R100
INTERMEDIATE "DIODE" FREEWHEEL

Intermediate Sprag Assembly
Part Number E91Z-7A089-B

Outer Race To Drum Thrust Washer
Part Number E91Z-7G401-A

Direct Clutch Housing
Part No. YC3Z-7D044-BA (No Washer)
Part No. F81Z-7D044-BA (With Washer)
