Technical Service Information

THM 3T40 (125C) RATTLE OR CLICKING NOISE

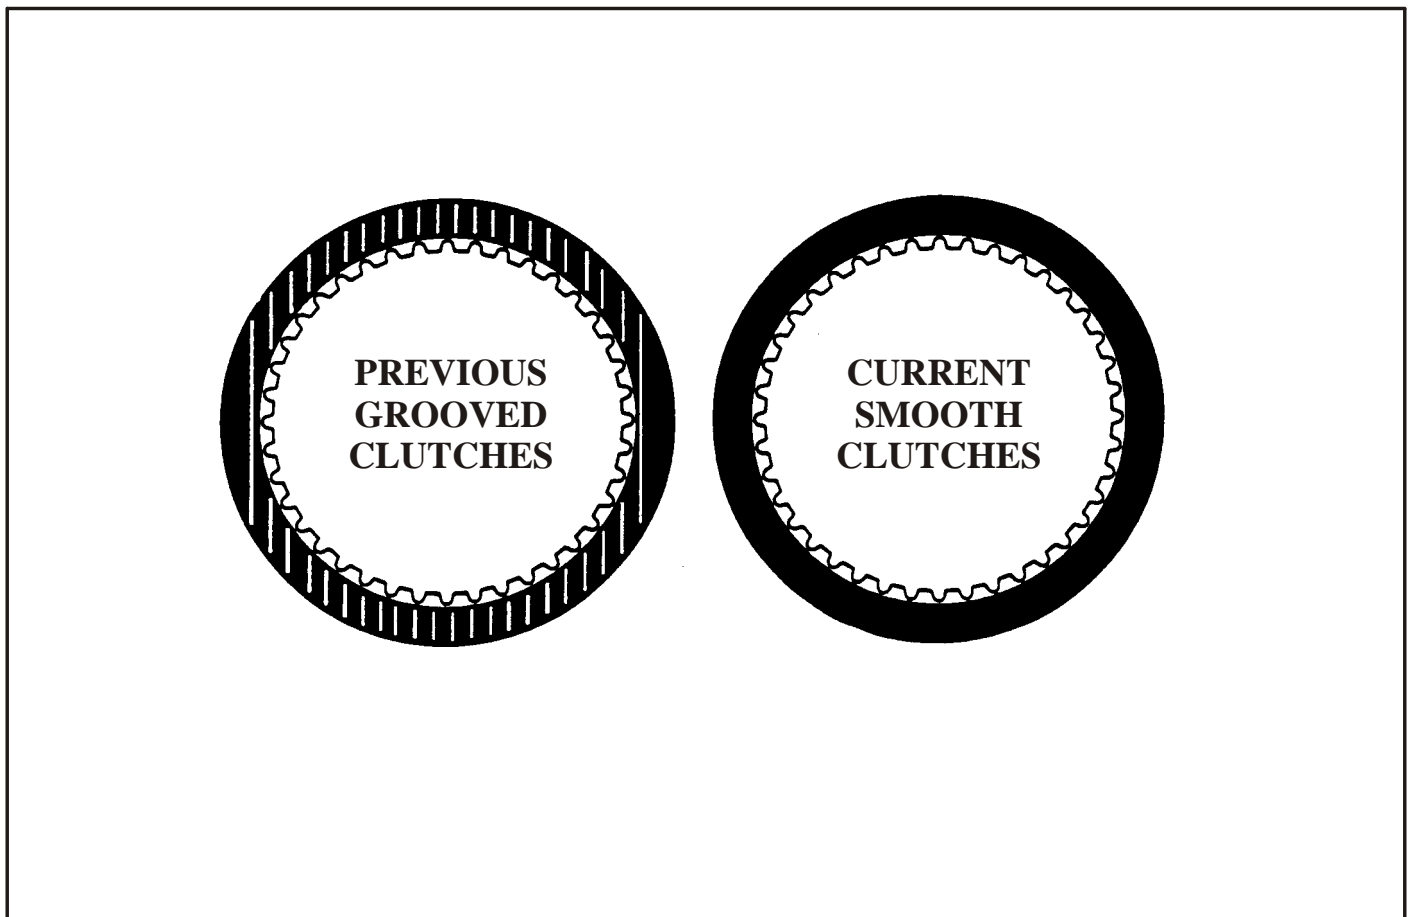
Figure 1

COMPLAINT: An intermittent rattle and/or clicking noise that is most evident in 3rd gear.

CAUSE: The noise may be caused by 'Grooved' lo-reverse lined clutch plates (See Figure 1).

CORRECTION: Install 'Smooth' lo-reverse lined clutch plates, available under OEM Part No. 8666667 the new clutch plates went into production May 5, 1989 (Julian Date 125).
