## THM 440-T4 DELAYED 2-3 SHIFT

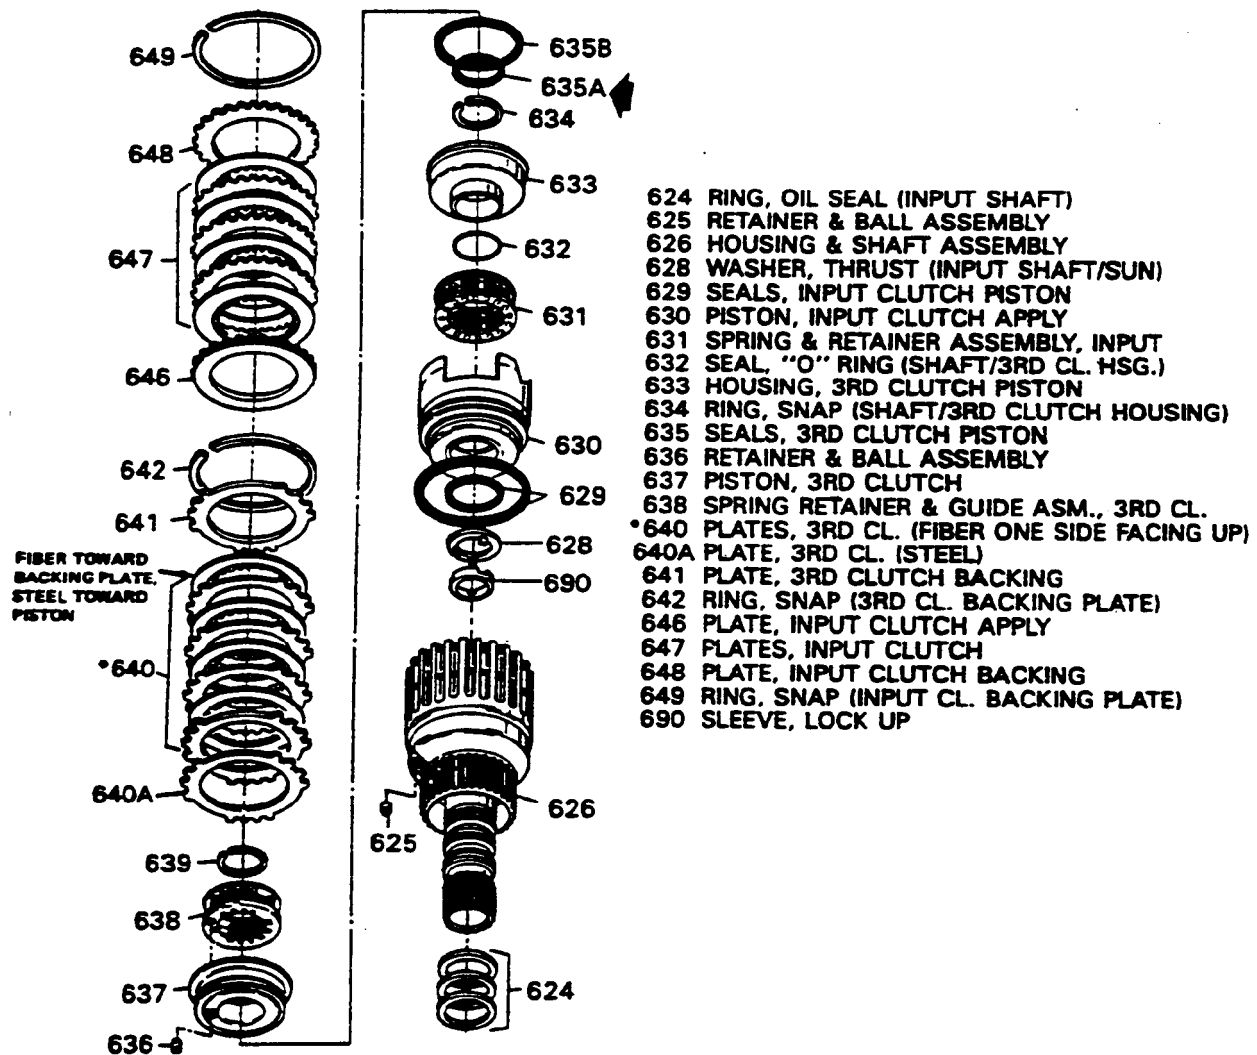
Figure 1

A long and/or delayed 2-3 shift on THM 440-T4 transaxle may be caused by a leaking 3rd clutch inner seal (Figure 1, Item 635A). A new, thicker seal is used in production and available for service replacement. The new seal can be recognized by a small group of hash marks on the inside diameter of the seal.
