THE SEMINAR TO SEE IN '93

TRANSMISSION SEMINAR 1993

This years "Seminar To See In '93" Will cover the most asked questions from the ATSG "Hotline" on the 4I60 (700-R4), 4T60 (440-T4), 4L80-E (400 Overdrive), and the Chrysler A500/518. This information will help when the same type problems arise on the vehicles coming into your shop.

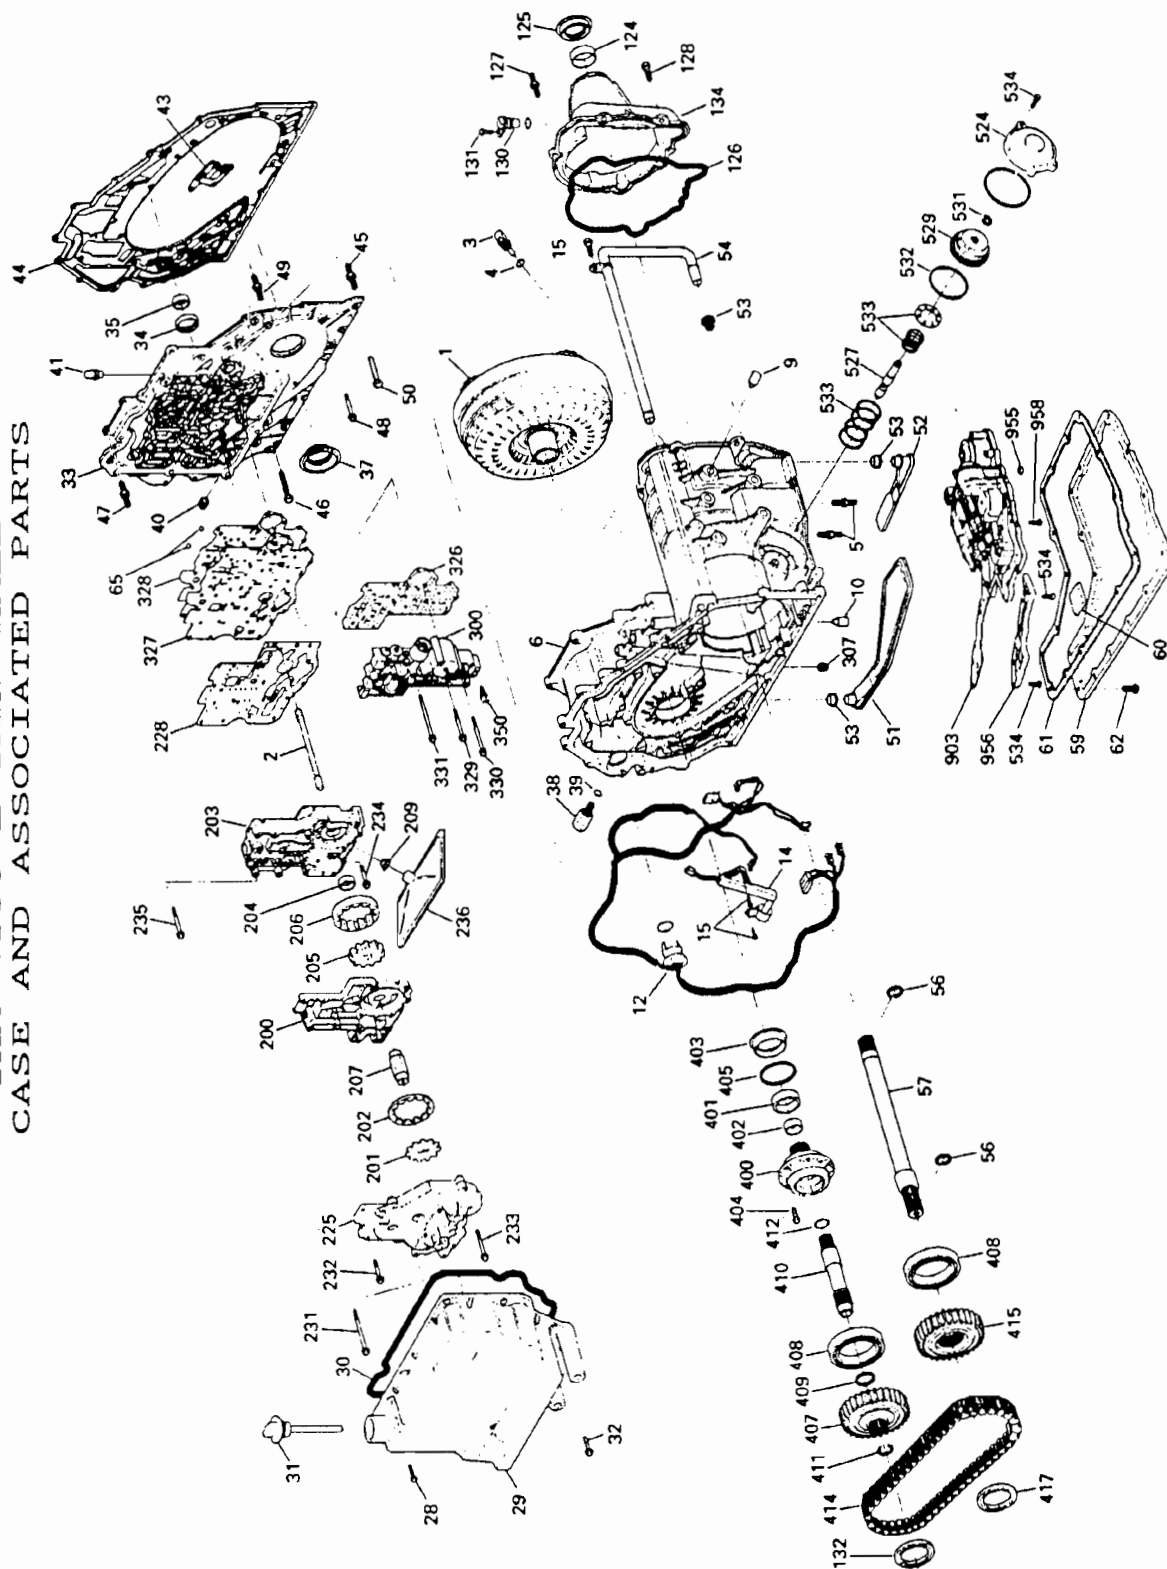
Figure 1

THM 4T80-E TRANSAXLE
CASE AND ASSOCIATED PARTS

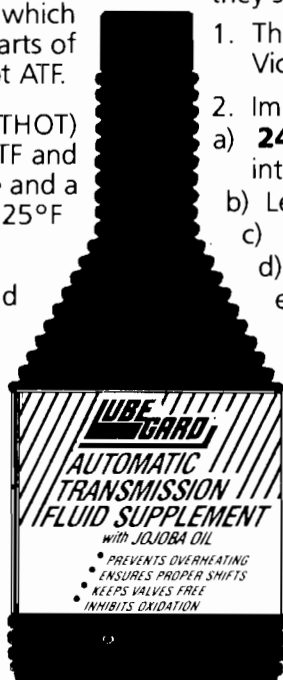
The tests run on the ATF with and without LUBEGARD® were:

1. Vickers® Sliding Vane Pump Wear Test which measures the wear on rubbing metal parts of a pump after 100 hours of pumping hot ATF.
2. Turbo Hydra-matic Oxidation Test (THOT) which measures the condition of the ATF and a bench stand transmission after twelve and a half days of running and shifting at 325°F with air injected into the fluid.
3. High Energy Friction Coefficient and Durability Test (HEFCAD) which measures the twisting (torque) of the motionless shaft of a set of automatic transmission clutches when stopping a flywheel moving at 3600 rpm on the other shaft in less than a second. The wheel is stopped and started 3 times per minute for 100 hours.

TEST RESULTS

Test results on GM Factory Fill with LUBEGARD® were compared to GM Factory Fill without LUBEGARD®, they showed:

1. The wear on the contacting parts of the Vickers® Vane Pump was reduced **over 50%**.
2. Improvement in areas of Oxidative Stability:
 - a) **24%** less oxidative breakdown of the ATF into acids.
 - b) Less sludge formation.
 - c) **30%** less oxygen uptake.
 - d) **60%** less pentane insolubles.
 - e) No penalty to transmission seals or fluid viscosity.
3. The following frictional improvements were:
 - a) Smoother, more stable power transfer through the clutches with less shock, or torque peak, at the beginning or the end of clutch engagement.
 - b) No sign of extra slipperiness that might cause excess clutch slippage and wear.

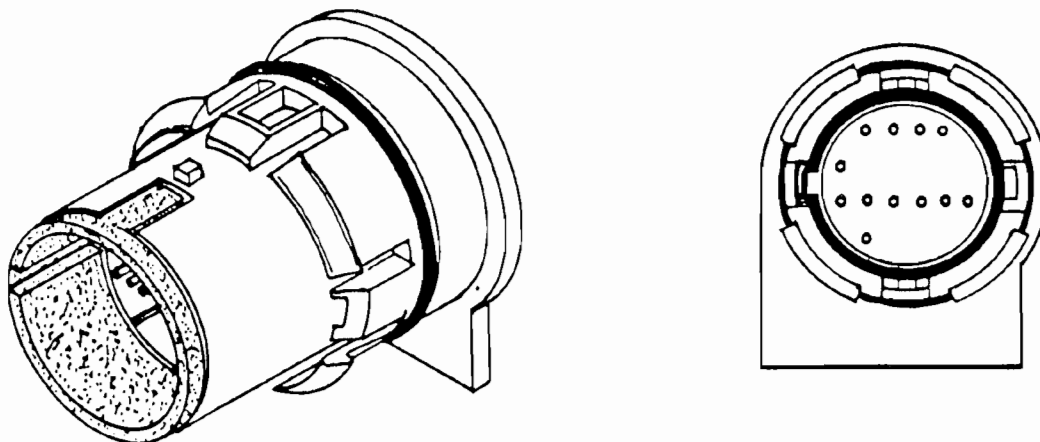
The transmission electrical connector is a very important part of the HYDRA-MATIC 4L60-E operating system. Anything that interferes with the electrical connection can cause the transmission to set Diagnostic Trouble Codes and/or operate incorrectly.

- Bent pins in the connector from rough handling during connection and disconnection
- Wires backing away from the pins or coming uncrimped (in either the transmission or vehicle wiring harness)
- Dirt contamination entering the connector when it is unconnected
- Pins in the connector backing out of the connector or pushed out during connection
- Excessive transmission fluid leaking into the connector, wicking up into the vehicle wiring harness and degrading the wire insulation *
- Water/moisture intrusion in the connector
- Low pin retention from excessive connection and disconnection of the wiring harness
- Pin corrosion from contamination

NOTE: THE TRANSMISSION CASE CONNECTOR AND THE LOCK-UP SOLENOID ARE INTREGAL PARTS OF THE TRANSMISSION WIRING HARNESS AND MUST BE REPLACED AS AN ASSEMBLY.

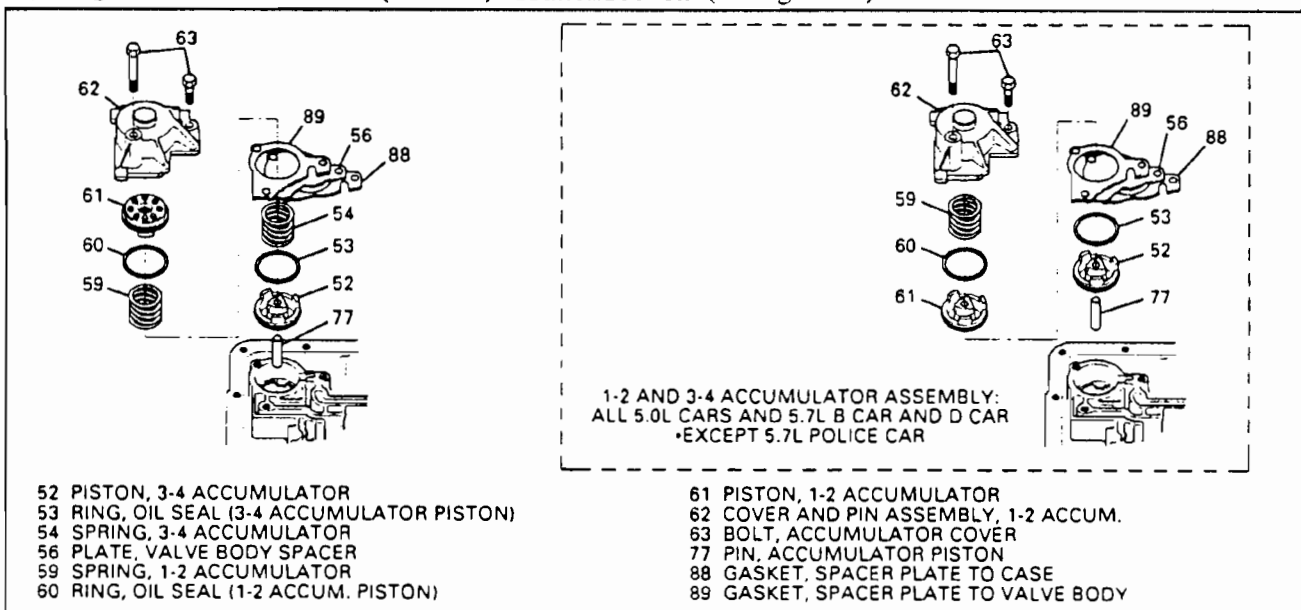
Figure 34

We have also provided you with the accumulator spring color code chart for ALL 1993 models of the THM 4L60 (700-R4) transmission (see figure 34).

1993 MODELS	BCM, BWM	AAM, ADM, AFM, ASM, BBM, BHM, BRM	SAM	SFM	HBM, HLM	HJM	HDM	YAM, YCM, YDM, FFM, FMM	FAM, FOM	BFM, LHM	BAM, CPM
1-2 ACCUMULATOR SPRING COLOR	DARK GREEN	YELLOW	YELLOW	NO PAINT	DARK GREEN	VIOLET	DARK GREEN	YELLOW	YELLOW	NO PAINT	NO PAINT
3-4 ACCUMULATOR SPRING COLOR	NOT USED	NOT USED	RED	DARK GREEN	YELLOW	YELLOW	VIOLET	NO PAINT	VIOLET	NO PAINT	VIOLET

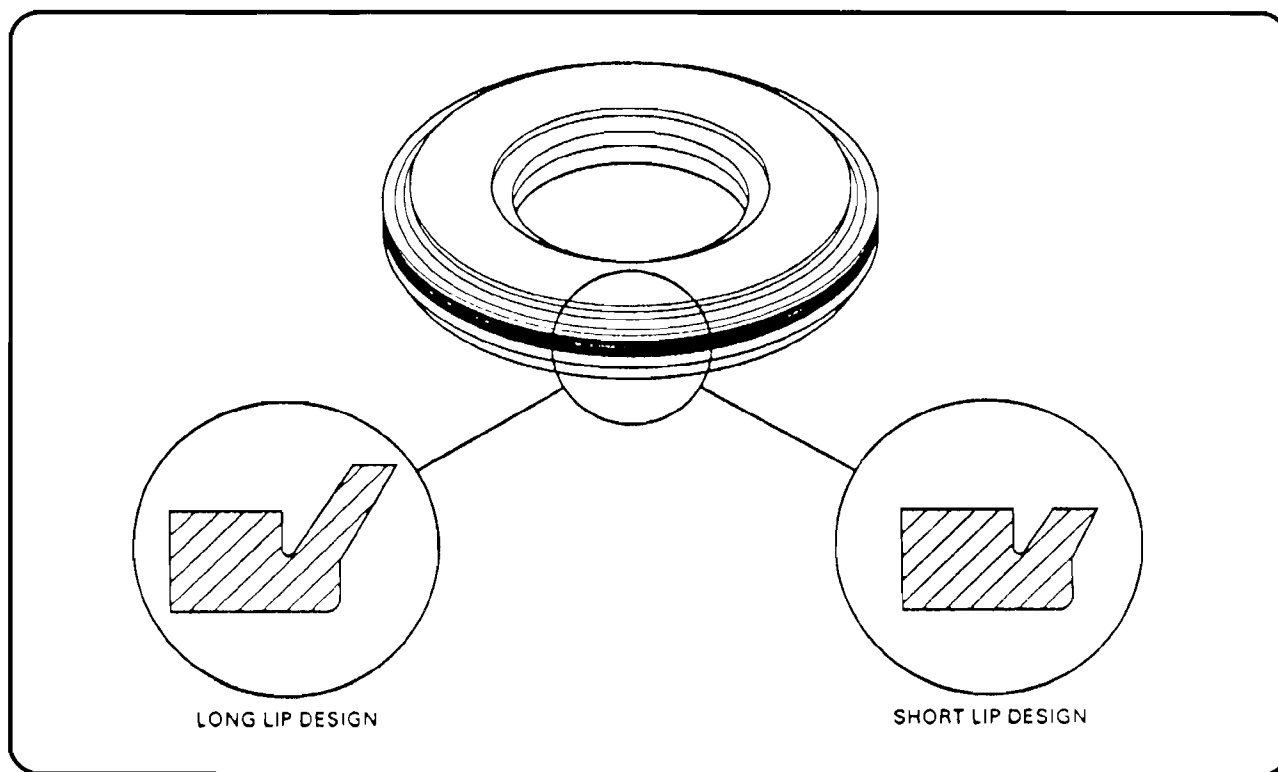
Figure 36

COMPLAINT: Some 1989-1991 THM 4L60 (700-R4) transmissions may exhibit a no reverse or delayed reverse condition, especially when the outside temperatures drop near 20° Farenheit.

CAUSE: The cause may be a "Short Lip" design seal installed on the reverse input clutch piston outer seal (See Figure 36).

Overhaul Seal and Gasket Package 8683958

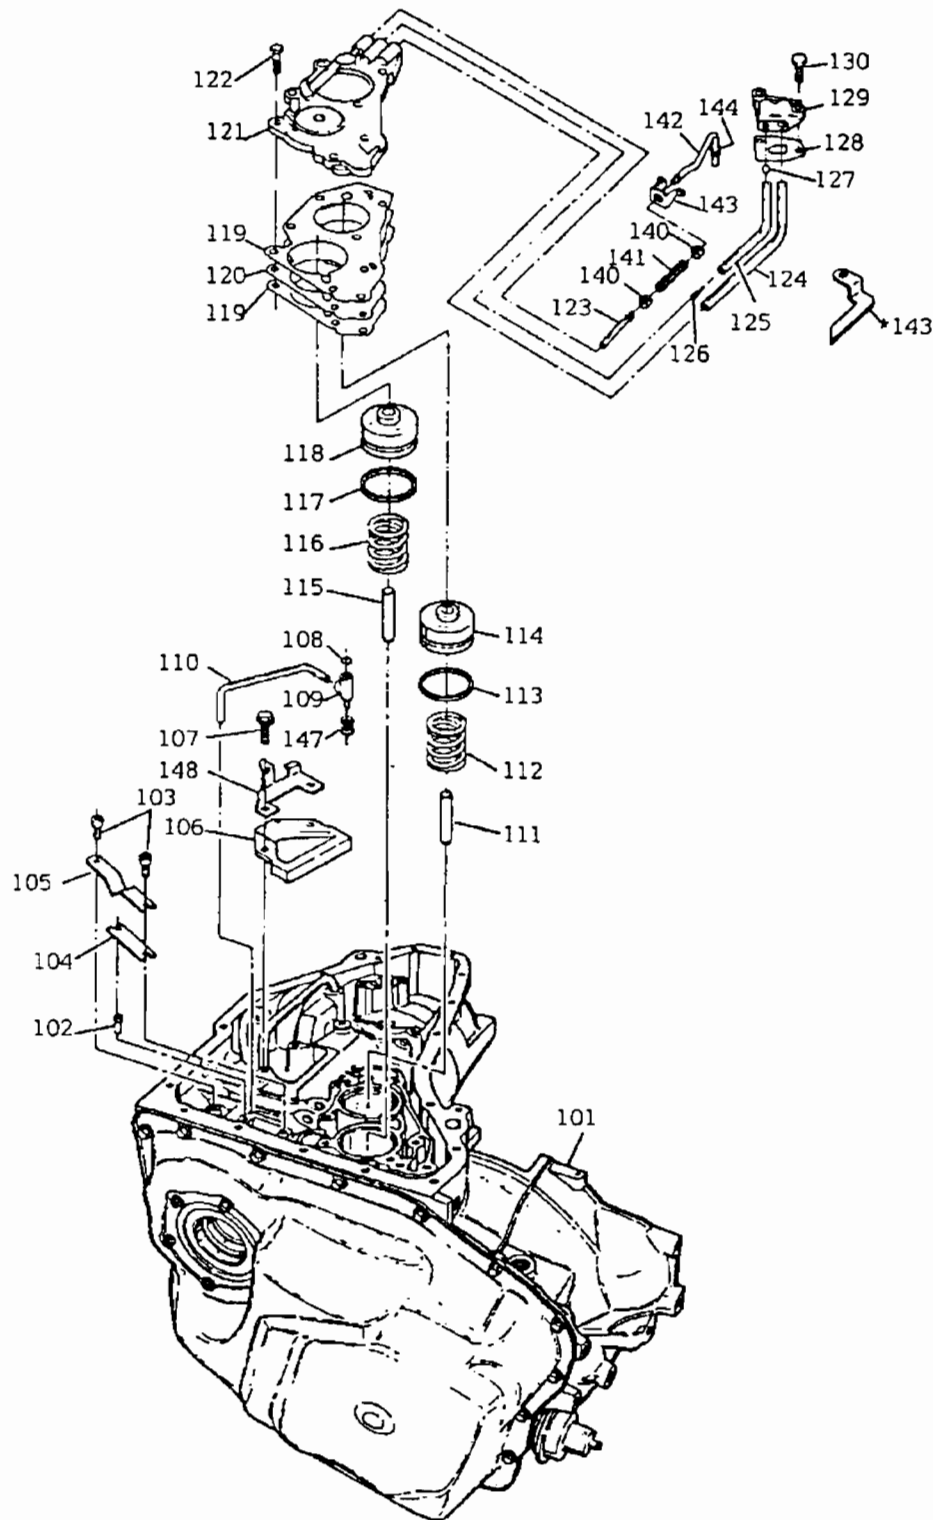
Figure 38

- COMPLAINT:** Vehicle starts in 2nd gear after a upshift sequence, but will usually take manual low.
- CAUSE:**
- No. 1- Line pressure too high.
 - No. 2- Double gaskets or damaged gaskets on the 1-2 and 3-4 accumulator spacer plate (see figure 38).

- No. 2- Use only one gasket on each side of the plate and replace gasket as necessary
 - No. 3- A) Modify the original 1-2 shift valve as shown in figure 40. This is a very simple machining operation on a lathe. The factory has upgraded the 1-2 shift valve with a "boss cast on the end of the valve.

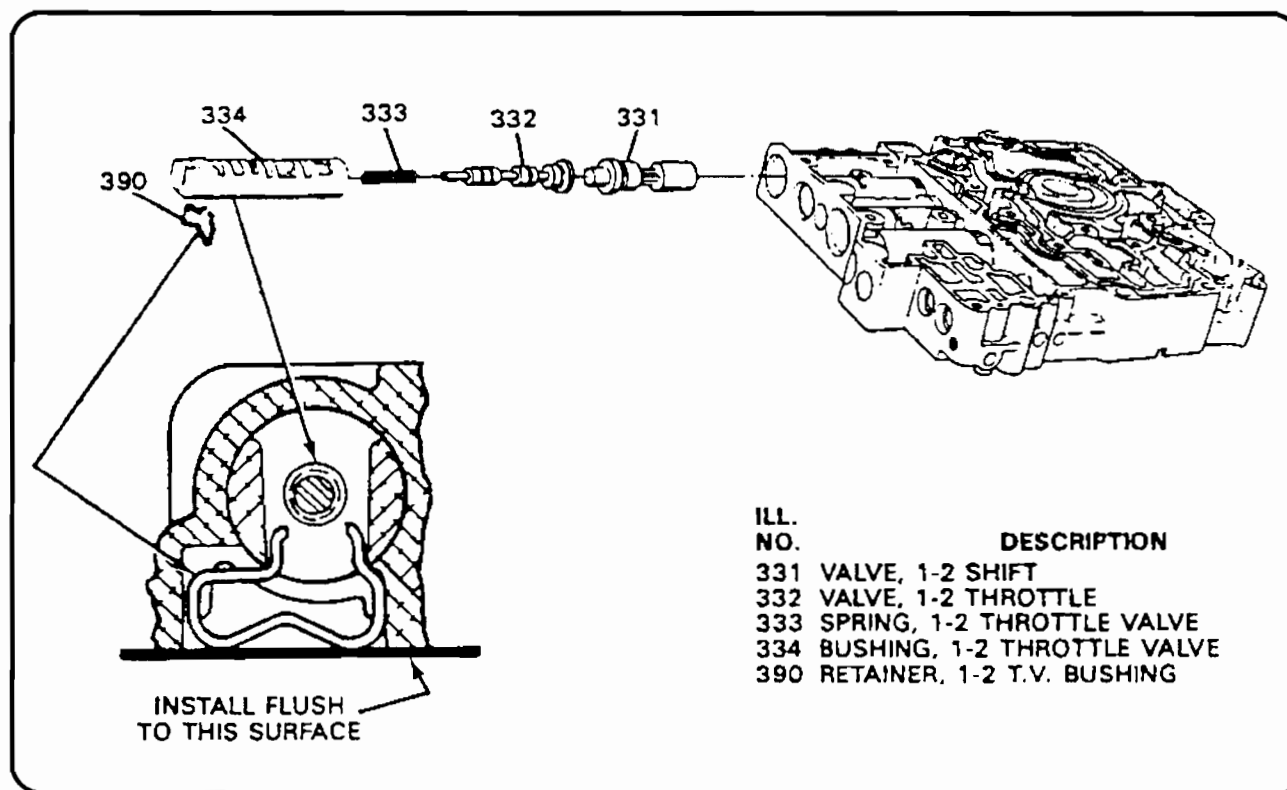
Figure 41

B) The 1-2 shift valve, throttle valve or spring may be pushed in too far. The retainer should be installed flush with the machined surface of the valve body (see figure 41).

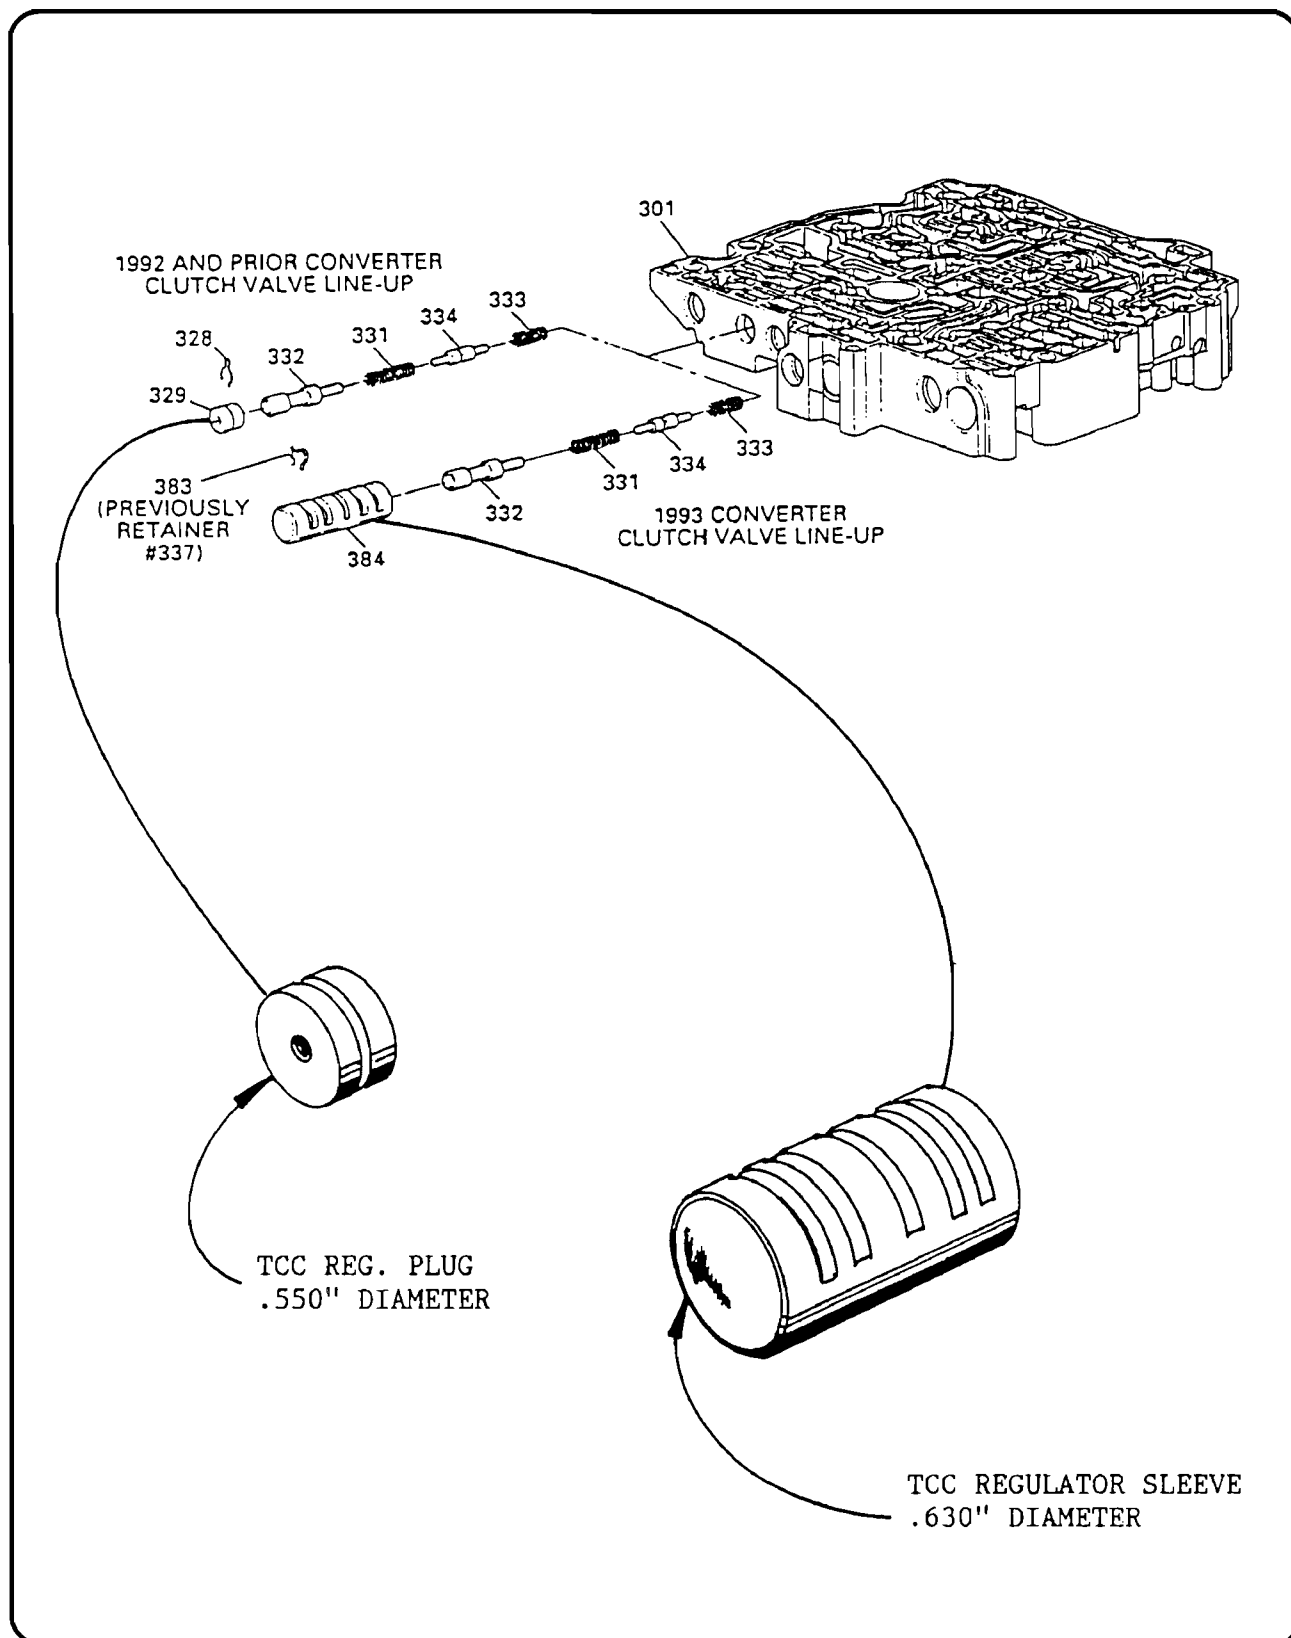
Figure 43

- (1) **VALVE BODY CASTING** - The aluminum plug and retainer clip for the converter clutch regulator valve were eliminated and replaced with a new bushing and a new style retainer. This makes it much easier to remove this line-up out of its valve body bore (See Figure 42).
The 1-2 accumulator valve bushing (Both Primary and Secondary), the 2-3 accumulator valve bushing, and the 3-4 accumulator valve bushing were also re-designed for improved shift feel.
These changes required changes in the worm tracks in the valve body casting and the easiest way to identify the 1993 valve body is the diameter of the TCC regulator bore as shown in Figure 43.

NONE of the parts listed above will interchange with one another. If you change one piece, you must change them ALL.

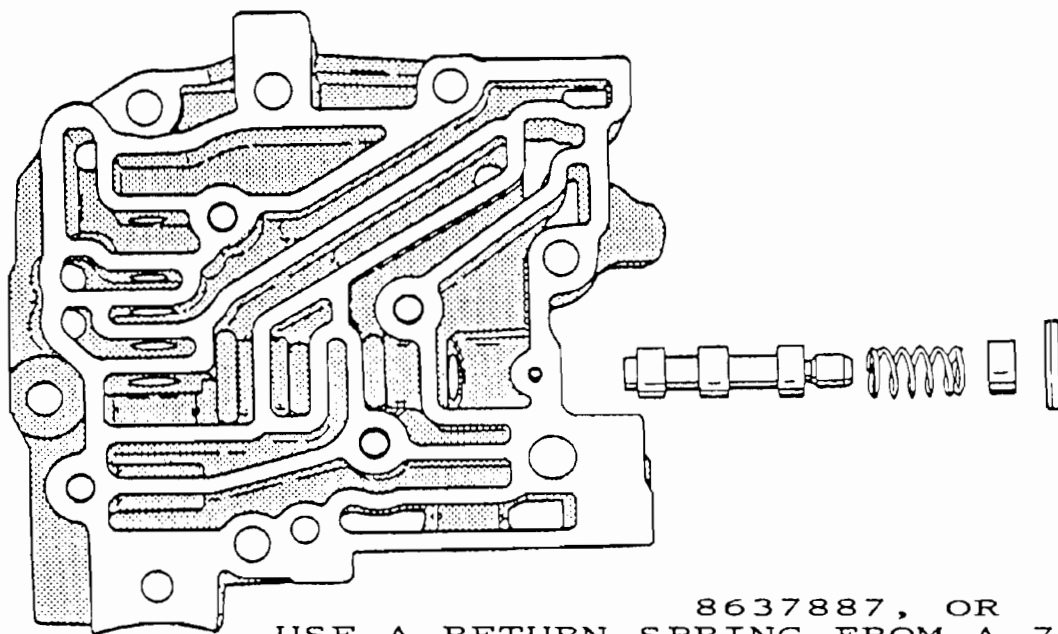
Figure 50

CAUSE: One cause may be low converter charge pressure. Another cause may be slow drain of converter release oil from the front side of the converter clutch piston.

CORRECTION: Install a stronger converter clutch regulator valve spring, OEM part number 8637887, or use a return spring from a 700 reverse input housing return spring assembly. Also drill the converter clutch exhaust hole in the spacer plate to .080"
Refer to Figures 50 & 51

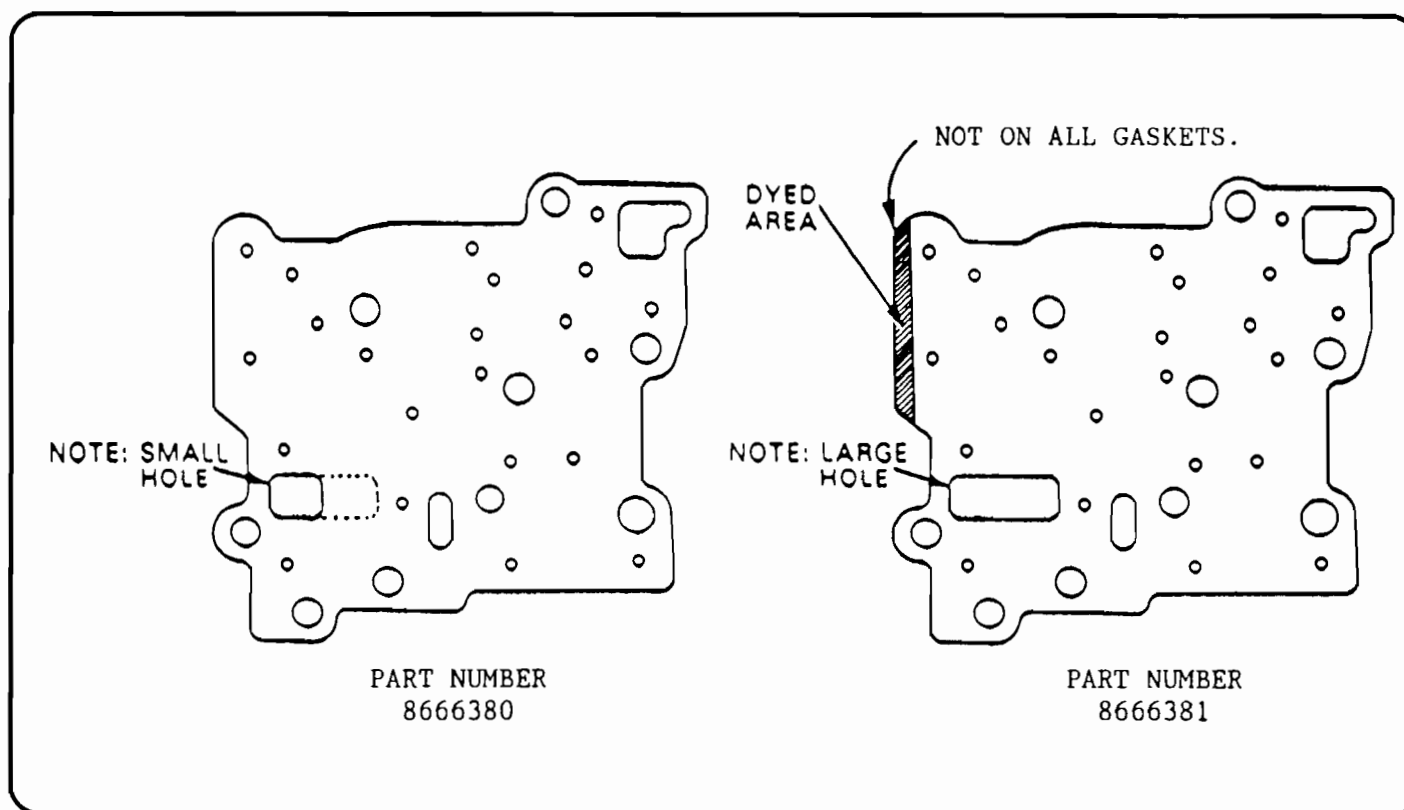
Figure 52

CAUSE: Not enough converter clutch apply oil.

CORRECTION: Install the auxiliary valve body cover gasket with the large hole (see figure 52), or modify the gasket with the small hole by cutting on the dotted line to make a large hole gasket out of the small hole gasket (see figure 52).

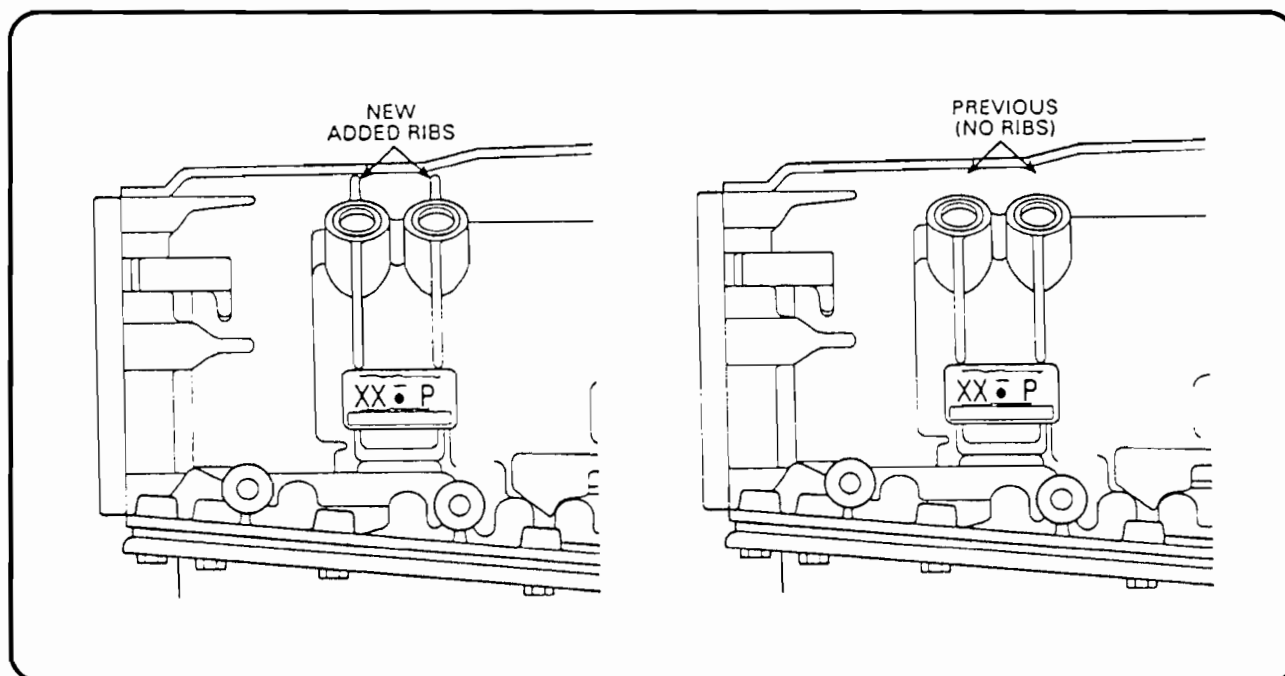
Figure 60

- COMPLAINT:** Some THM 4L80-E/4L80-E transmissions may experience a no reverse condition and/or a broken case assembly in the area of the rear band anchor pins.
- CAUSE:** This is caused by the lugs on the rear band assembly not holding on the case anchor pins, causing the reaction drum not to hold.
- CORRECTION:** Beginning on April 11, 1992 (Julian Date 101) all THM 4L80-E/4L80-EHD transmissions were built with a revised reverse band assembly which is wider in the band lug area (See Figure 59) , and should be used during all rebuilds.
All 1992 model THM 4L80-E/4L80-EHD transmissions were built with a new case assembly with "Added Ribs" in the anchor pin area (See Figure 60)

Reverse Band Assembly (New Design) 8681620

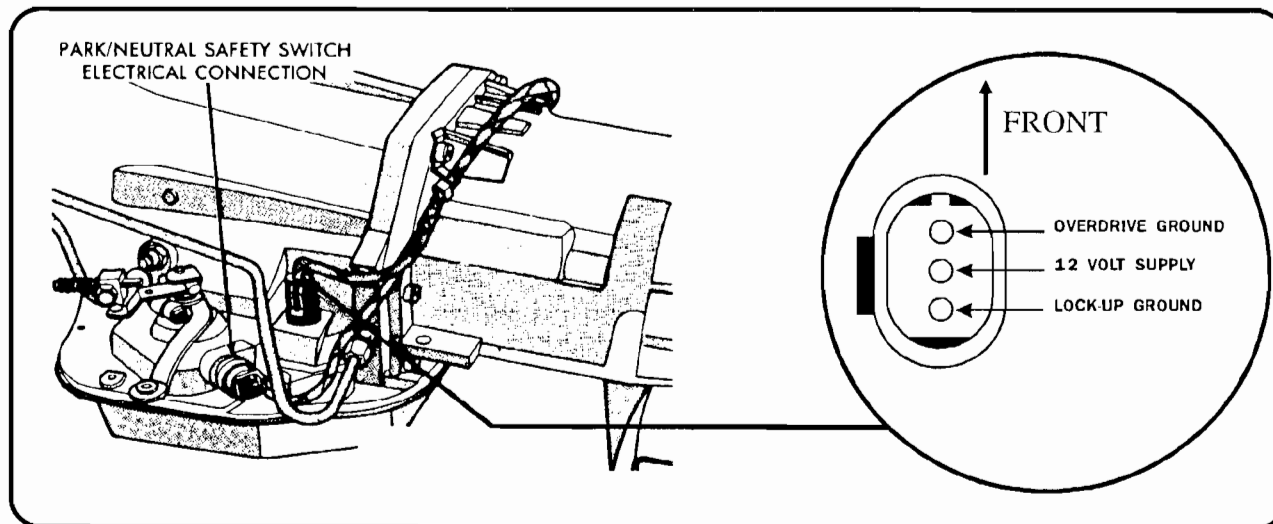
Figure 64 identifies the three terminals located in the case connector near the rear cooler fitting.

A quick check that can be made when the vehicle has lost lock up and overdrive is to supply your own 12 volts to the middle pin. When the vehicle is in third gear, ground the front pin. A shift to overdrive should be felt. When the rear pin is grounded, lock up should come on. If one or both operations has failed with this test, the problem is an internal one and will require a solenoid check. Both solenoids are normally open to exhaust and closes when energized and should have 25 to 35 ohms resistance at room temperature. When this check has been completed and the solenoids are in good working order, there is a non-electrical fault in the transmission causing the no overdrive or no lock up condition.

If the quick test shifted the transmission into overdrive and lock up came on, then an external electrical problem exists. A scanner will interface with the SMEC to retrieve fault codes. Figure 65 shows the location of the diagnostic connector and the SMEC with its 60 way and 14 way connectors.

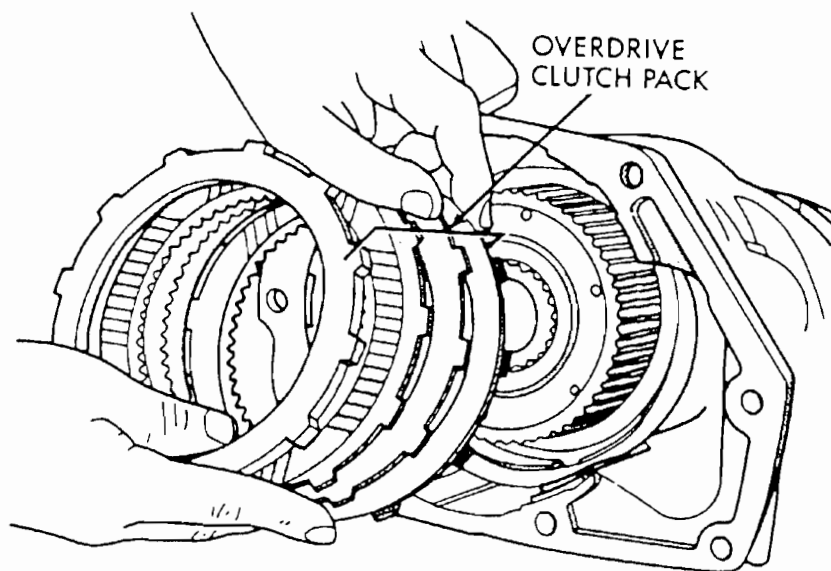
Figure 73

- COMPLAINT: The transmission may exhibit a "rattling" sound when the 3-4 and/or 4-3 shifts occur.
- CAUSE: The clearance in the O.D. clutch pack causes a rattling condition during the apply and release.
- CORRECTION: Install new waved overdrive plates part # 4461181

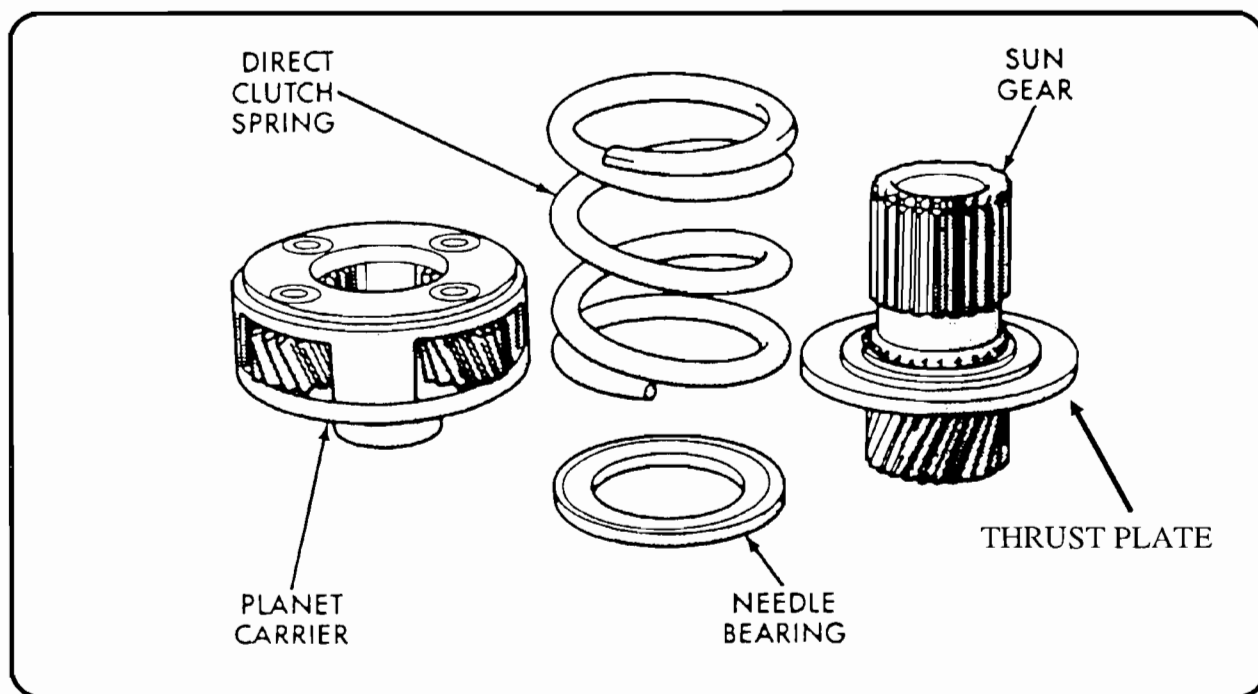
Figure 74

A new bearing and thrust plate has been designed for better lube to this area. this will retro fit back to all models and is highly recommended

UPDATED THRUST PLATE.....4461125
UPDATED THRUST BEARING.....4461126

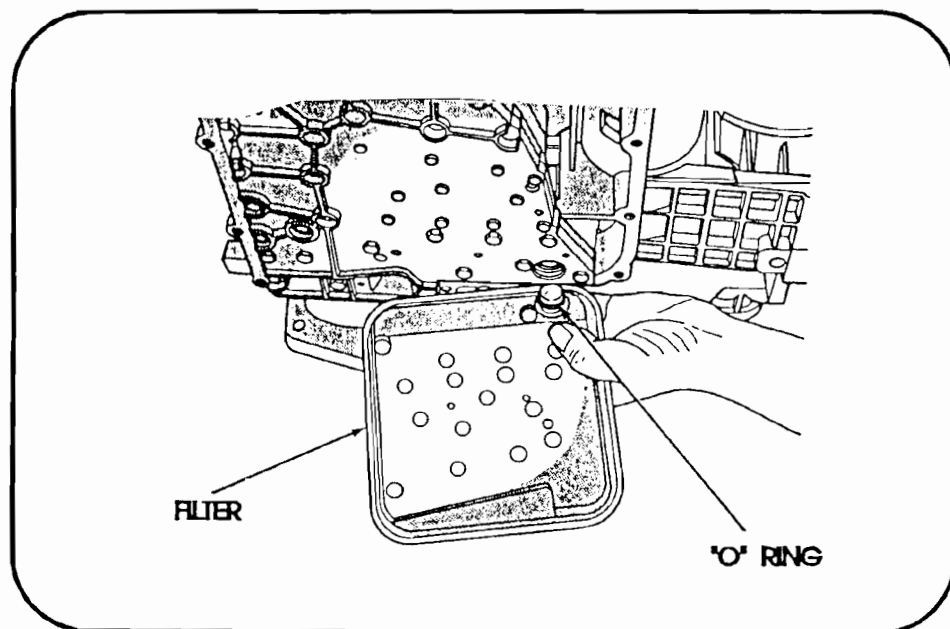
Figure 83

- NOTE:** Always replace the filter "O" ring and pre-fill the filter with clean fluid. (see figure 83).
