## **FORD AOD NO KICKDOWN OR PASSING GEAR**

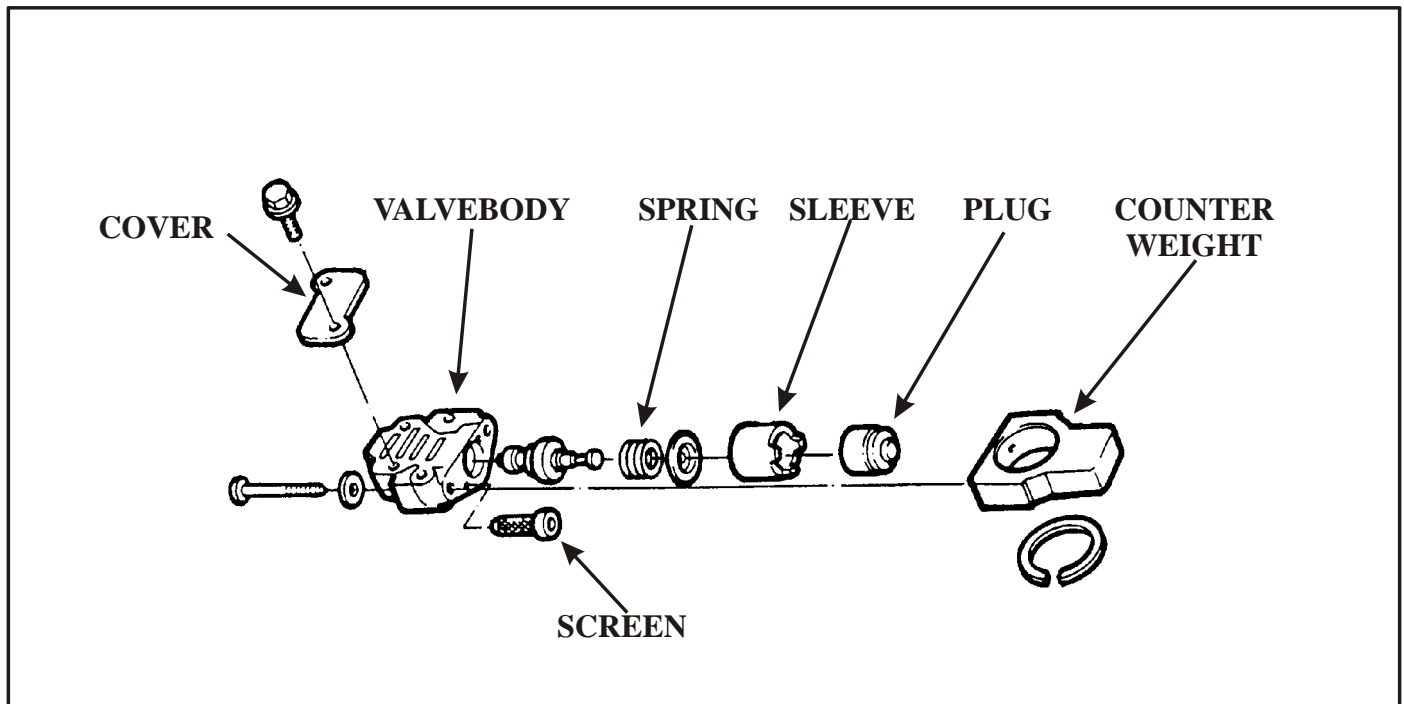
Figure 1

**COMPLAINT:** No kickdown or passing gear at any vehicle speeds or any throttle Position.

**CAUSE:** The cause may be the governor mis-assembled with the sleeve installed backwards. Proper installation is with the "Castles" towards the counterweight, as shown in Figure 1.

**CORRECTION:** Install sleeve with the "Castles" towards the counterweight, as shown in Figure 1.
