THM 4T60-E (CADILLAC)

3RD GEAR STARTS

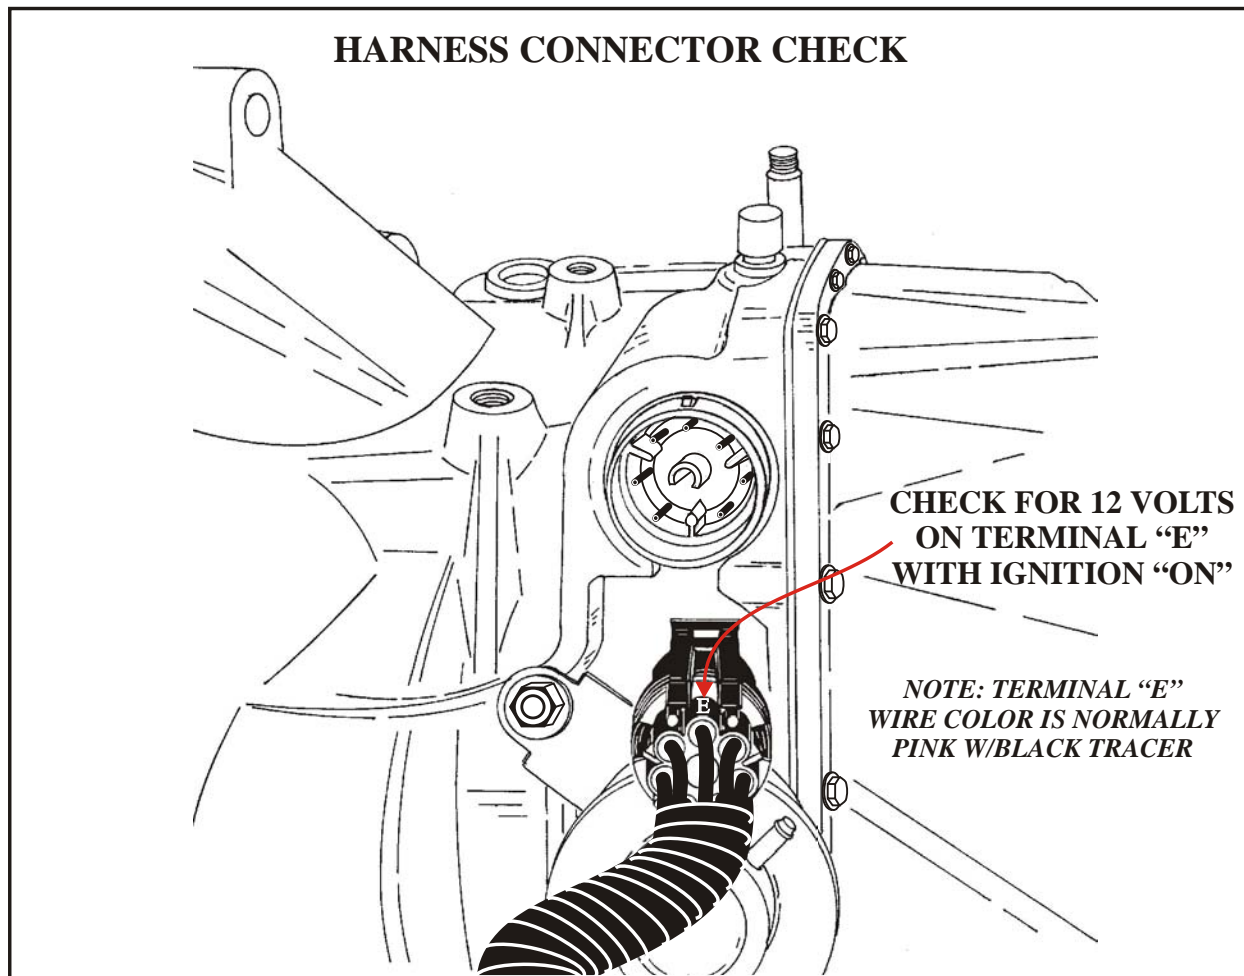
Figure 1

CORRECTION: Locate the "E" terminal on the harness connector, shown in Figure 1, and check for battery voltage with the ignition on. If there is NO voltage at terminal "E", refer to Figures 2&3 for fuse location and vehicle application and replace the fuse. **NOTE:** The fuse in question is highlighted for identification purposes.

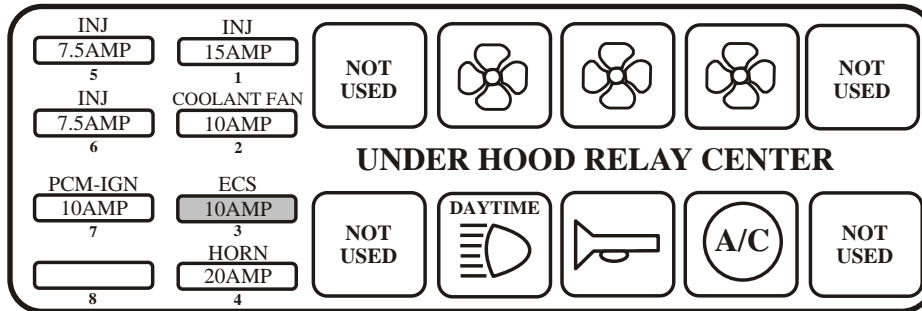
91 SEVILLE & ELDORADO

LOCATION: UNDER HOOD RELAY CENTER

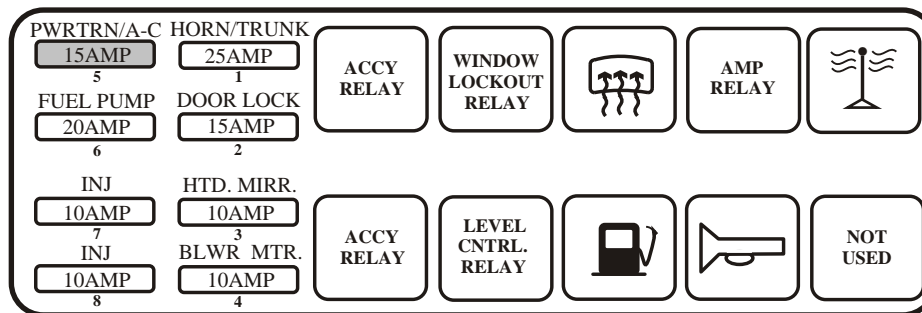
91- 93 DEVILLE

**LOCATION: INSTRUMENT PANEL FUSE BLOCK & RELAY CENTER
(INSIDE VEHICLE ON PASSENGER SIDE)**

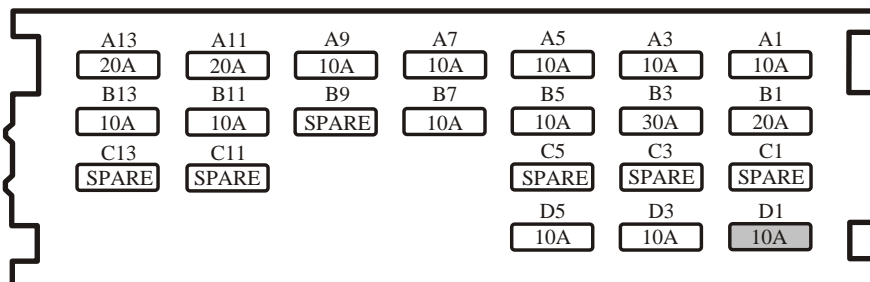
92 SEVILLE & ELDORADO

LOCATION: ENGINE COMPARTMENT FUSE PANEL
