# Technical Service Information

## FORD AXOD NEW SCREEN IN CASE

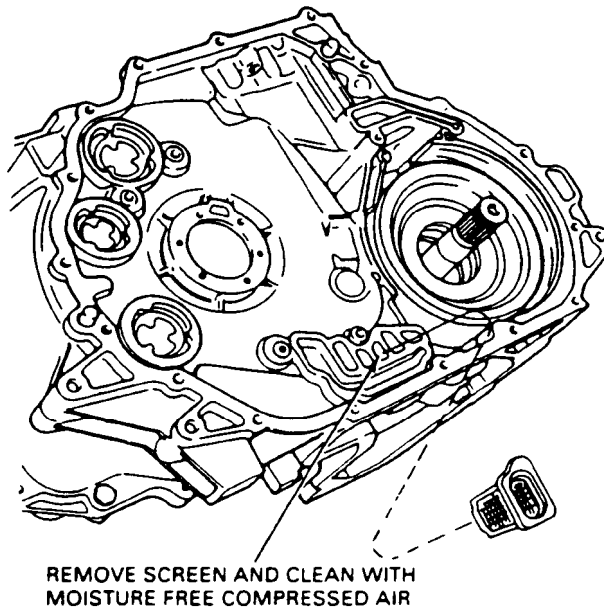
**CHANGE:** A new filter has been added to the 1989 AXOD 1-2 servo apply circuit (See Figure 1).

**REASON:** The filter prevents large metal chips from entering the valve body.

- (1) CHAIN COVER - 1-2 servo passage changed to accommodate the new screen,
- (2) TRANSAXLE CASE - 1-2 servo passage changed to accommodate the new screen.

The new screen WILL NOT retro fit to previous models. The 1-2 servo passage on the previous models chain cover will not accommodate the new screen and an interference will occur.

NOTE: A no forward condition could occur if the filter becomes contaminated.

New Filter..... E9DZ-7H162-A
