KM SERIES TRANSAXLES SHIFTS 1-3, THEN GOES TO FAILSAFE

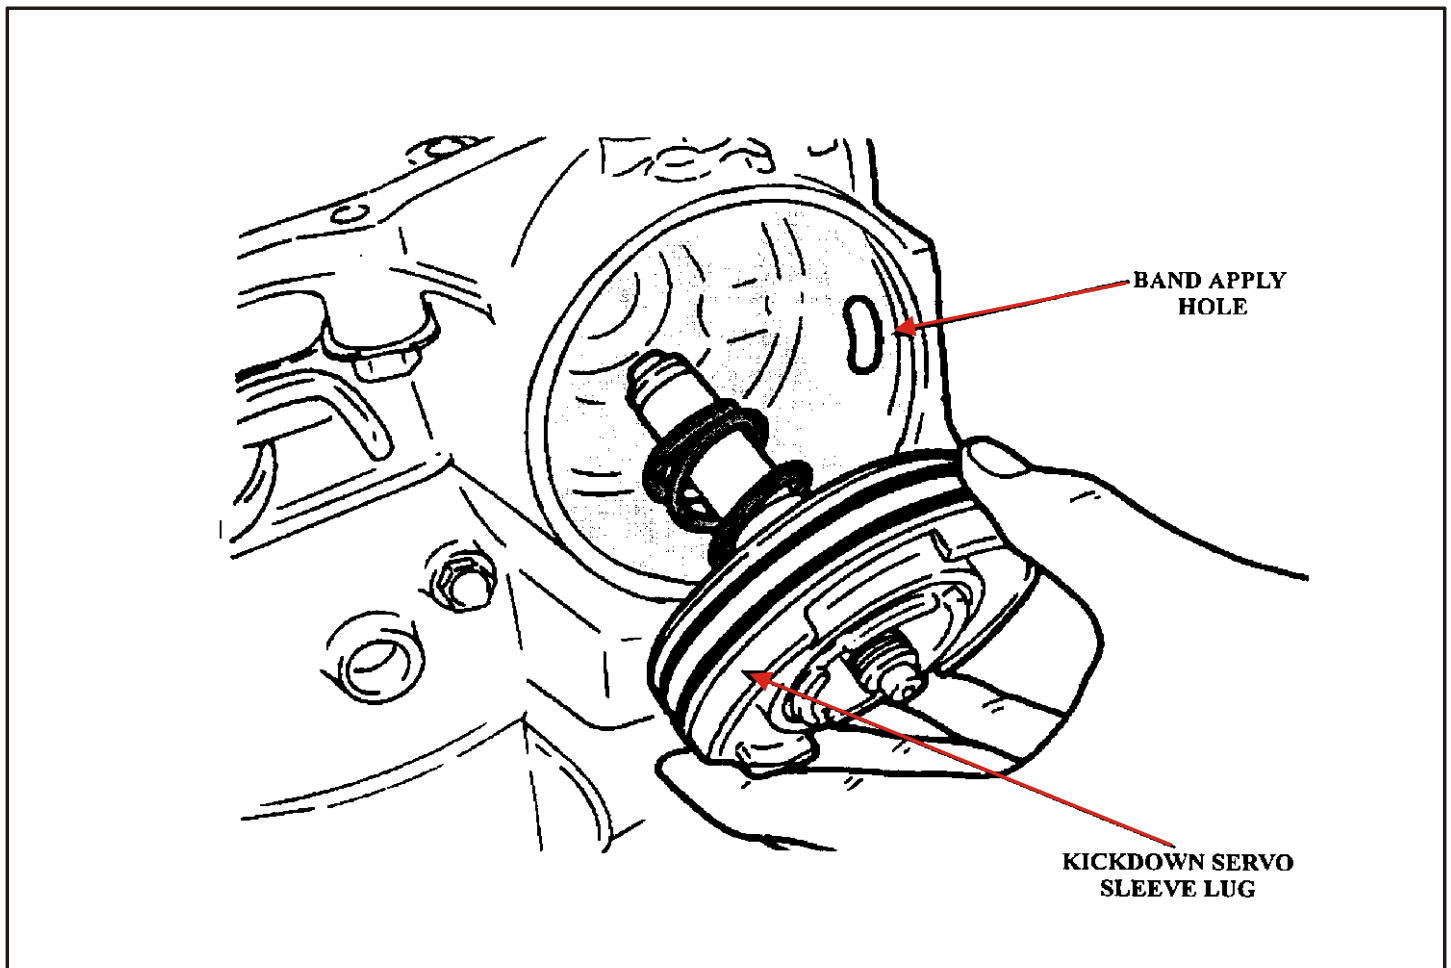
Figure 1

CAUSE: The cause may be, that the kickdown servo sleeve has been installed into the servo bore with the servo sleeve lug covering the band apply hole, preventing the band from coming on.

CORRECTION: Rotate the servo sleeve so that the band apply hole is fully open (See Figure 1).
