# Technical Service Information

## THM 440-T4 NEW 4TH CLUTCH STEEL PLATES

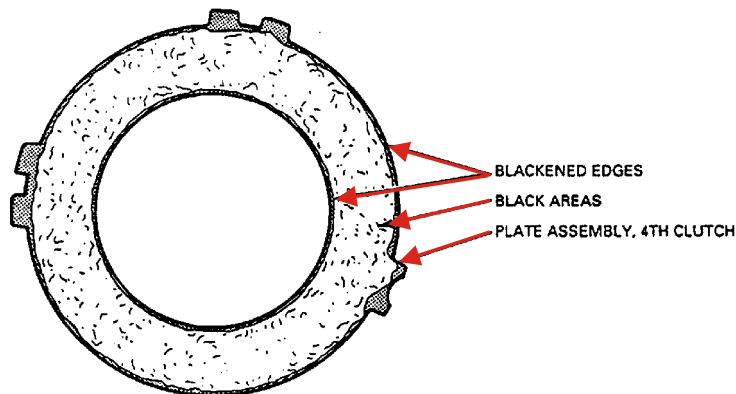
Figure 1

**CHANGE:** New 4th clutch steel plates with "Blackened" edges (See Figure 1).

(1) 4TH CLUTCH STEEL PLATES - Will have "Blackened" edges and the clutch surfaces will have some lightly blackened areas (See Figure 1). Do not replace the steel plates merely for this condition, as it is normal.

**REASON:** The new plates are made with a new process, to aid manufacturing. The by-product of this new process is that the edges will be blackened, and the clutch surfaces will have some lightly blackened areas.

The new "Blackened" 4th clutch steel plates will retro-fit back to ALL previous models. When the supply of previous steel plates is depleted, the blackened plate will be the only one available through OEM sources.
