Technical Service Information

FORD 5R55N VERSUS 5R55W TRANSMISSION DIFFERENCES

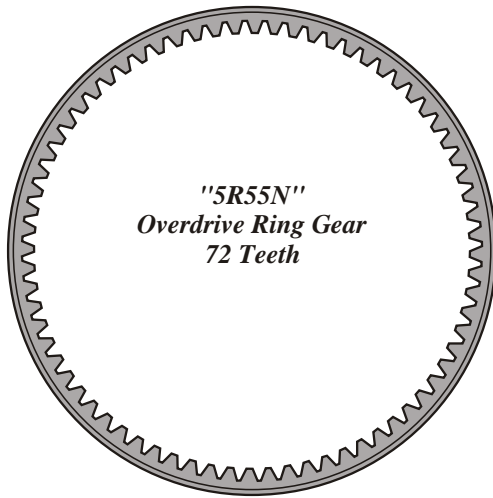
Figure 9

5R55N OVERDRIVE RING GEAR AND CENTER SHAFT

"5R55N"
Overdrive Ring Gear
72 Teeth

"5R55N"
Overdrive Center Shaft
72 Teeth

Figures 9 and 10 are illustrations of the two different overdrive ring gears and the overdrive center shafts. Notice the difference in the tooth counts of both pieces.

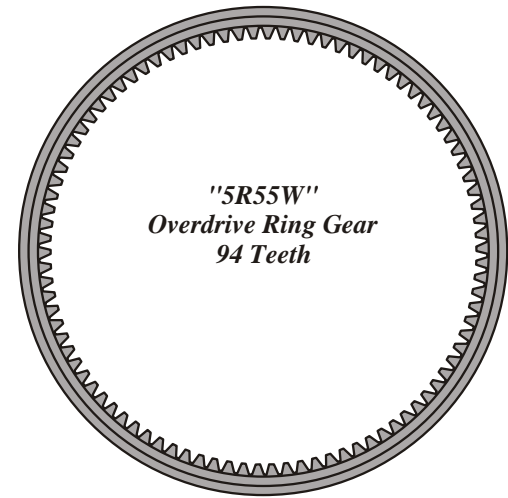
Figure 10

5R55W OVERDRIVE RING GEAR AND CENTER SHAFT

"5R55W"
Overdrive Ring Gear
94 Teeth

"5R55W"
Overdrive Center Shaft
94 Teeth
