# Technical Service Information

## THM 3T40 (125C) GOVERNOR SCREEN ADDED

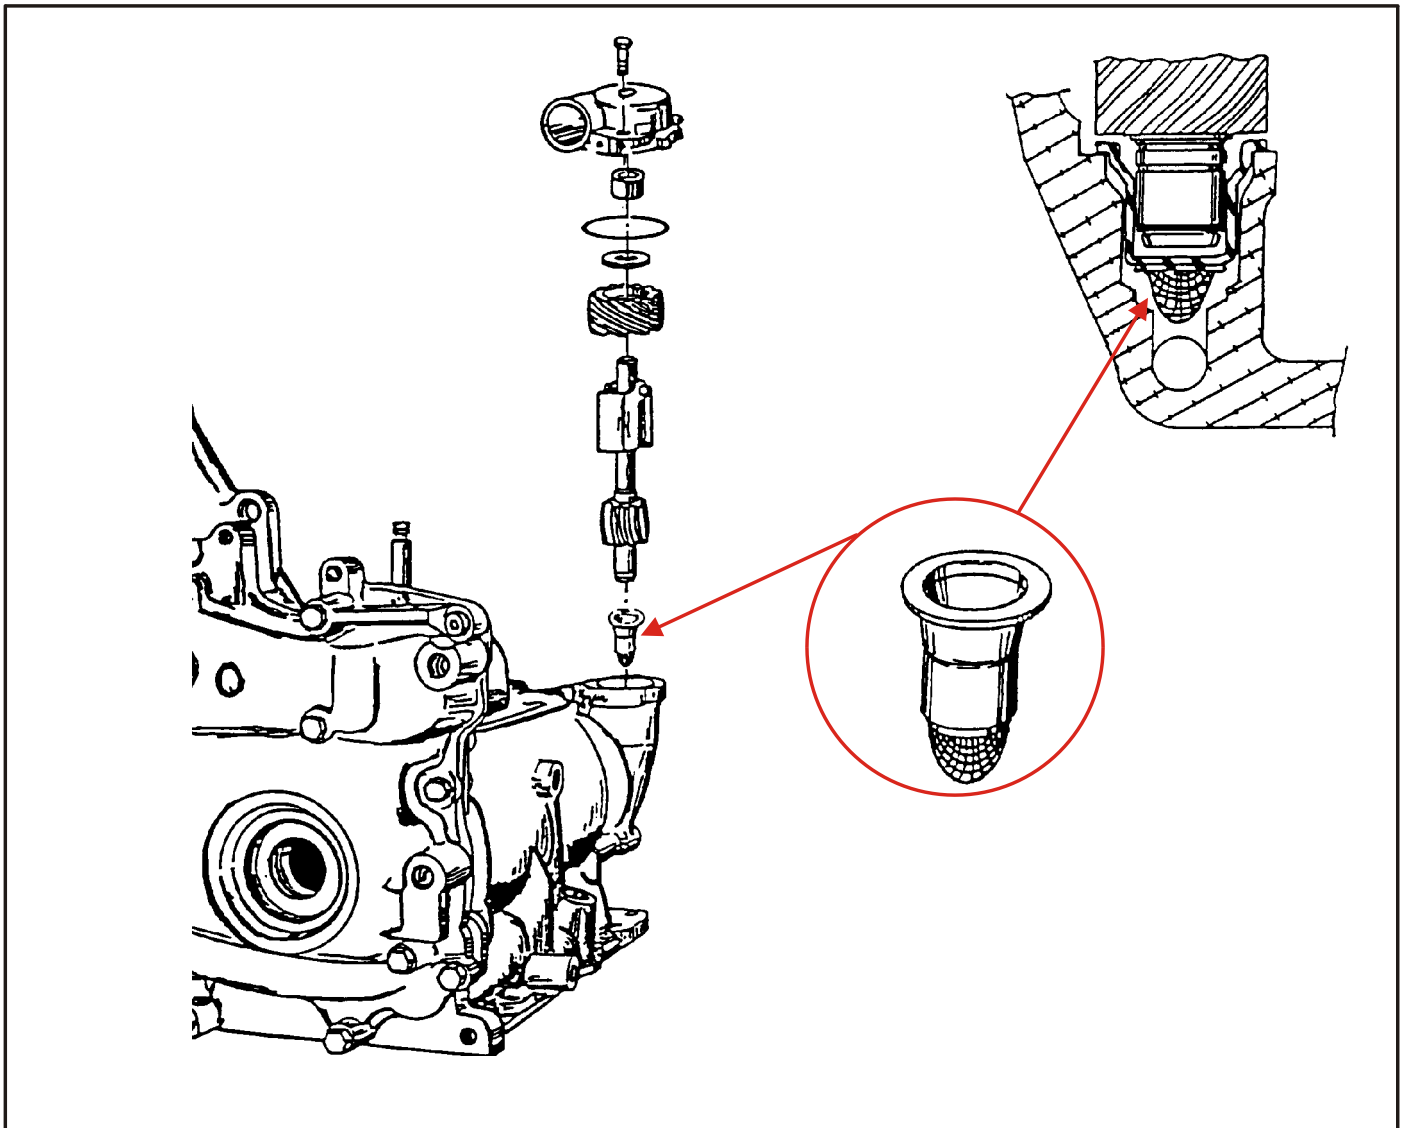
Figure 1

The governor screen was added (1986 Julian Date 203) to the governor sleeve in the case, to minimize the possibility of sediment entering the governor assembly and preventing the governor balls from seating properly (See Figure 1).

A machining change was needed in the case to make room for the new governor screen, thus it will not retro-fit to previous models.
