Technical Service Information

FORD 5R55N VERSUS 5R55W TRANSMISSION DIFFERENCES

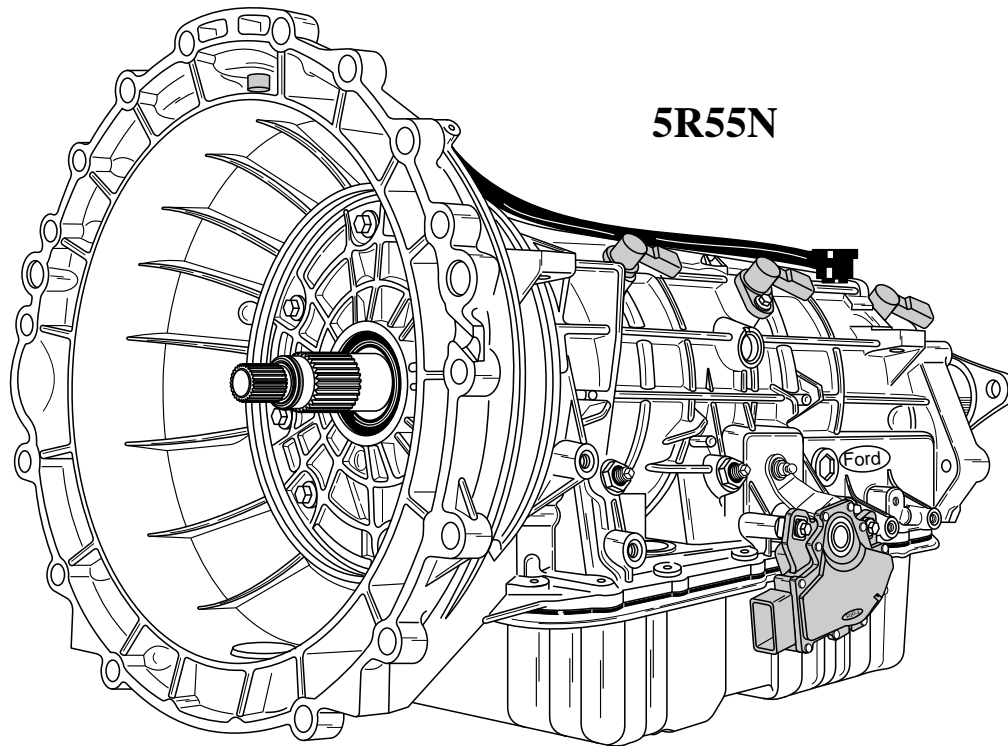
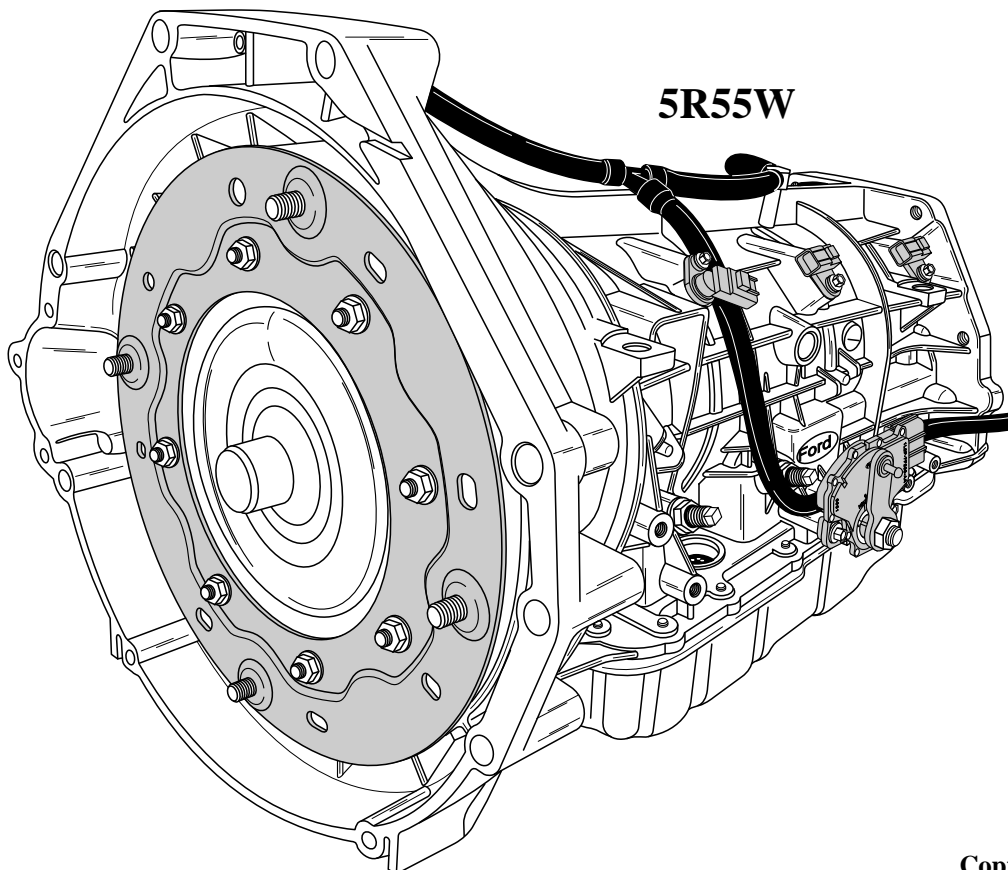
Figure 1

The Ford Motor Company's 5R55N (Non Sync.) transmission first appeared in the 2000 Lincoln "LS" and some of the Jaguar Models, which we are already somewhat familiar with. Beginning at the start of production for model year 2002, Ford has introduced the 5R55W (Wide Ratio) transmission into the some models of the Ranger and Explorer. The internal parts look almost identical, but will not interchange with their look alikes in the 5R55N transmission. The information in this bulletin will help you in getting the proper replacement parts back into the proper unit. Externally these transmissions are easy to identify and we have provided illustrations of both transmissions in Figure 1.

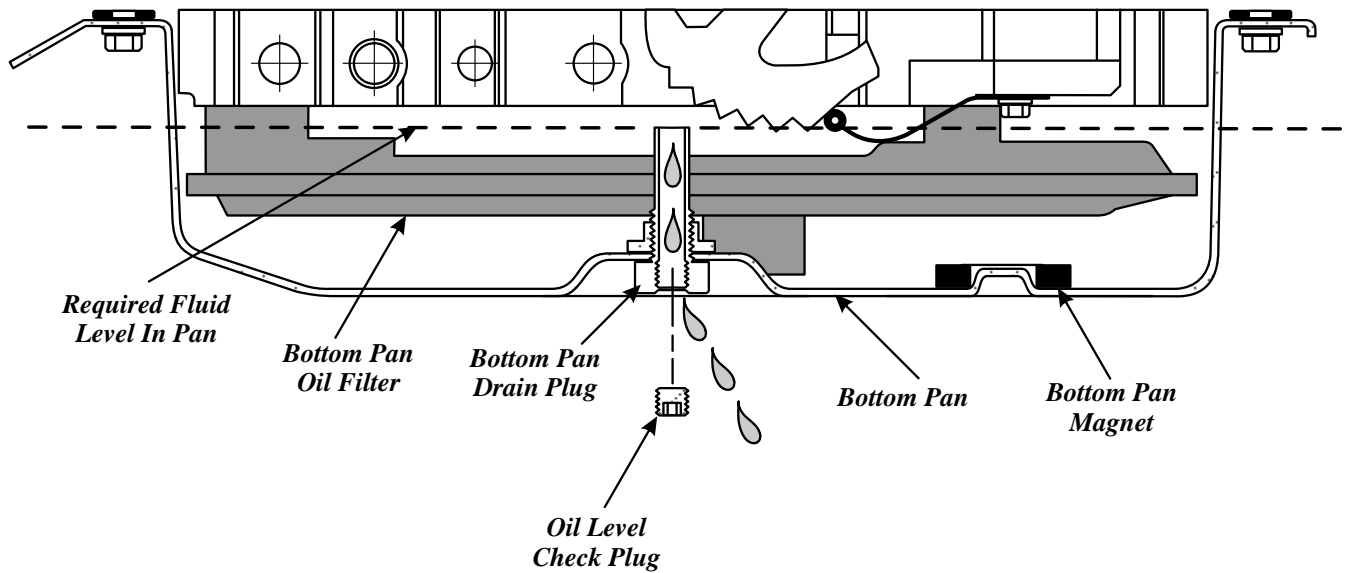
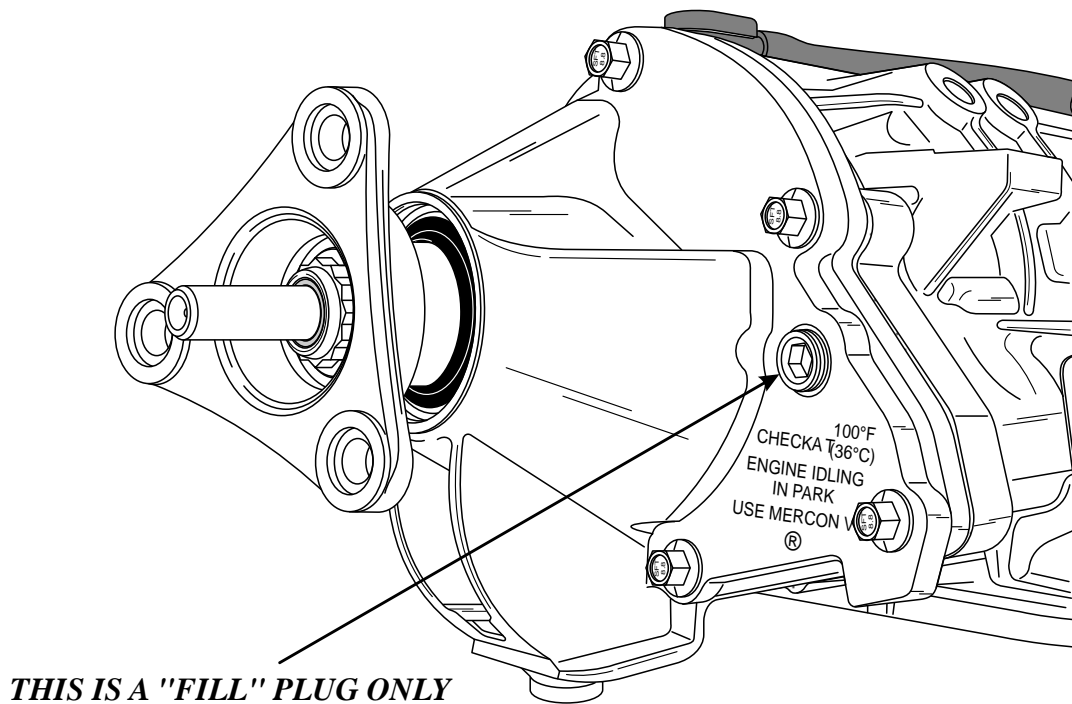
CHECKING FLUID LEVEL

Checking the fluid level on any vehicle equipped with Ford Motor Company's new 5R55N transmission may become confusing to some technicians. There is a plug in the extension housing, as shown in Figure 2, that would lead one to believe that this is where you check the fluid level, since some of the other manufacturers are currently checking fluid level in this manner, and it refers to the correct temperature to check the fluid right on the extension housing.

However, this is a **"Fill" plug only** on the new 5R55N transmission from Ford Motor Company, which is currently found in the 2000 Lincoln LS and some Jaguars. To **"Check"** for the correct fluid level, you must remove the check plug, which is located in the center of the bottom pan drain plug, and is removed with an allen wrench, as shown in Figure 2, while holding the drain plug with the proper size wrench so as not to loosen the drain plug.

We have provided you with a cut-away drawing of the bottom oil pan and the drain plug so that you will understand how this system works. Notice that the drain plug actually has a "stem" made on it that extends some distance up into the bottom pan, which is our way to establish the proper fluid level in the transmission. By removing the "Check" plug from the "Drain" plug, the fluid should just trickle over the stem and out through the center of the drain plug, as shown in Figure 2. The "Fill" plug in the extension housing is your only way to replace fluid in the transmission.

Figures 2 and 3 are illustrations of the fluid level checking procedure with a description of the procedure on the page preceding the illustrations.

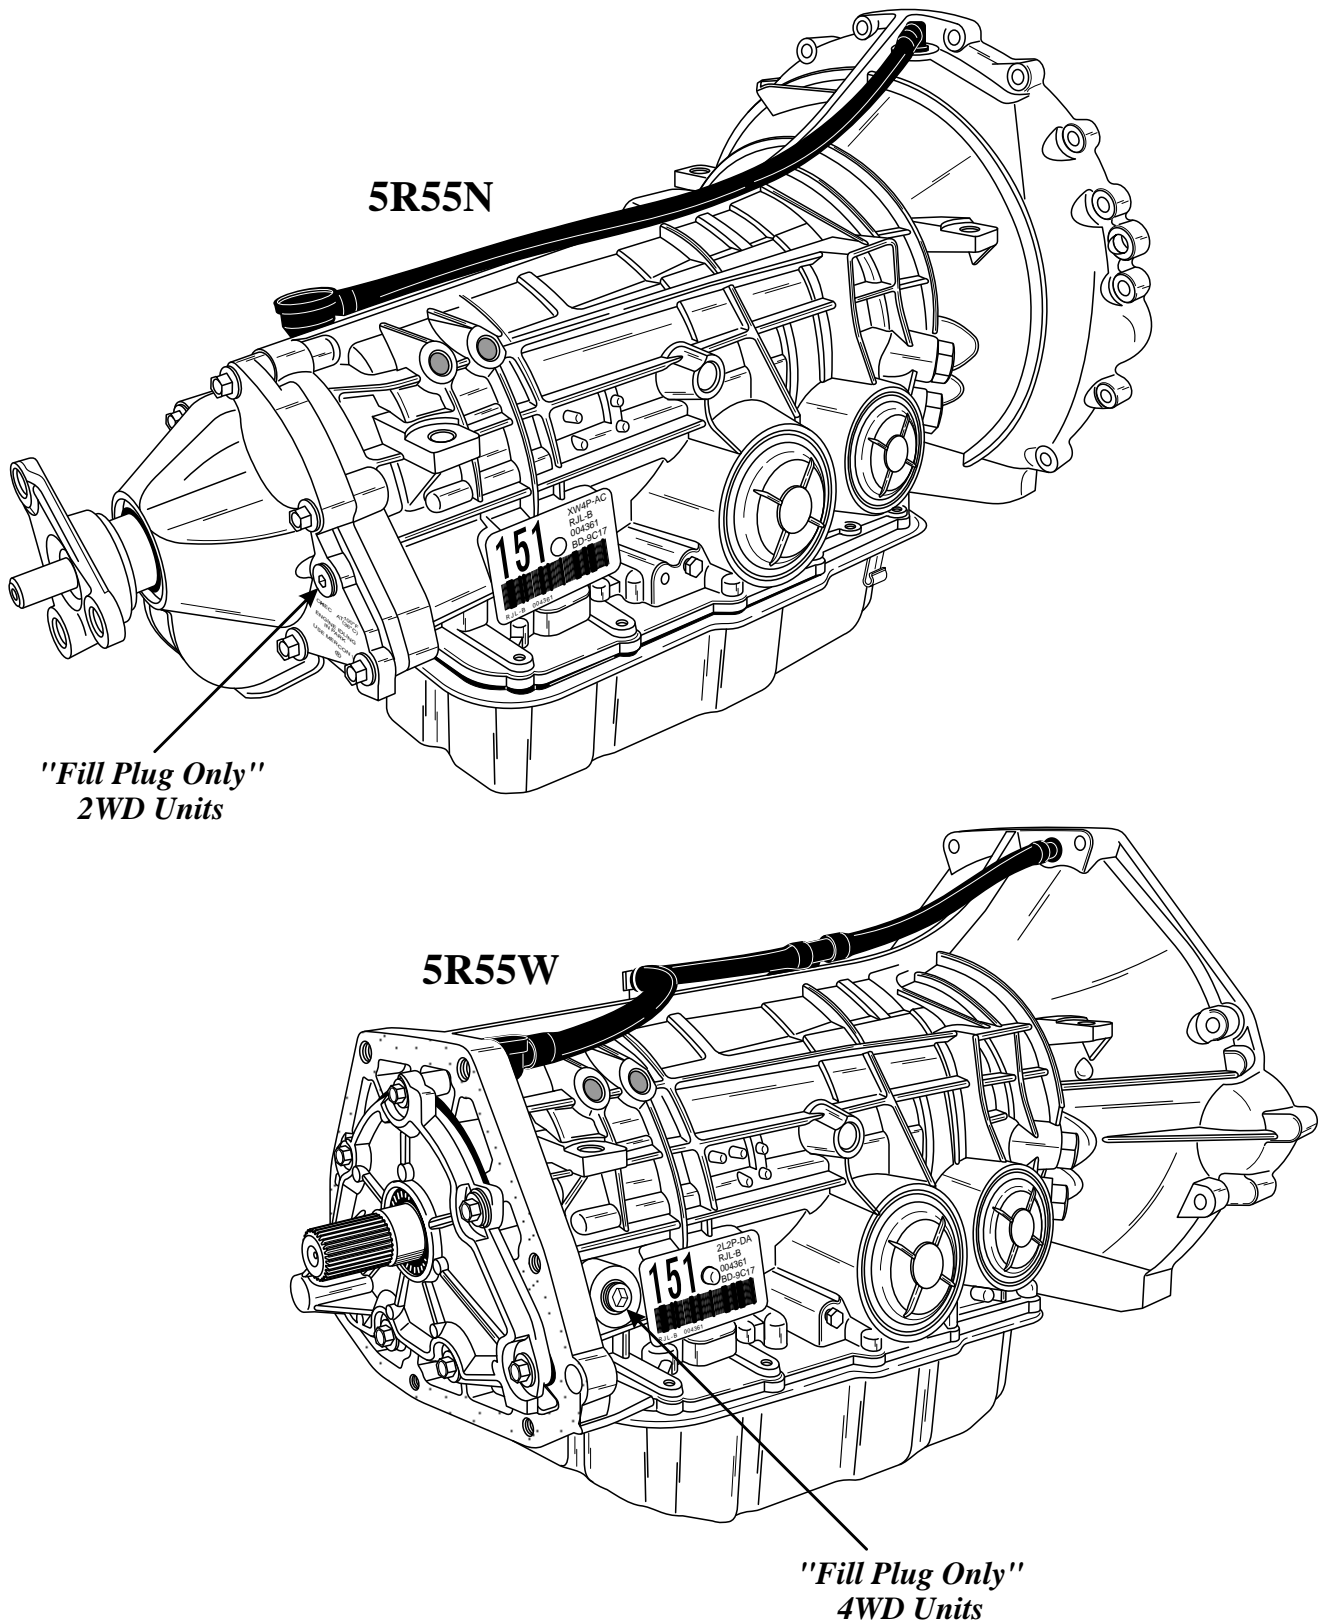
Figure 3

Checking the fluid level on any vehicle equipped with Ford Motor Company's new 5R55W transmission, is exactly the same as described above by removing the check plug which is located in center of the bottom pan drain plug, as shown in Figure 2. However, the **"Fill"** plug is located on the right rear of the transmission case, as shown in Figure 3. The 5R55W transmission is currently found the 2002 Explorer and 2002 Ranger.

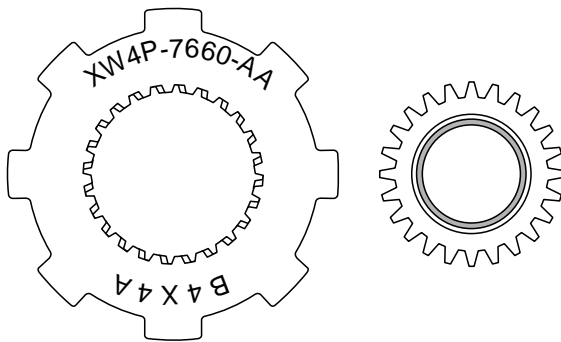
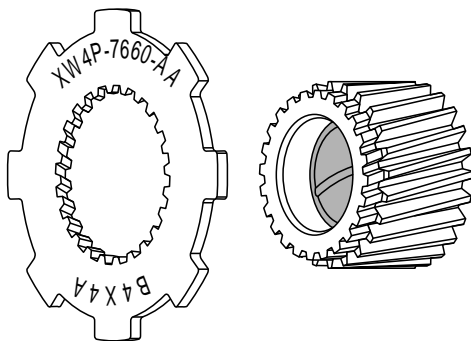
Figure 5

*"5R55N"
Overdrive Sun Gear
24 Teeth*

Figures 5 and 6 show you the differences in the overdrive sun gear and drive plate. Notice the differences in the tooth count on the sun gear.

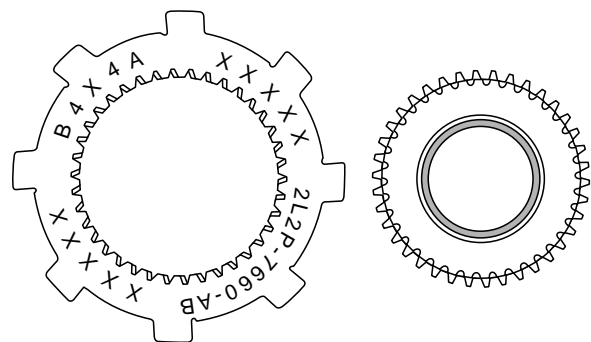
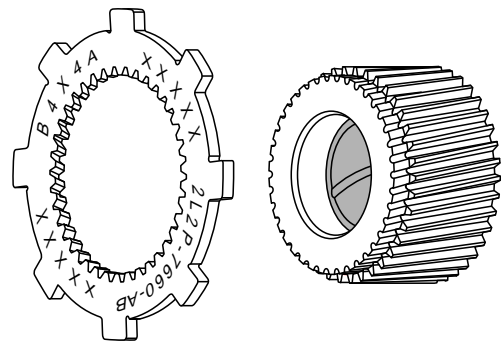
Figure 6

*"5R55W"
Overdrive Sun Gear
38 Teeth*

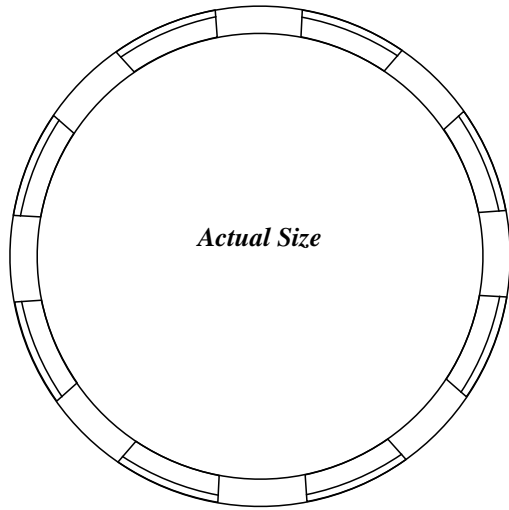
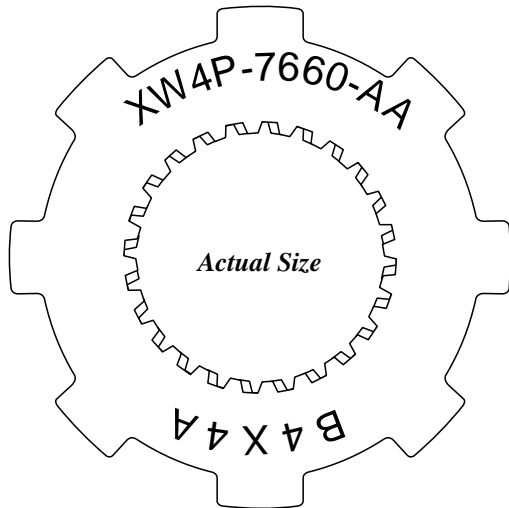
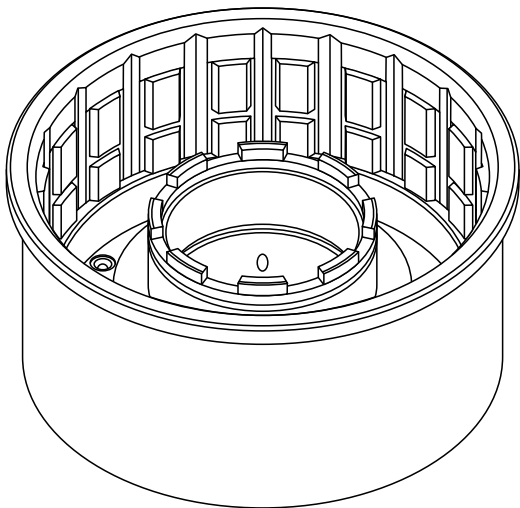
Figure 7

5R55N OVERRUN DRUM

Figures 7 and 8 are illustrations of the two different coast clutch housings. Notice that the slots to accept the tabs on the adapter plate are narrower and angled to the left at a very slight angle. This means that it will engage into the coast clutch housing in only one direction.

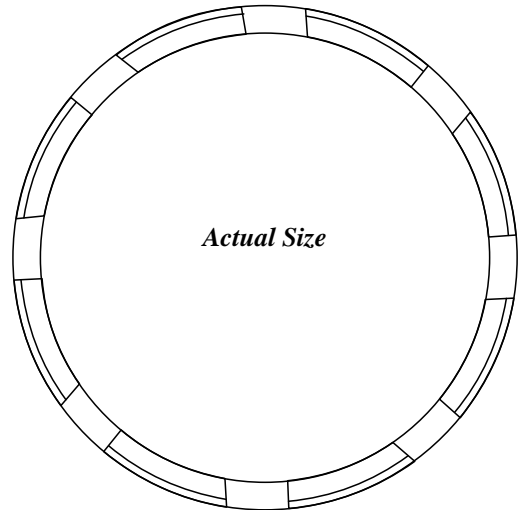
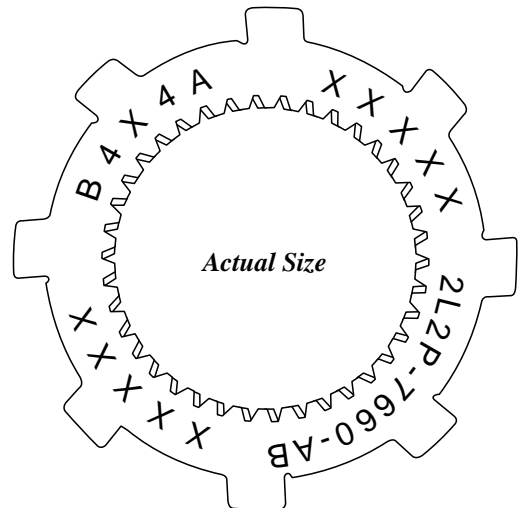
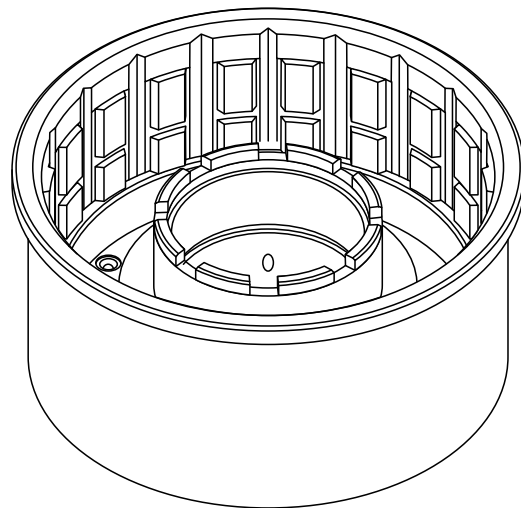
Figure 8

5R55W OVERRUN DRUM

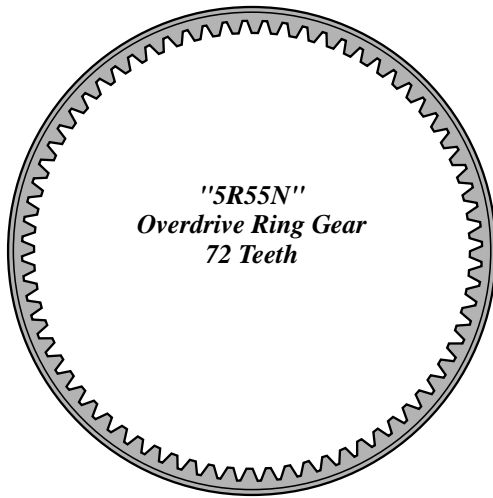
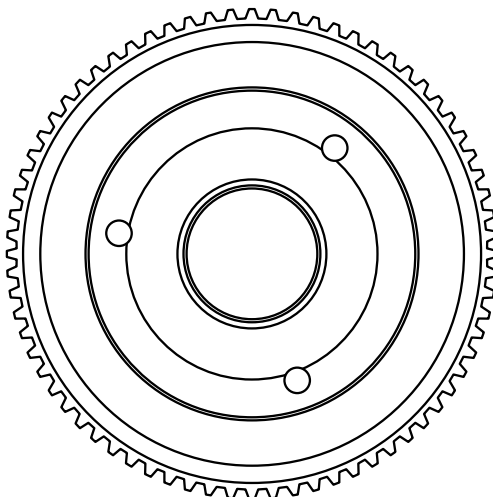
Figure 9

5R55N OVERDRIVE RING GEAR AND CENTER SHAFT

*"5R55N"
Overdrive Center Shaft
72 Teeth*

Figures 9 and 10 are illustrations of the two different overdrive ring gears and the overdrive center shafts. Notice the difference in the tooth counts of both pieces.

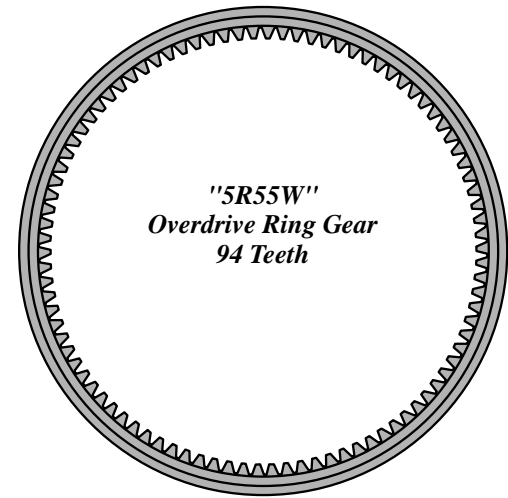
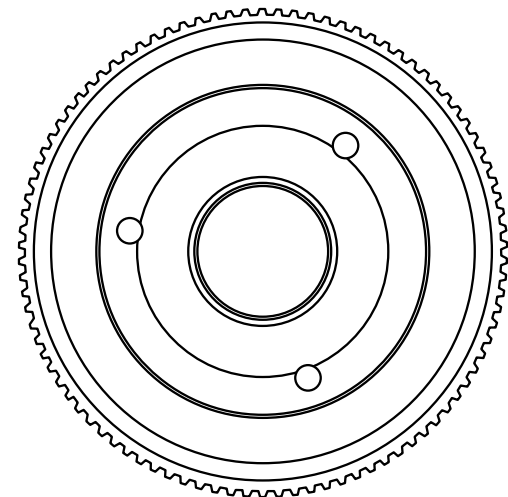
Figure 10

5R55W OVERDRIVE RING GEAR AND CENTER SHAFT

*"5R55W"
Overdrive Center Shaft
94 Teeth*

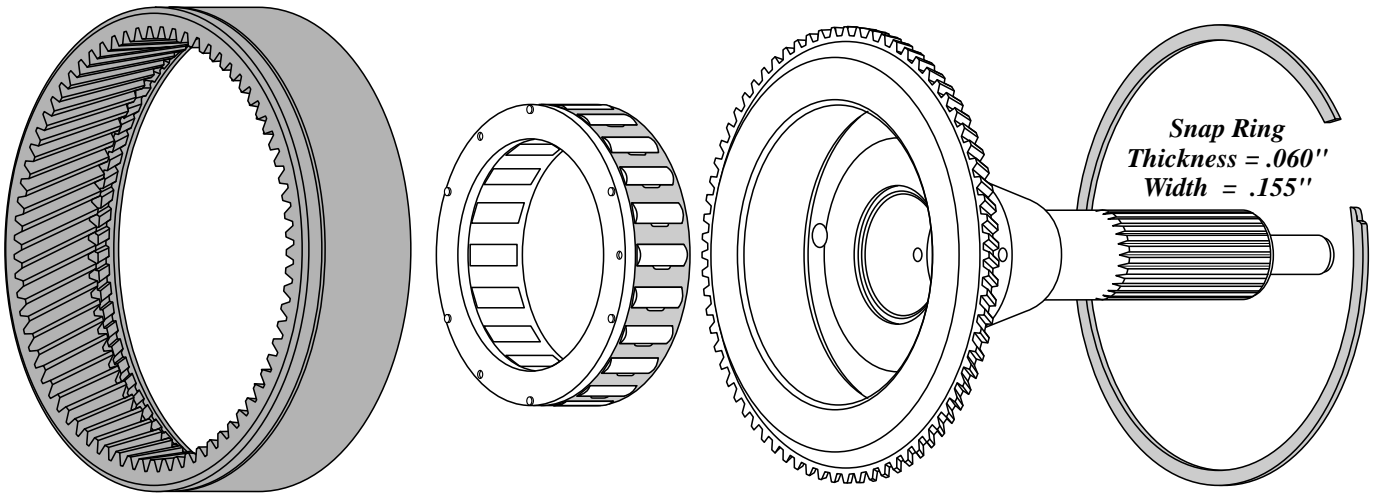
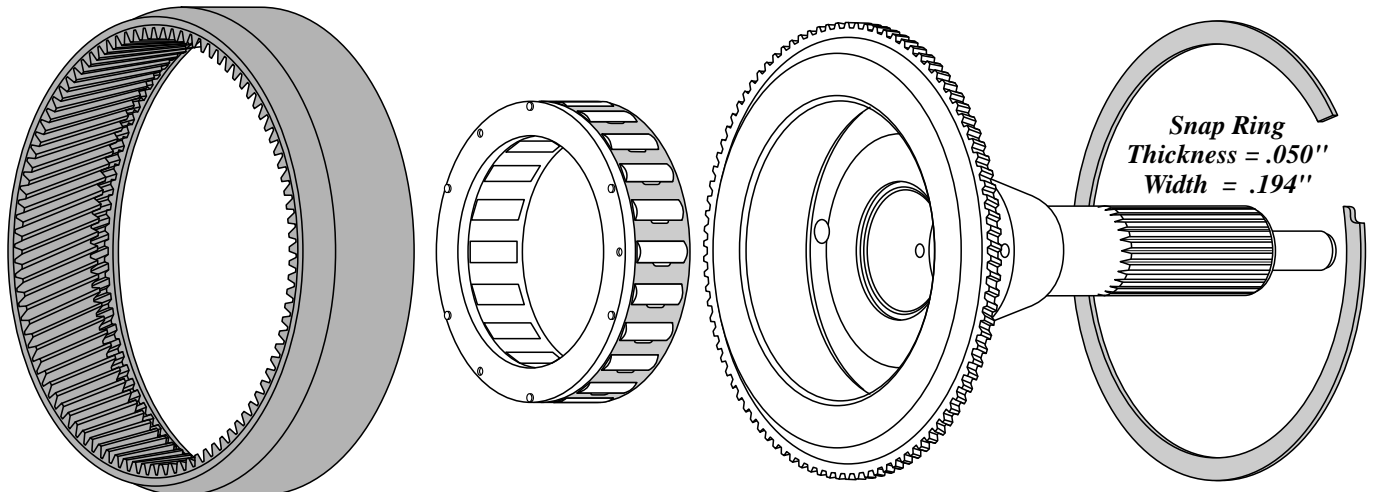
"5R55N" Overdrive Ring Gear Snap Ring

"5R55W" Overdrive Ring Gear Snap Ring

Figure 11 illustrates the difference in the snap ring that retains the overdrive center shaft in the ring gear and the dimensions for identification.

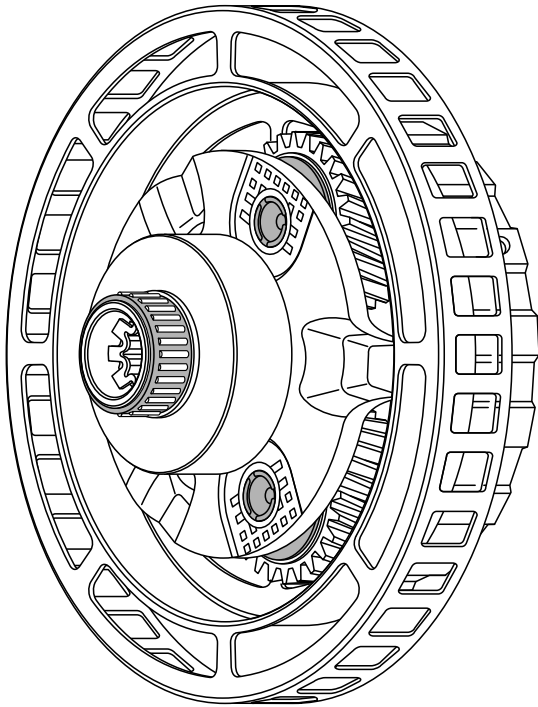
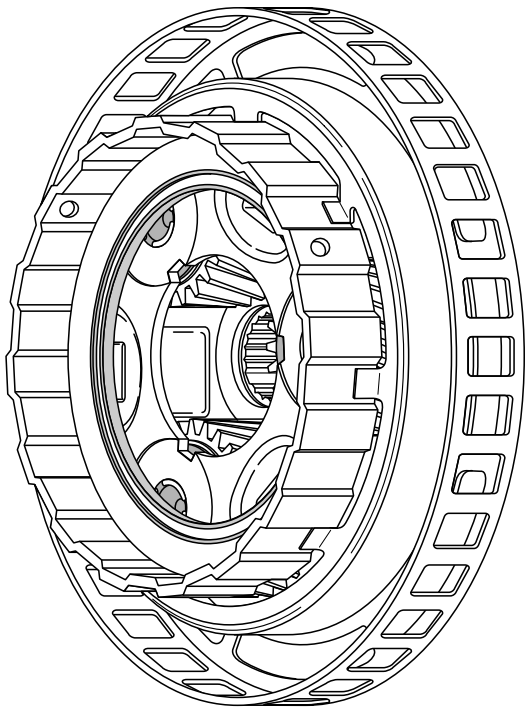
Figure 12

5R55N OVERDRIVE CARRIER

*"5R55N" Overdrive Carrier
25 Tooth Pinions*

Figures 12 and 13 are illustrations of the two different overdrive carriers. Notice the difference in the tooth counts on the planetary pinions.

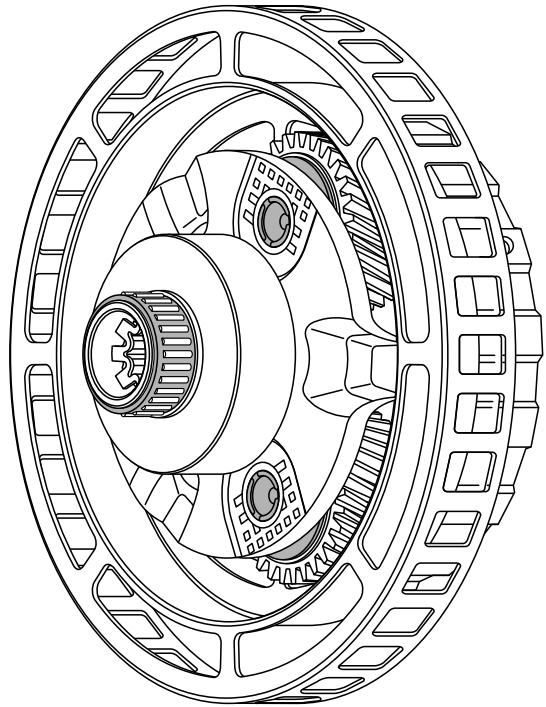
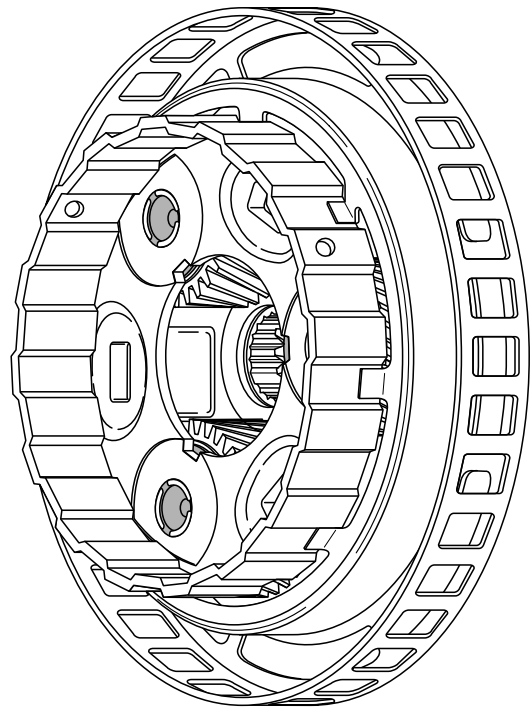
Figure 13

5R55W OVERDRIVE CARRIER

*"5R55W" Overdrive Carrier
28 Tooth Pinions*

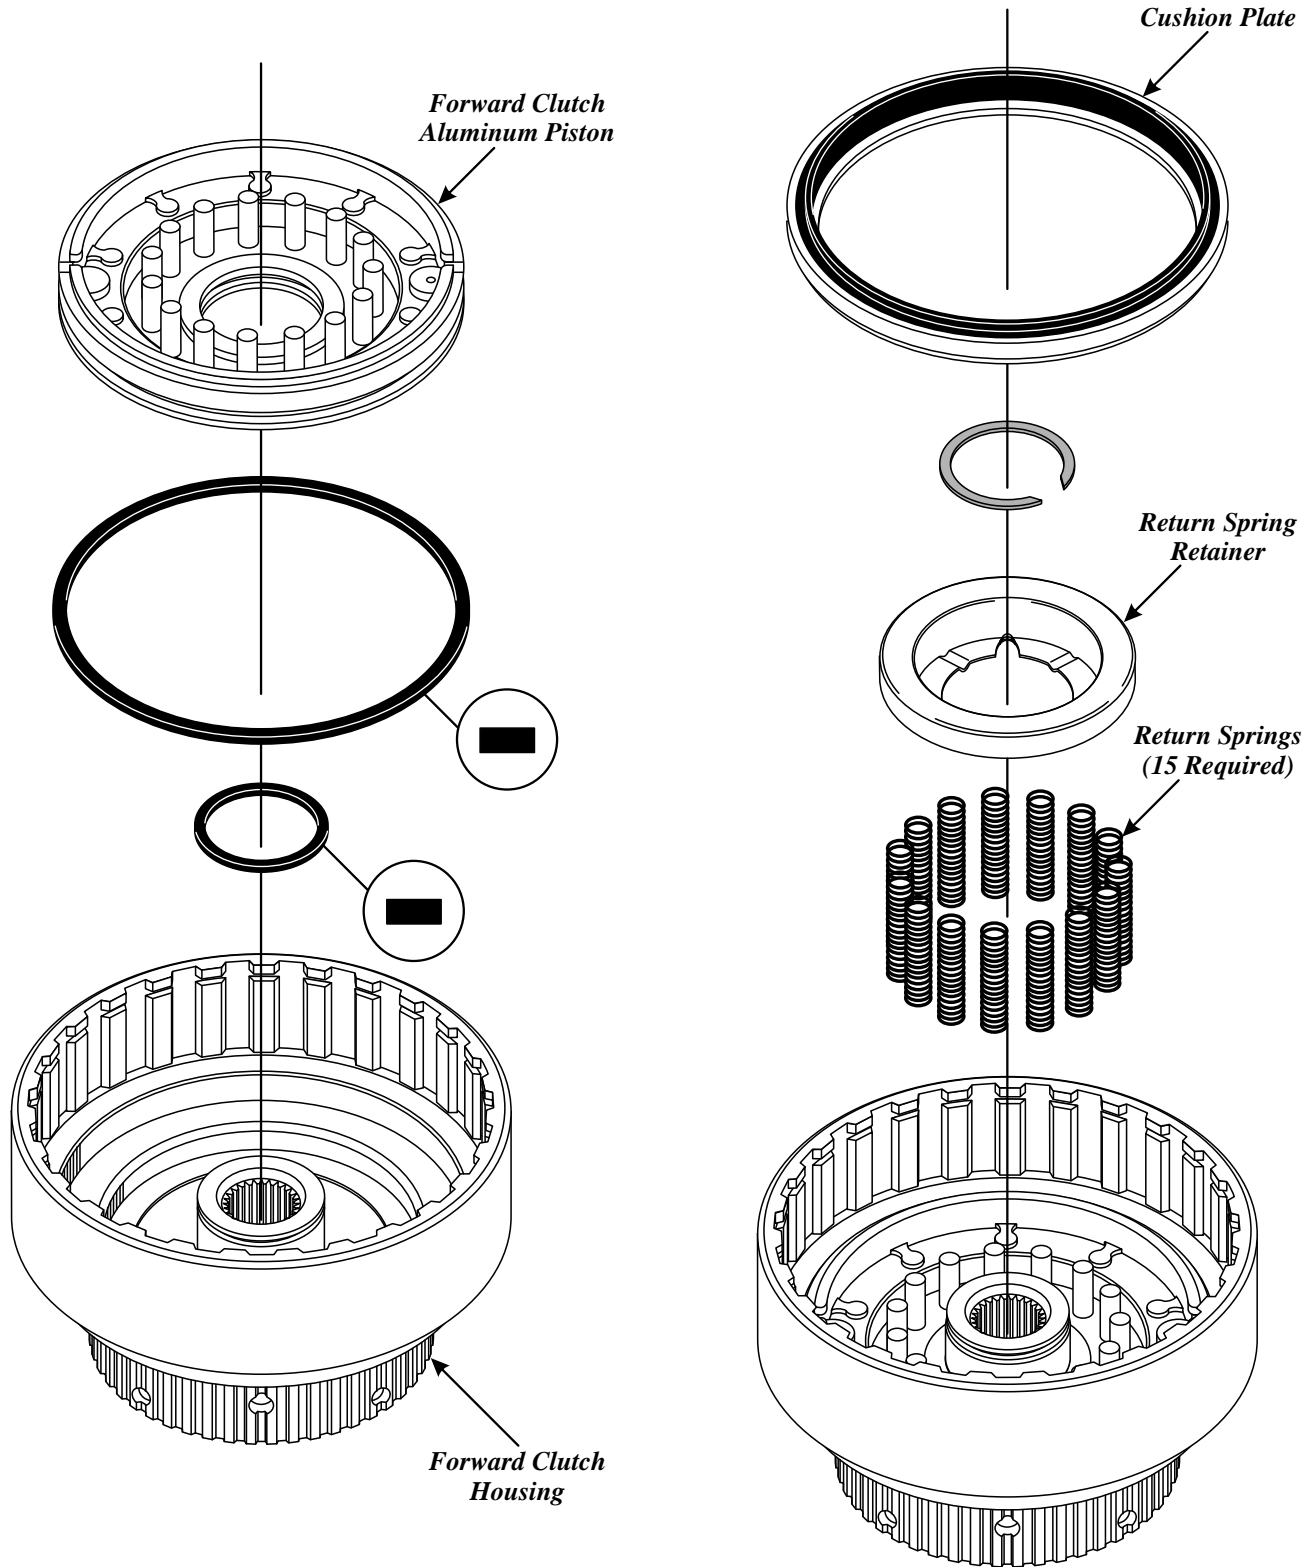
5R55N FORWARD CLUTCH COMPONENTS

Figure 14 illustrates the internal components of the forward clutch housing for the 5R55N. Figure 15 illustrates the internal components of the forward clutch housing for the 5R55W. The empty forward clutch housings and the forward clutch components are the same in both units.

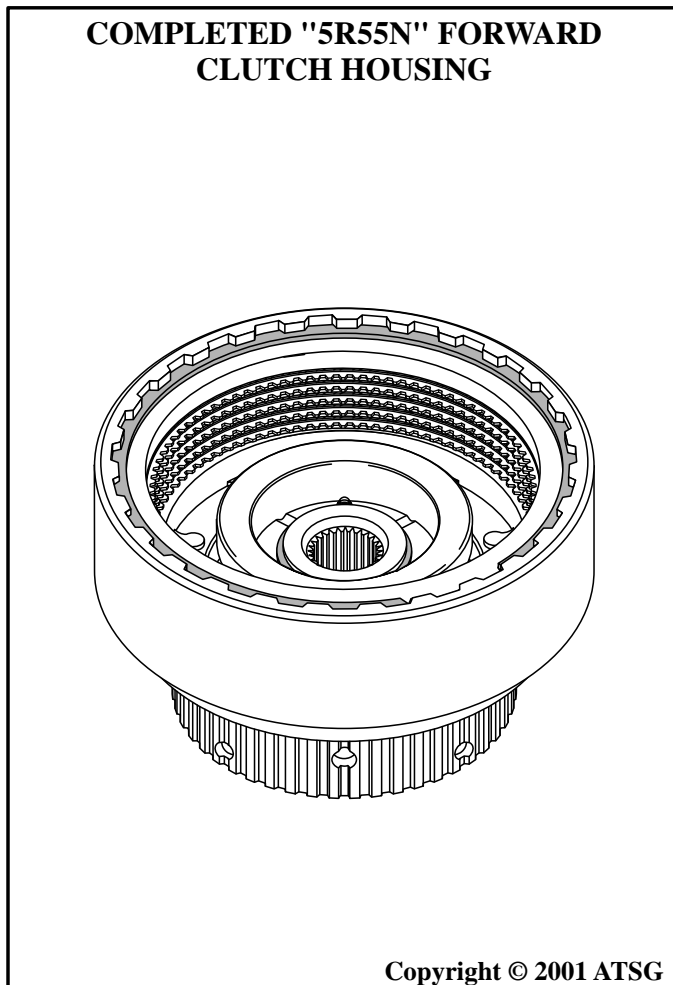
Figure 16

Figures 16 and 17 are illustrations of the two different, completed forward clutch housing assemblies. Notice that the only visible difference is the piston and the return spring retainer.

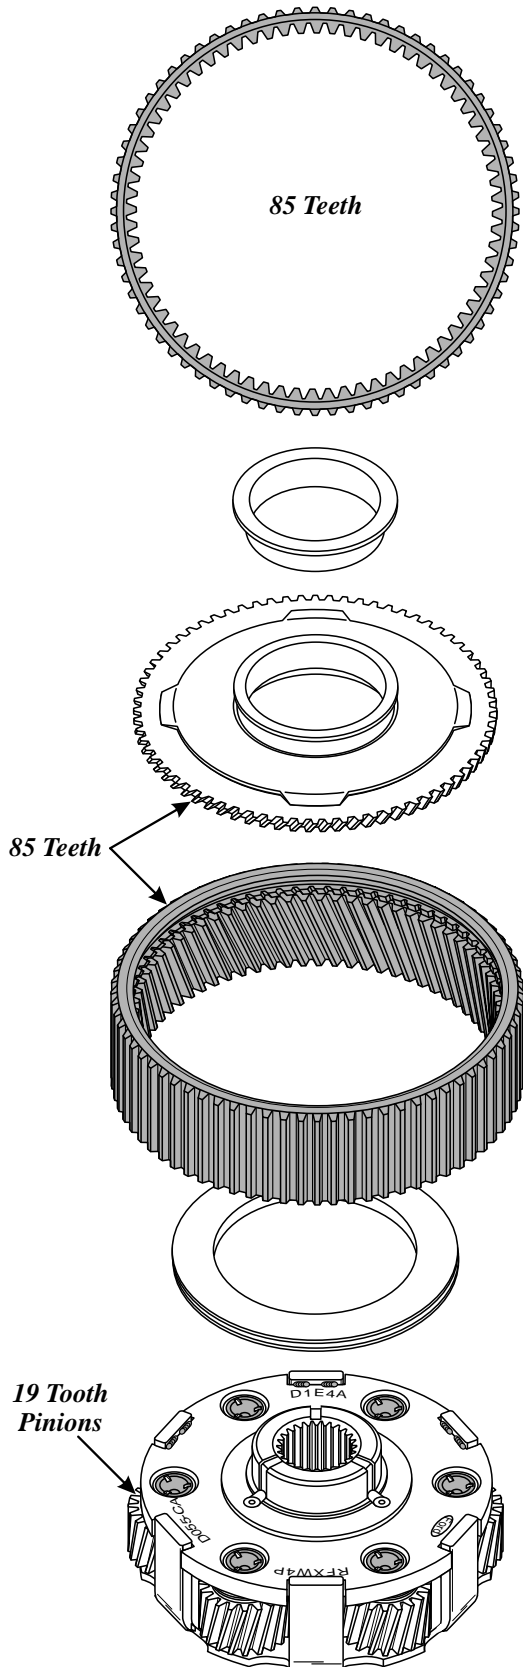
Figure 18

5R55N FORWARD PLANETARY

Figures 18 and 19 are illustrations of the two different forward planetary carriers and the two different forward planetary internal ring gears. Notice the different tooth count on the planetary carrier pinions and the different tooth counts on the forward internal ring gear.

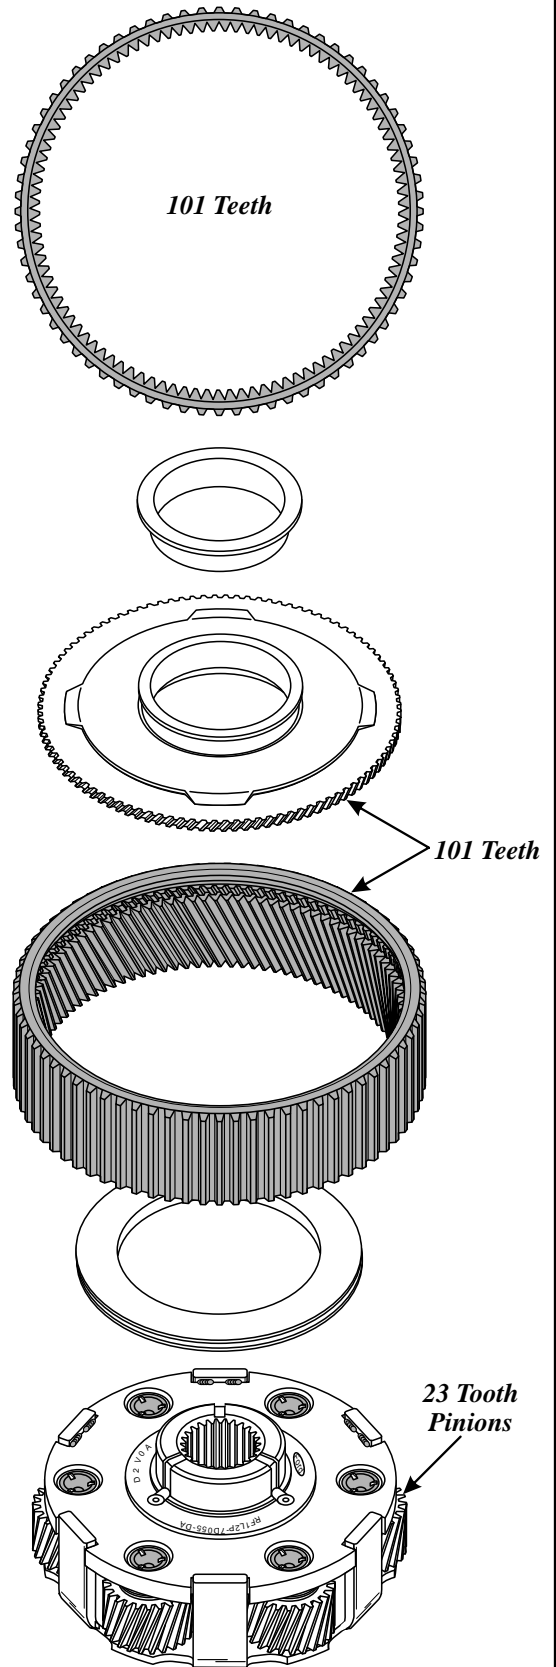
Figure 19

5R55W FORWARD PLANETARY

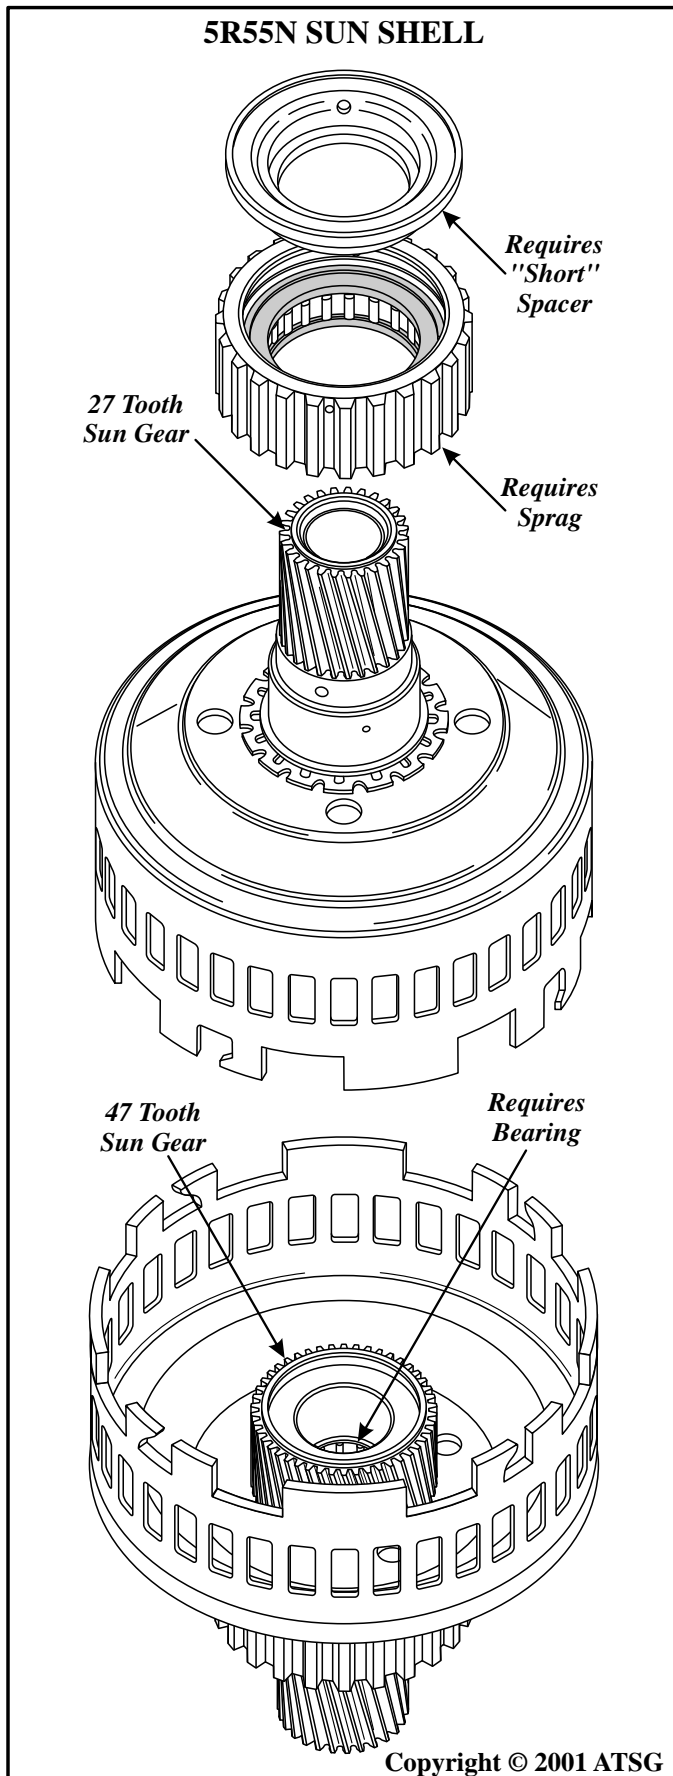
Figure 20

Figures 20 and 21 are illustrations of the two different sun gear and shell assemblies. Notice that the 5R55N uses an intermediate sprag and the 5R55W does not. This required a taller spacer as shown in Figure 21. Notice also the difference in tooth count of the forward sun gear, but the rear sun gear remains the same.

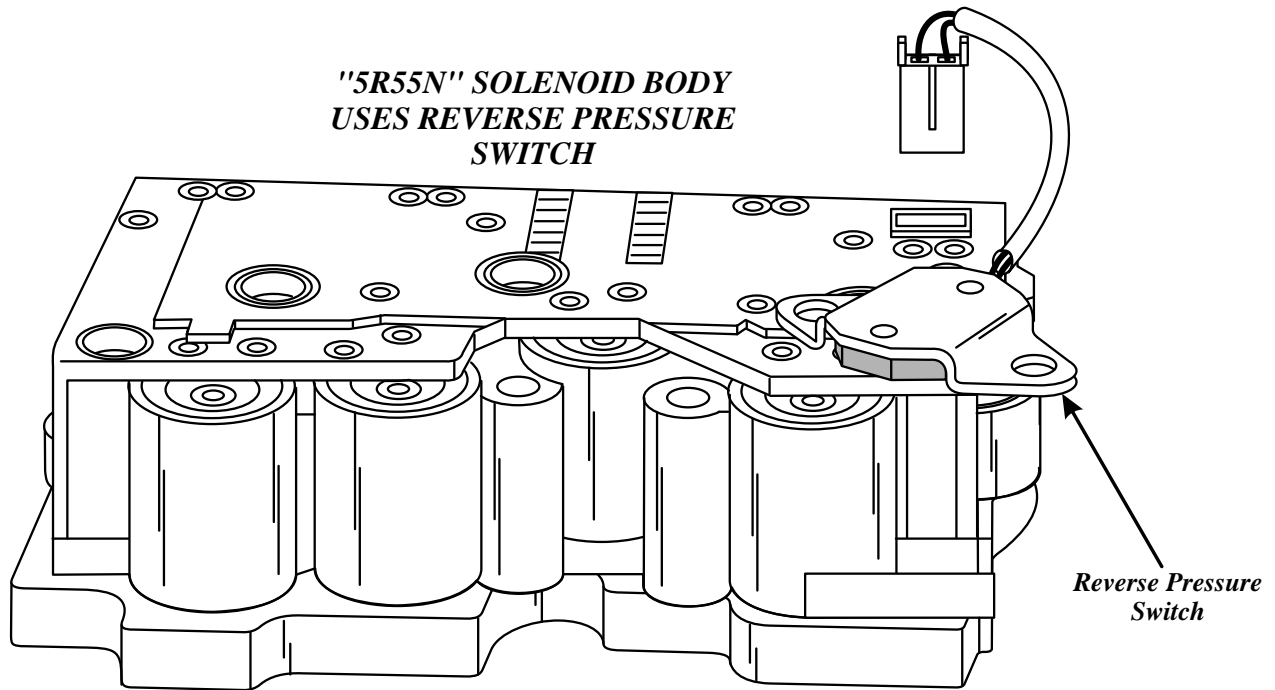
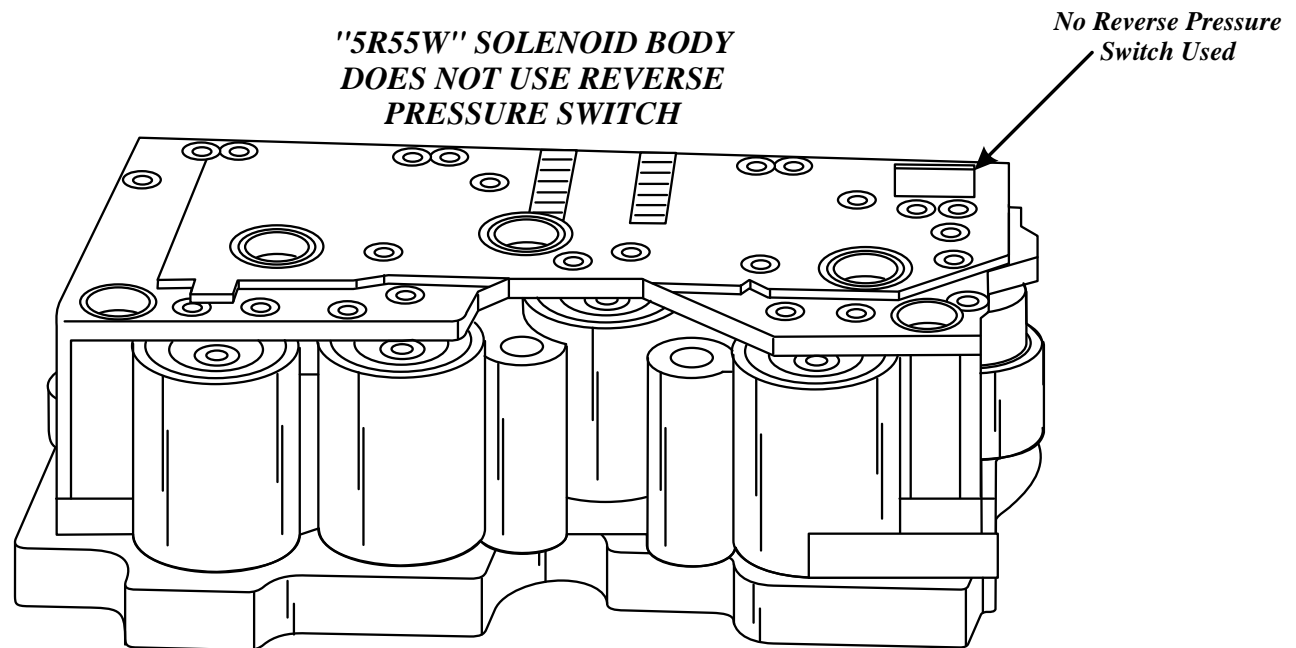
SOLENOID BODY ASSEMBLY DIFFERENCES

Figure 22 shows illustrations of the two different solenoid pack assemblies. Notice that the 5R55W does not use a reverse pressure switch and the hole where it plugs in is obviously different.

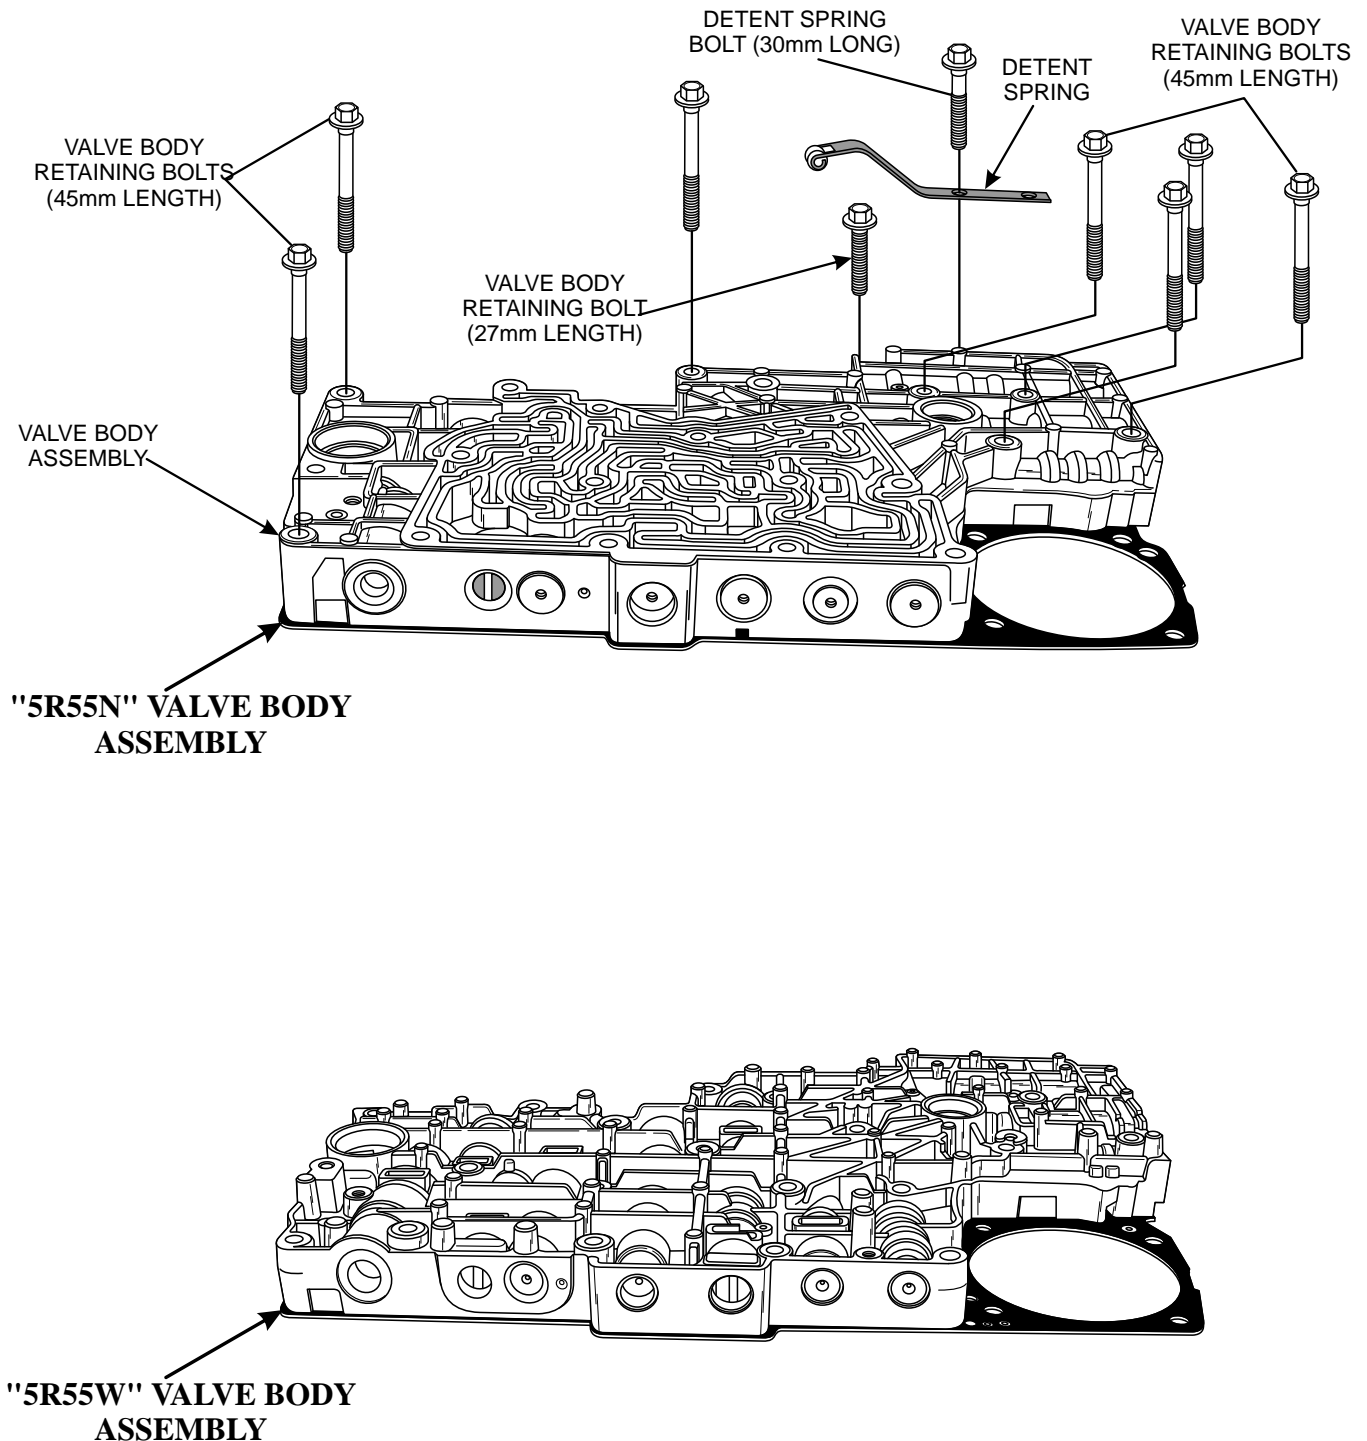
VALVE BODY COMPARISON

Figure 23 shows 3 dimensional illustrations of the two different valve body assemblies. The most noticeable difference is the 5R55W does not use a cover plate. The bolt pattern however, is exactly the same as the 5R55N transmission.
