Technical Service Information

FORD 5R55N VERSUS 5R55W TRANSMISSION DIFFERENCES

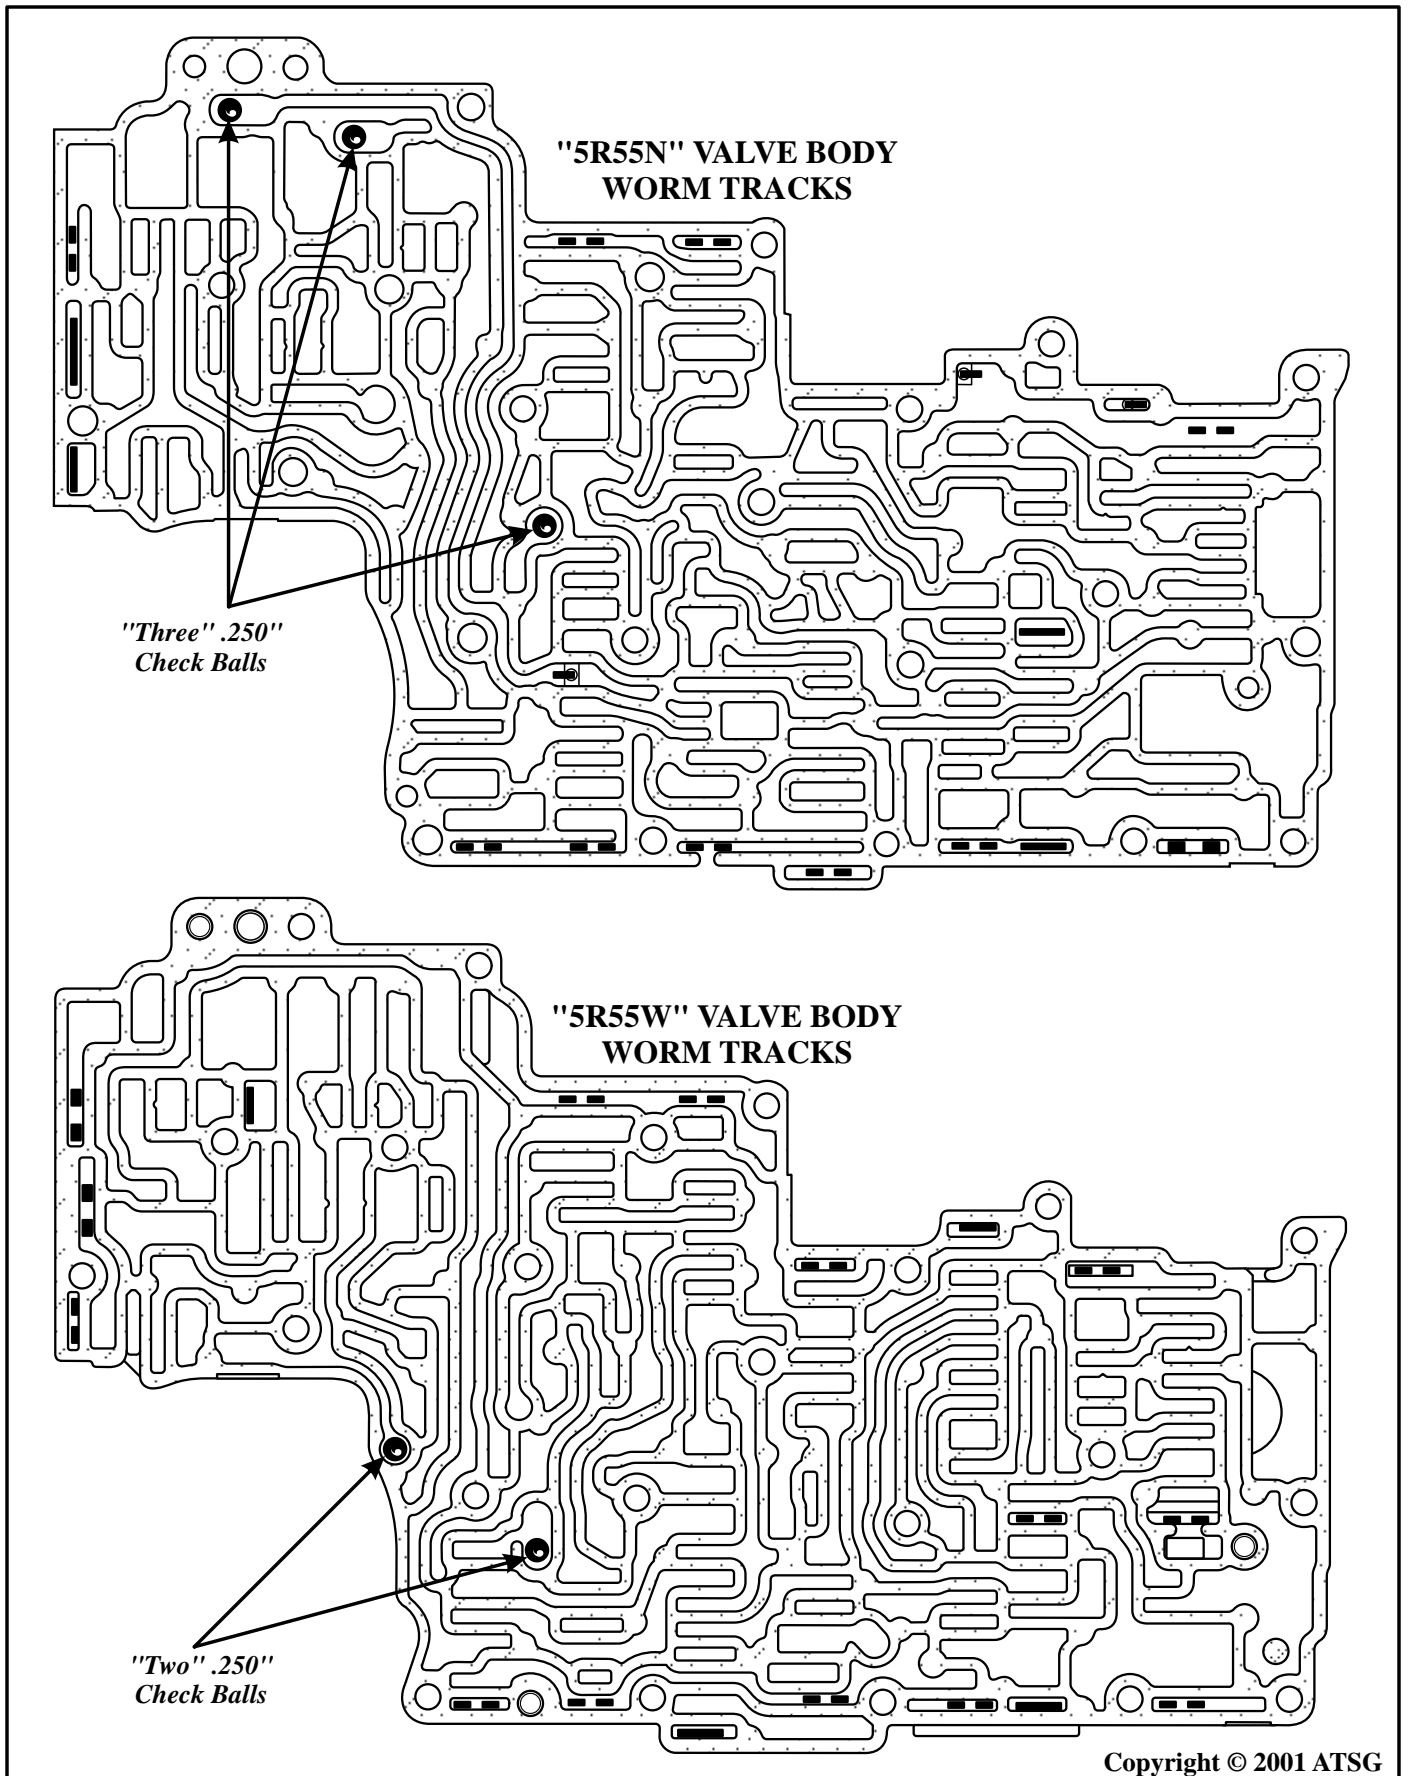
Figure 24 shows illustrations of the two different valve body assemblies in the worm track area, different amount of checkballs and the locations, and the retainer locations for both valve bodies.

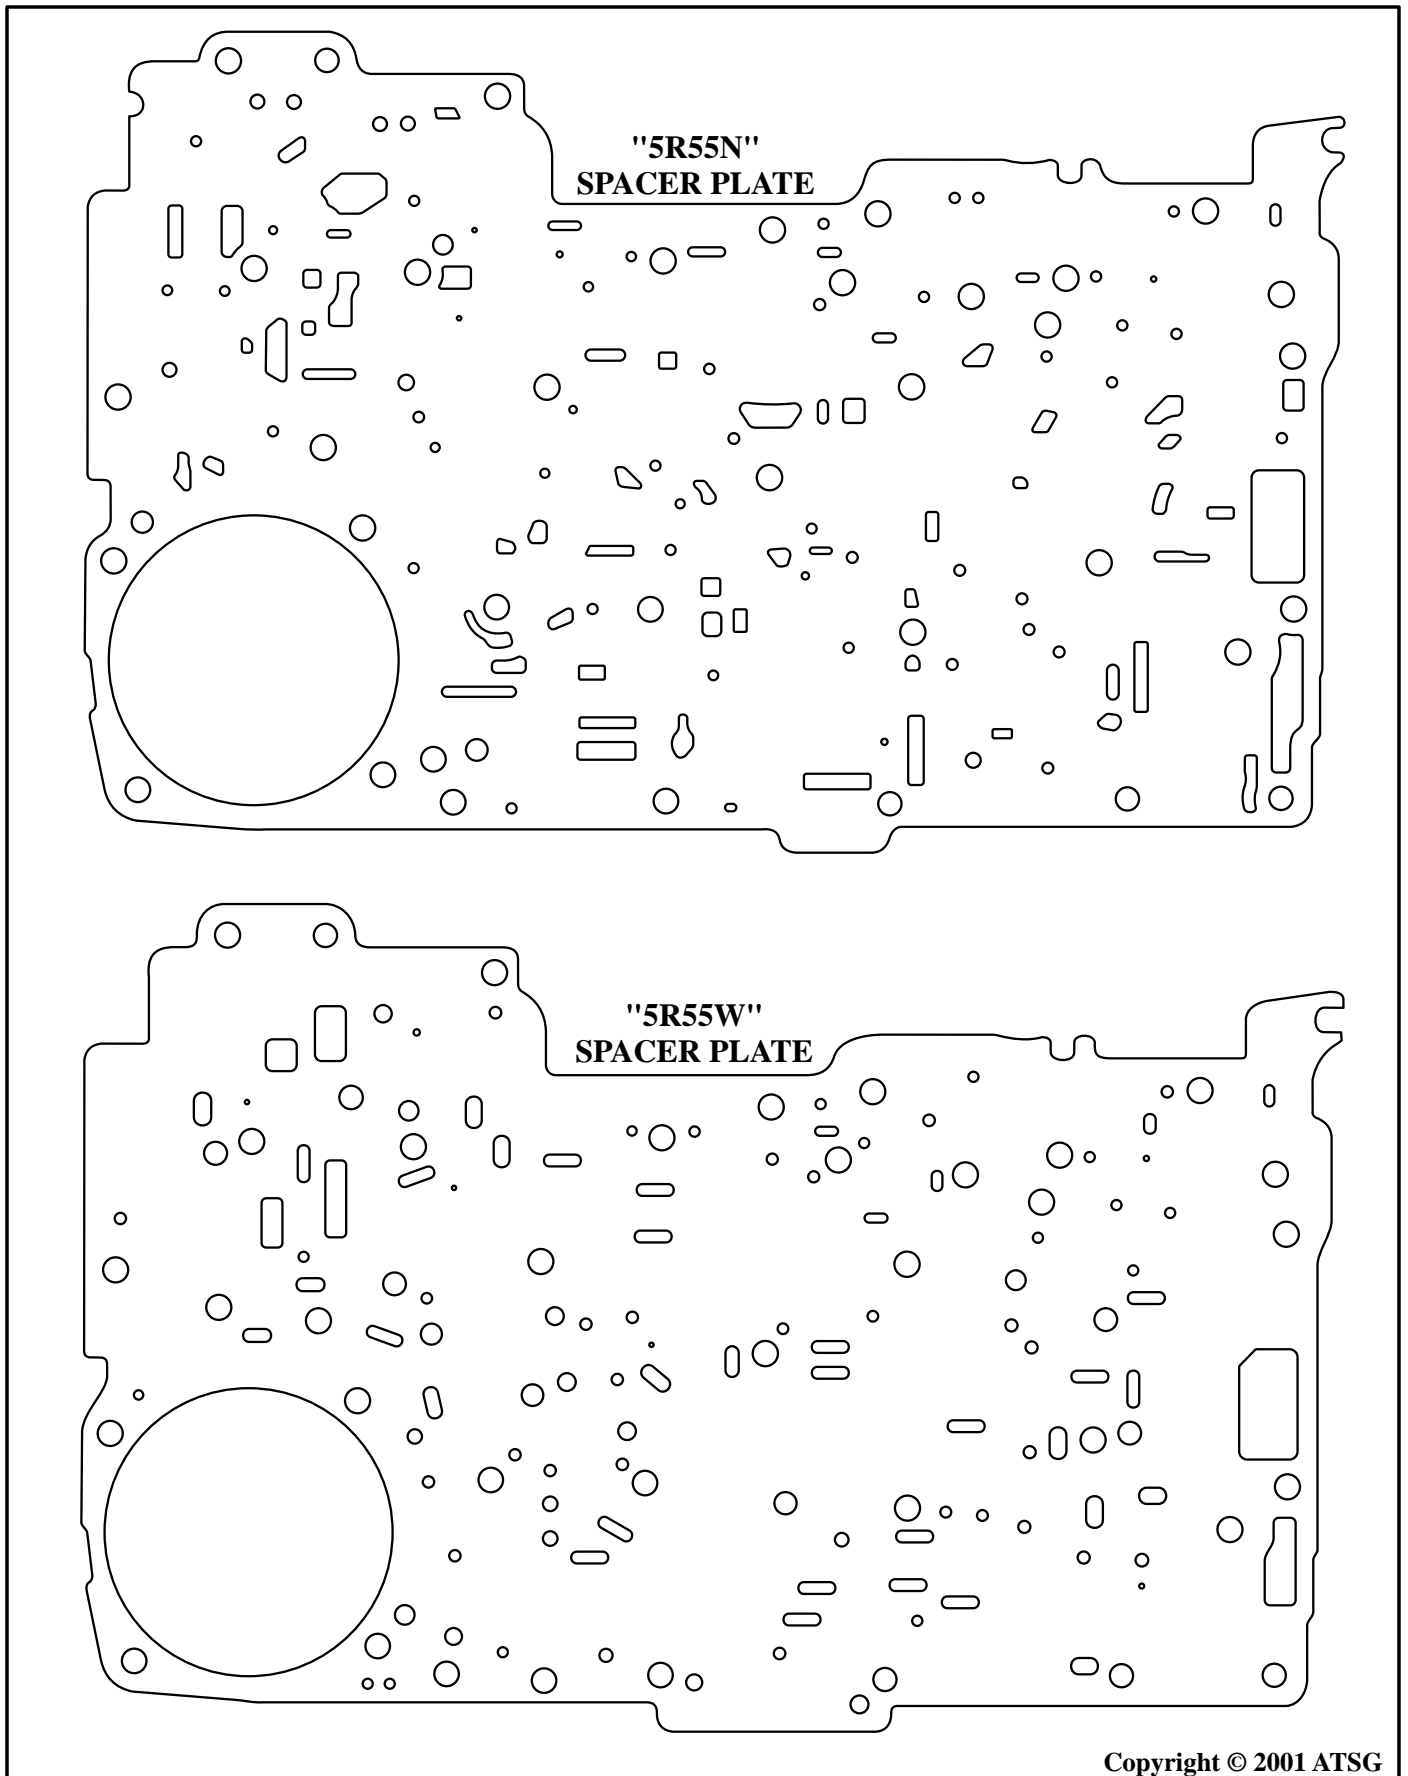
Figure 25 is illustrations of the two different valve body spacer plates. One hole location for the spacer plate retaining bolts has changed to help prevent you from a mis-match.

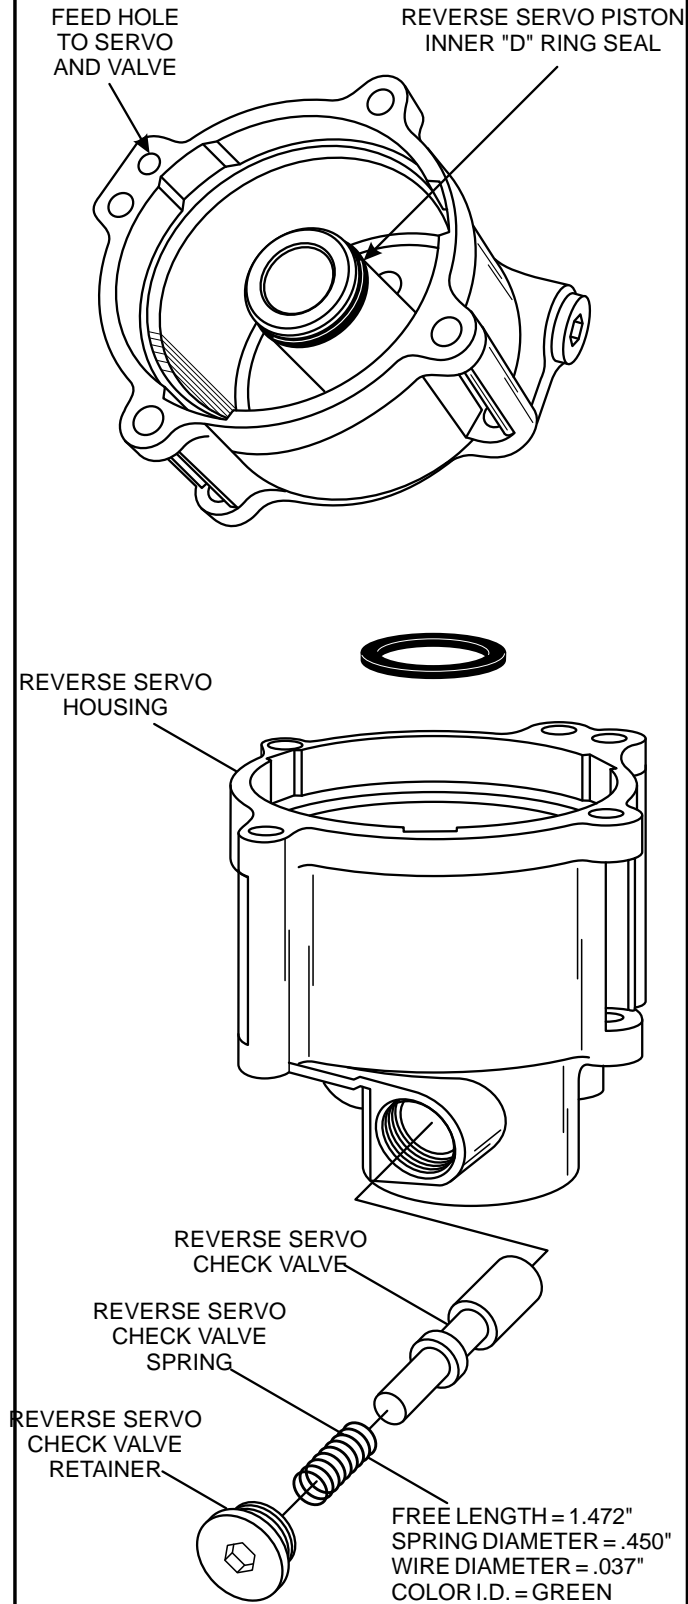
Figure 26

"5R55N" REVERSE SERVO HOUSING

Figures 26 and 27 are illustrations of the two different reverse servo housings. Notice that the 5R55W transmission has two feed holes in the housing, has a larger diameter for the inner piston seal, and has a different reverse servo check valve.

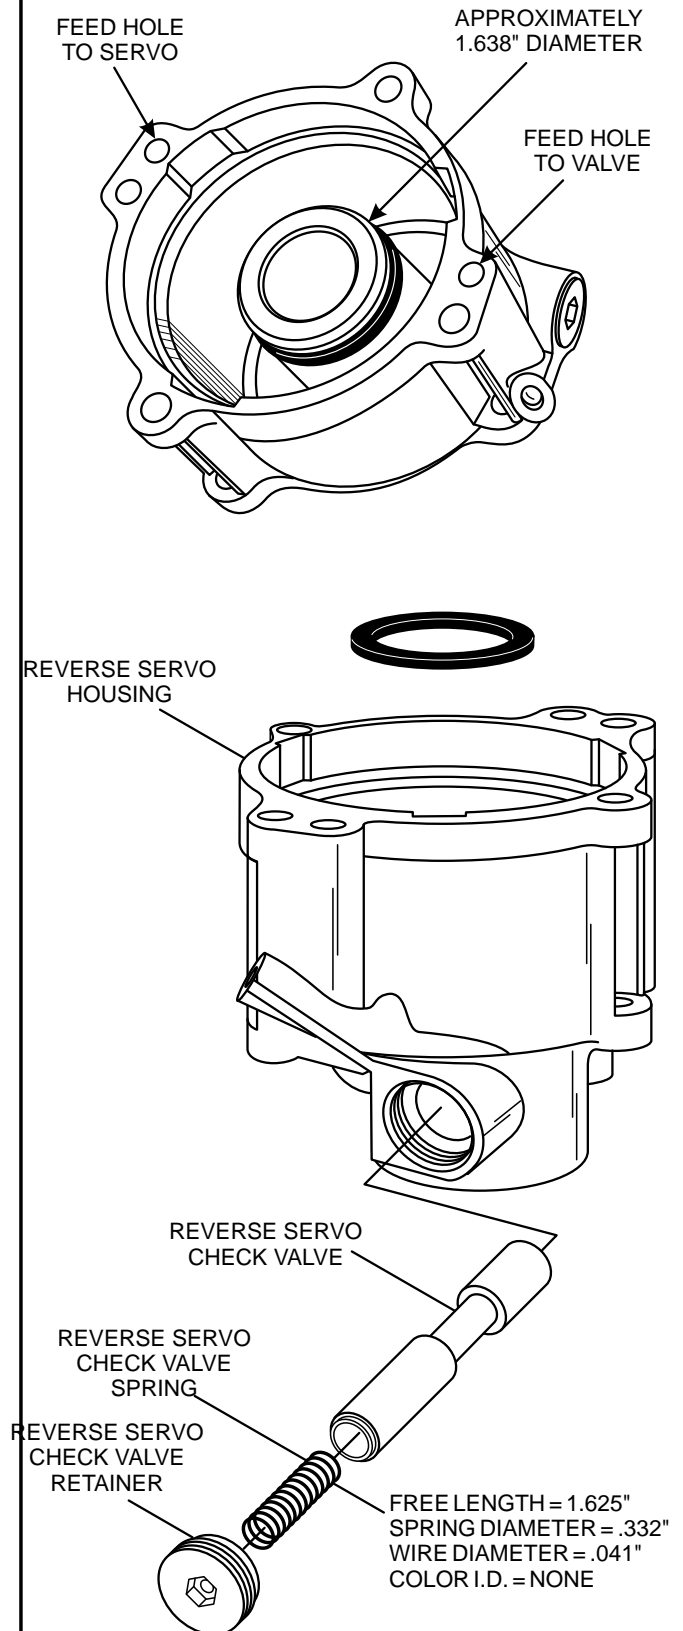
Figure 27

"5R55W" REVERSE SERVO HOUSING

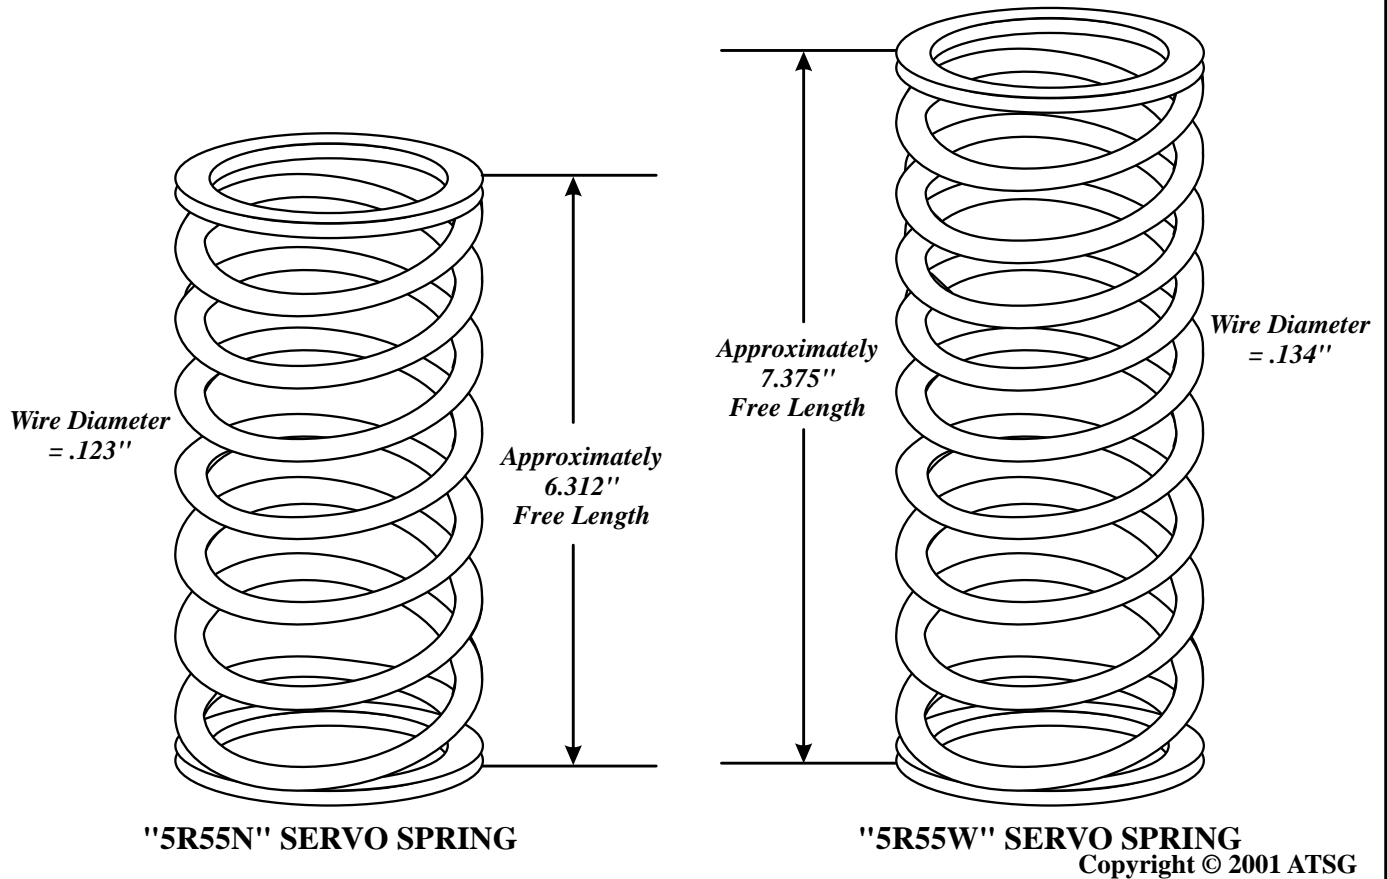
REVERSE SERVO RETURN SPRING COMPARISON

Figure 28 is illustrations of the two different of the two different reverse servo return springs. Notice the difference in the spring dimensions.

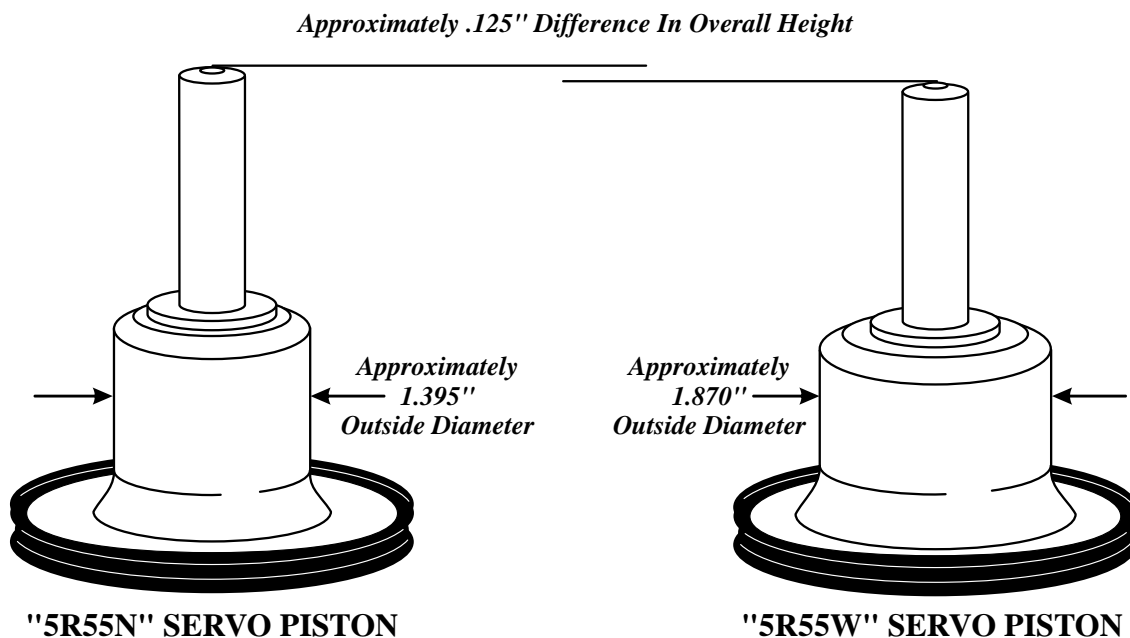
REVERSE SERVO PISTON COMPARISON

Figure 29 is illustrations of the two different of the two different reverse servo pistons. Notice the difference in the outside diameter of the body, to accommodate the larger diameter in the housing.

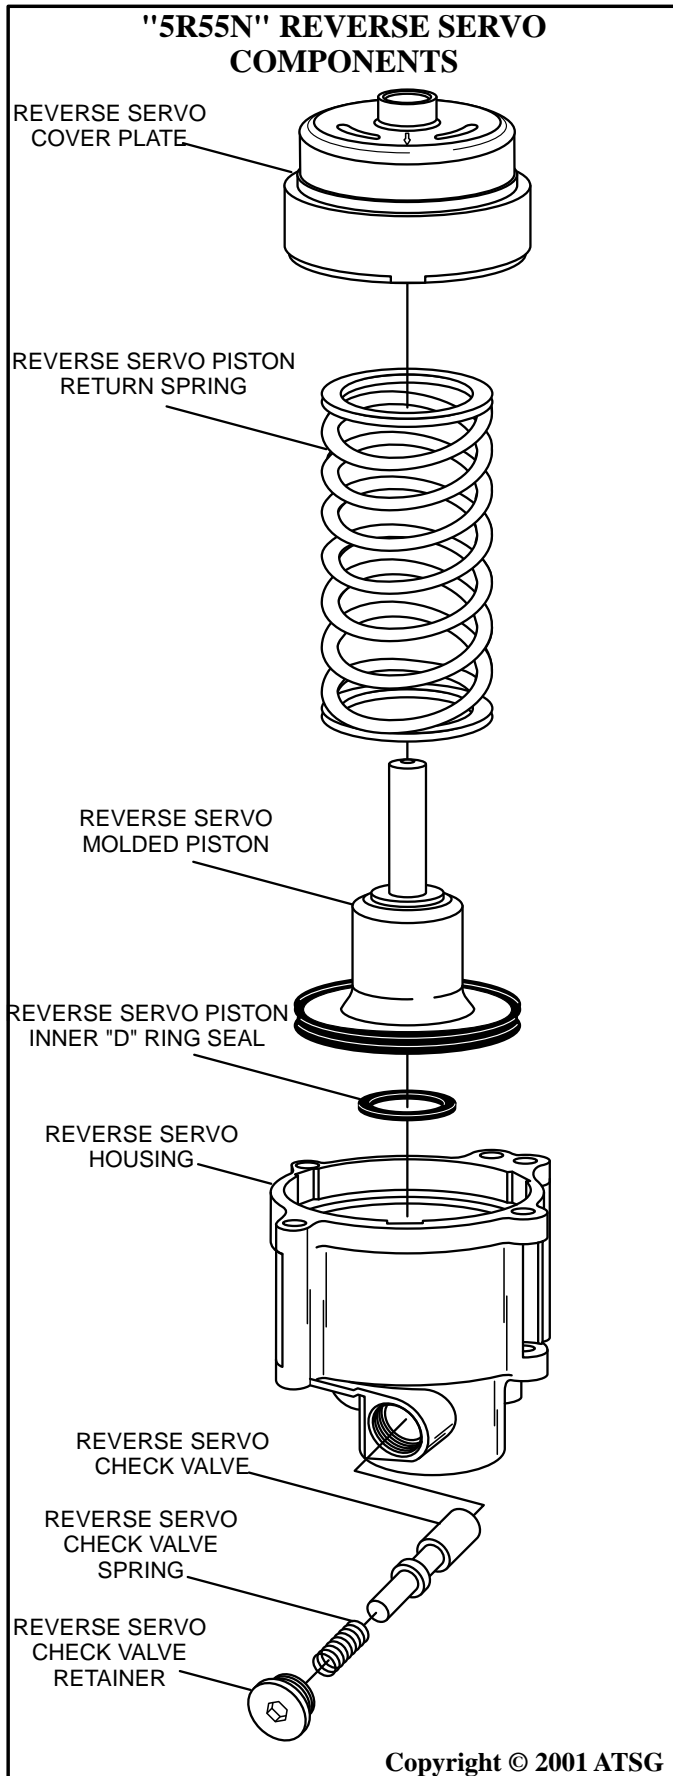
Figure 30

Figures 30 and 31 are illustrations of the two different reverse servo components and the assembly process for each of them.

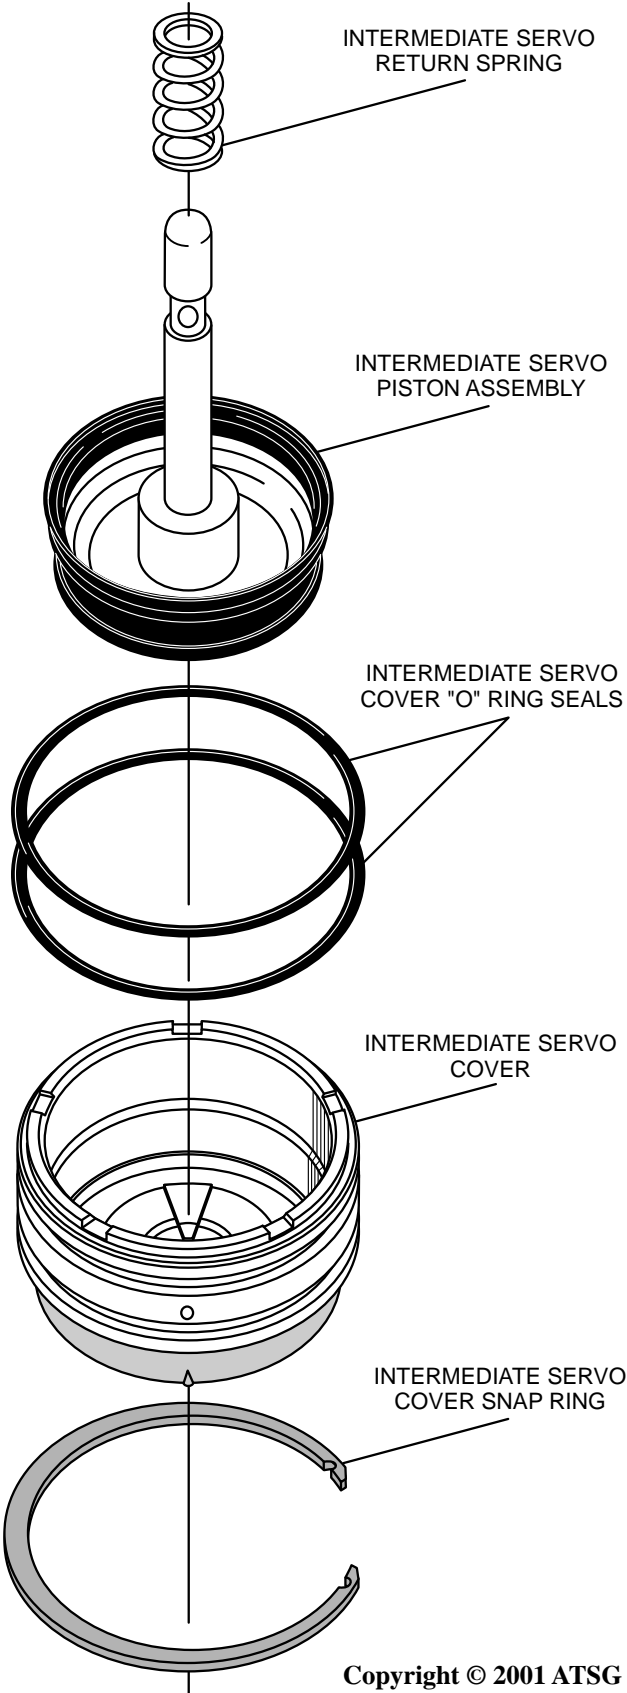
Figure 32

"5R55N" INTERMEDIATE SERVO COMPONENTS

Figures 32 and 33 are illustrations of the two different intermediate servo covers and the intermediate servo pistons.

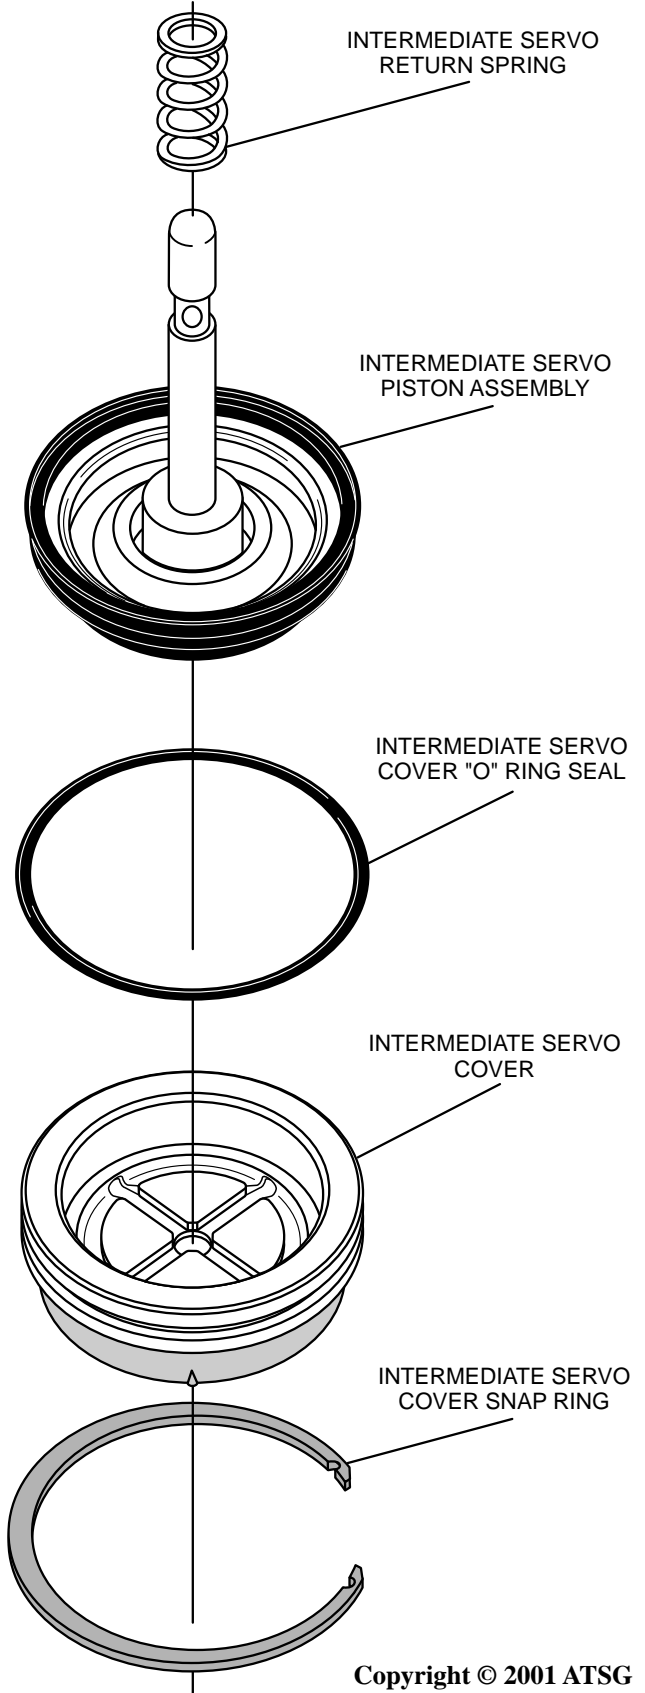
Figure 33

"5R55W" INTERMEDIATE SERVO COMPONENTS
