Technical Service Information

THM 440-T4 SPACER PLATE I.D. (3-2 LINE CONTROL)

CHANGE: A 4th design Reverse Band Assembly is now in production on all THM 440-T4 transaxles.

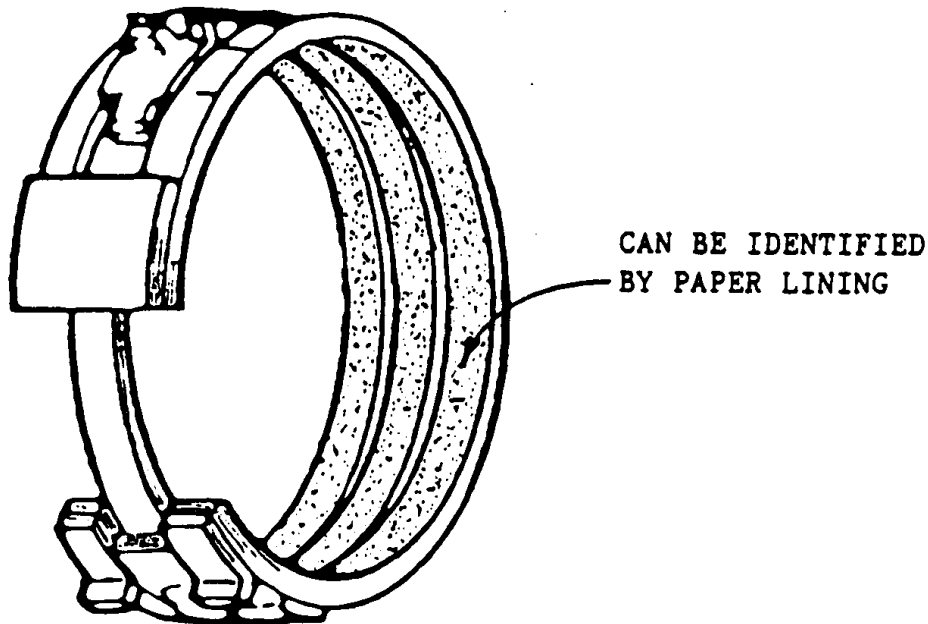
Figure 1

PARTS AFFECTED: (1) REVERSE BAND ASSEMBLY -been changed, The lining on the reverse band has once again and can be identified by the "Paper" lining on the band itself (See Figure 1).

INTERCHANGEABILITY:
It will retro-fit back to all previous models and is highly recommended to help eliminate a harsh reverse apply condition.

SERVICE INFORMATION:
Reverse Band Assembly (4th Design)..... 8675152
