# Technical Service Information

## FORD ATX SPEEDO DRIVE AND DRIVEN GEAR DAMAGED

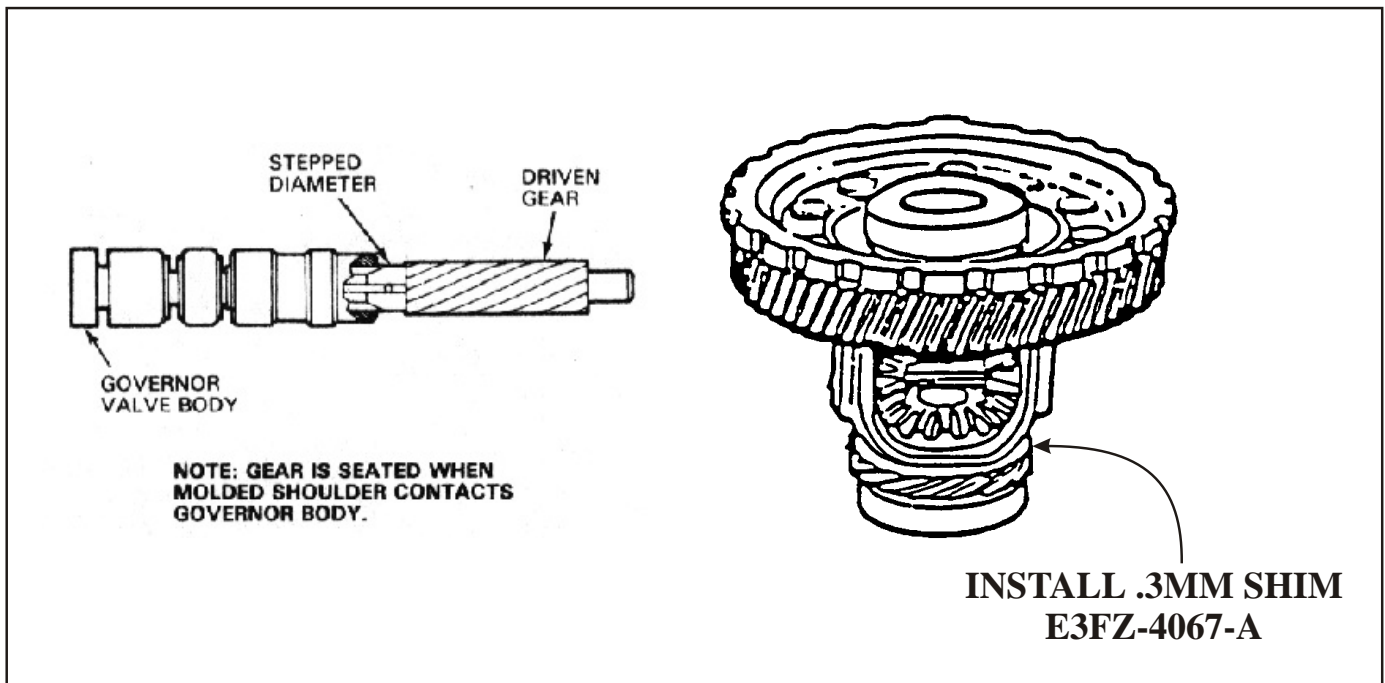
Loss of speedometer, speed control, and/or transaxle governor operation or function may be caused from the speedometer drive gear wearing against the differential housing causing gear wear *and looseness*. This condition will cause speedometer driven gear wear, and a "Hourglass" wear pattern of the governor gear. To service this condition replace the speedometer drive gear on the differential housing (OEM Part No E3FZ-17285-B). Prior to installing the drive gear, install a .3mm shim (E3FZ-4067-A) between the differential and the speedometer drive gear to eliminate repeat repairs. Replace speedometer driven gear and governor gear as required. Refer to ATSG Techtran Manual, Page 92, for differential removal without removing entire transaxle.
