# Technical Service Information

## TOYOTA 241-H NO 3-4 UPSHIFT

**COMPLAINT:** 1990-92 Toyota Corolla, equipped with **241-H All Wheel Drive** transmissions, may exhibit a no 3-4 upshift after overhaul.

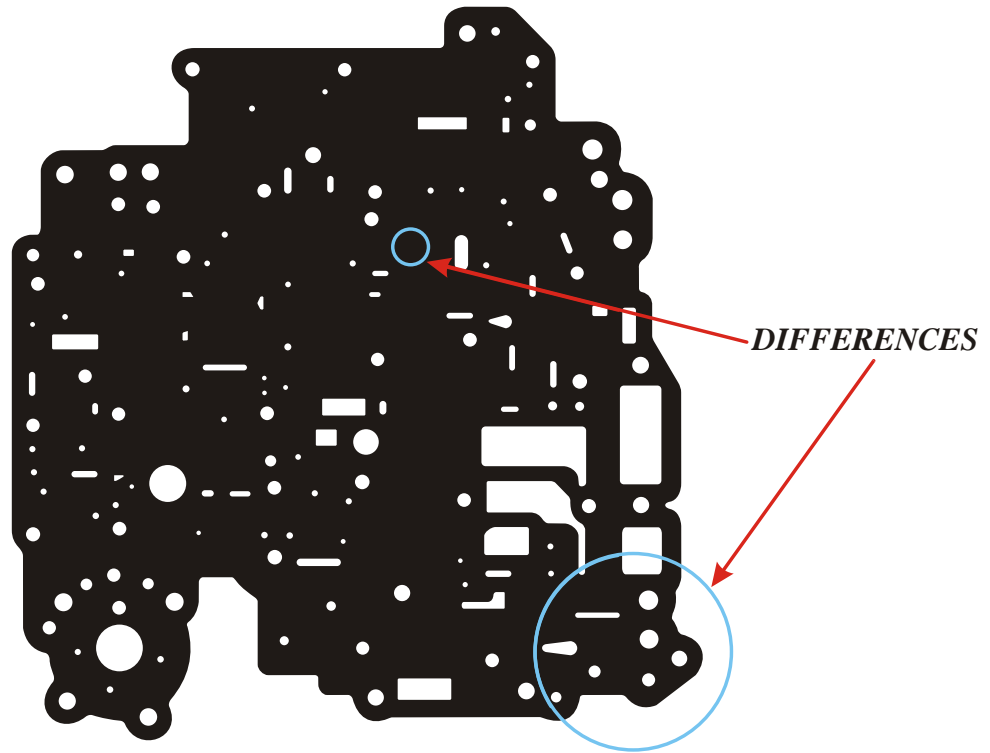
**240 L-No. 1 GASKET**

**CAUSE:** The cause may be, that during overhaul 240-L No.1 and No.2 valve body gaskets were used in place of the 241-H No.1 and No.2 valve body gaskets. The reason is that the two different gaskets sets have small subtle differences, as shown in Figures 1 and 2, and the 241-H gaskets **do not** come in current overhaul kits.

**CORRECTION:** Install the correct No.1 and No.2 valve body gaskets as per the Service Information listed below. Additional part numbers are provided in Service Information for the Transfer case gasket and seal kit and the left axle seal which are not provided in current overhaul kits.

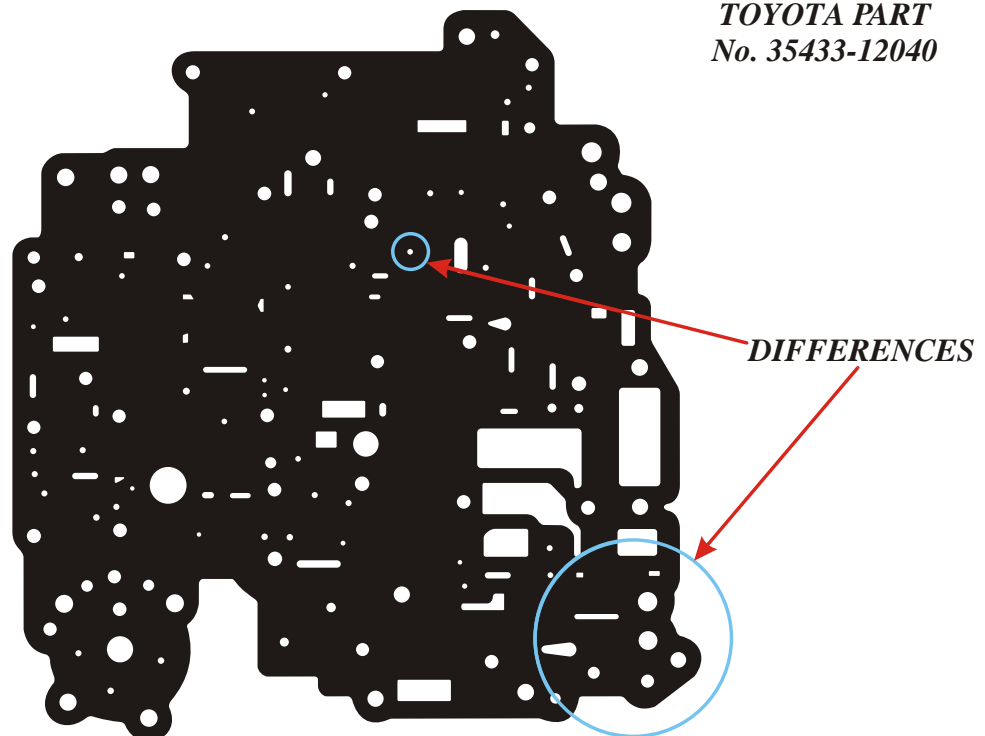
**240 H-No. 1 GASKET**

**TOYOTA PART**  
**No. 35433-12040**

Transfer Case gasket and seal kit (Toyota part number).....	35172-12020
Left axle seal (Toyota part number).....	35172-1220
Valve body gasket No.1 (Toyota part number).....	35433-12040
Valve body gasket No.2 (Toyota part number).....	35434-12020
