# Accessibility and Safety Audit for Persons with Disabilities at BUET

Plan 446

Transportation Planning Studio

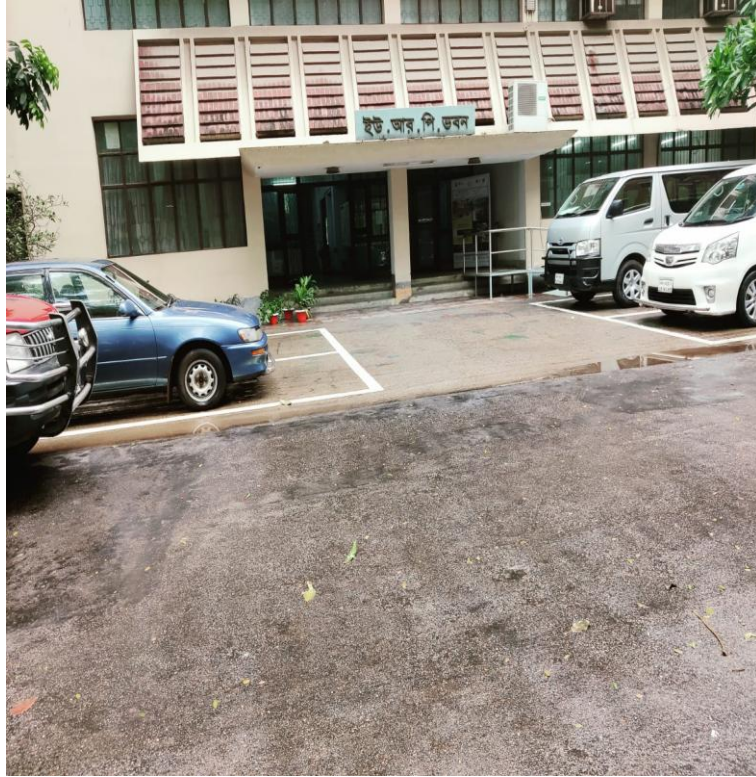
**Location :** In front of Department of URP

No Parking Space designated for Disable People

Number of Parking Spaces for Disable People	×
Signs	×
Slope	×
Vehicular entrance	×

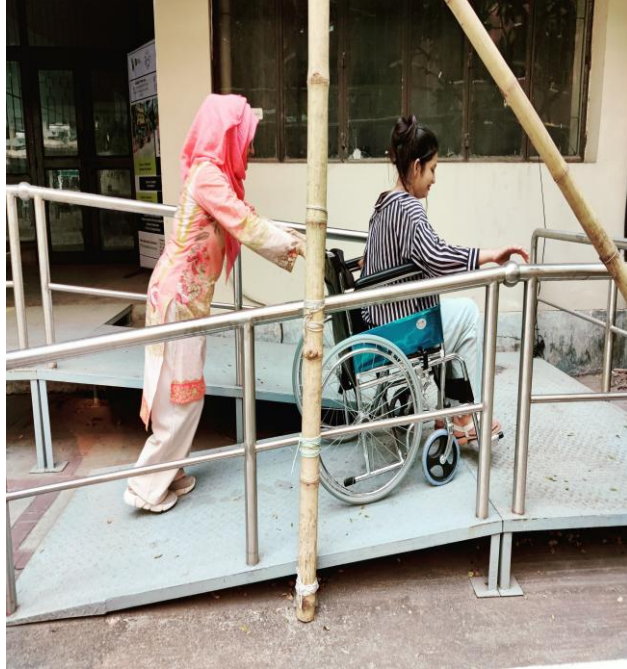
Difficulty in Accessing the Ramp without Assistance

Running Slope	1:9 (standard 1:12, MoHPW, 2020)
Width	3 ft.
Ramp Surface	Slip Resistant
Landings	Free of obstruction
Presence of Guard	✓
Lighting	✓

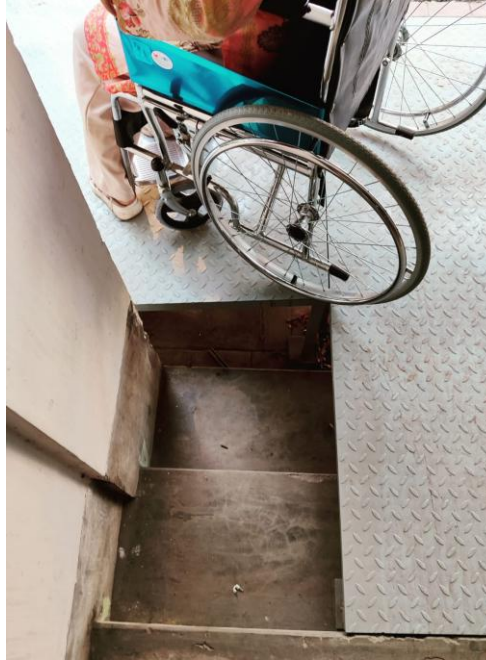
Safety issue: Hollow space beside edge

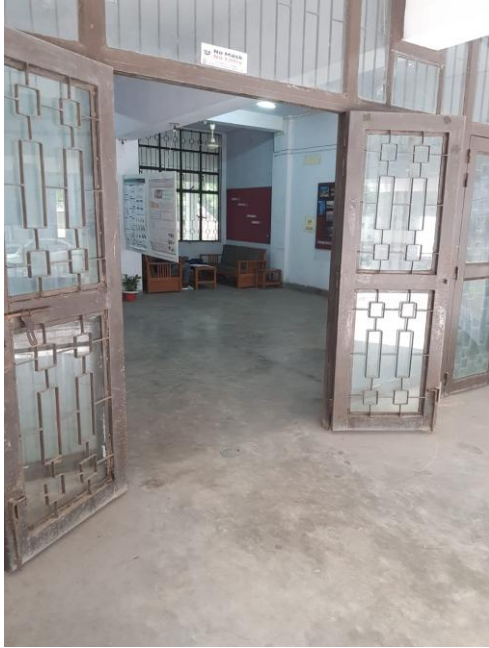
Door 1

Opening door easily operable

Location : In front of URP	Location: Back of URP
Width	5 ft.	3.5 ft.
Signage	×	×
Number of Entrances	1	1
Threshold	×	×
Opening Doors (One side)	✓	✓
Presence of Revolving Door	×	×
Emergency Exit	×	×
Door Handle	Easily Operable	Easily Operable

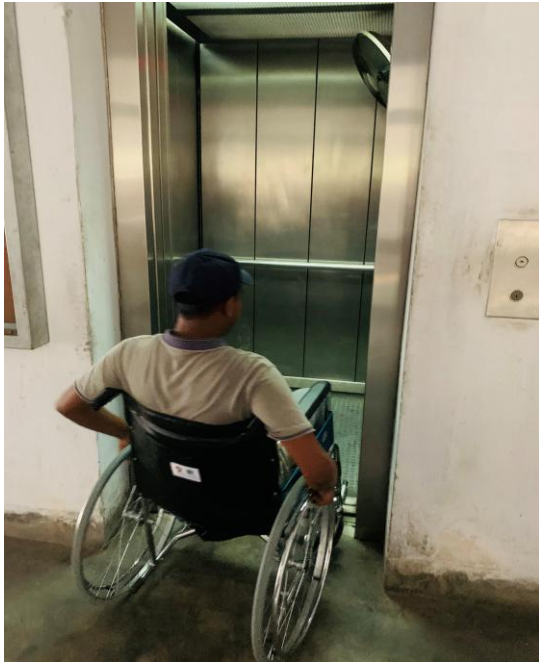
Adequate Width for Entering

Platform	Levelled
Entrance Width	3 feet (Standard)
Operating controls	Within Reach
Lift use	15 seconds (Enough for entering)
Turning Space inside lift	Not enough

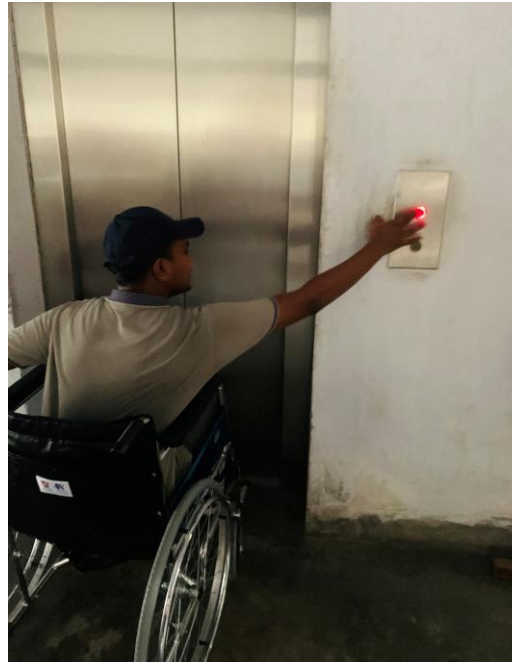
Operating Controls within Reach

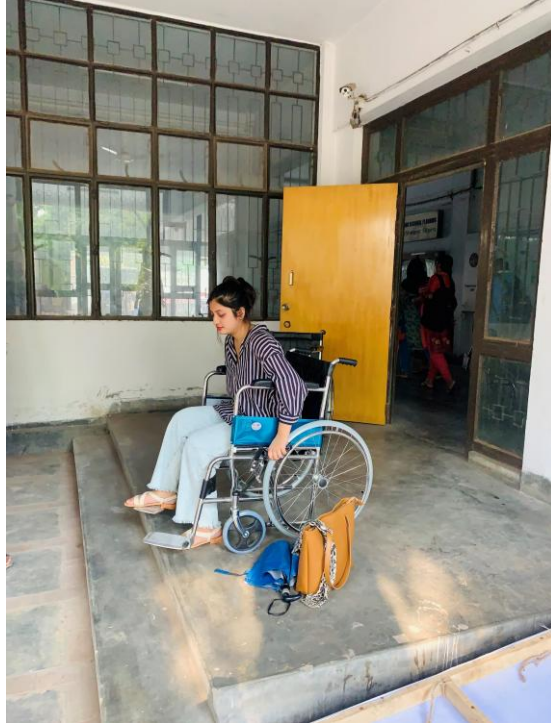
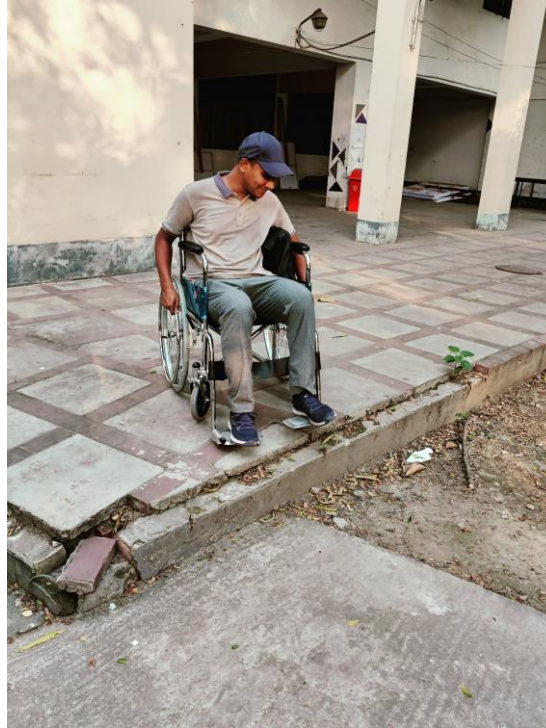
**Location :** Back side of Department of URP

**Accessibility Indicator : Exterior Ramp**

Presence of Ramp

×

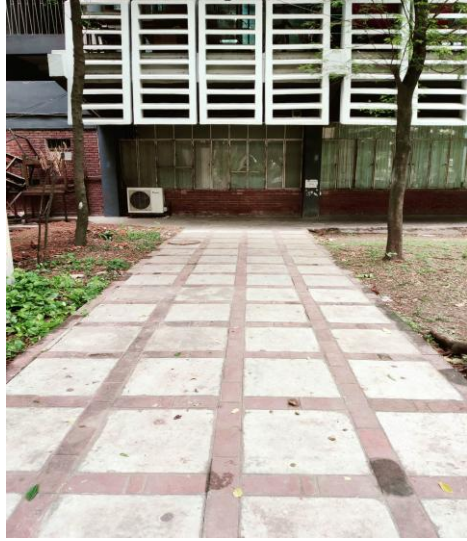
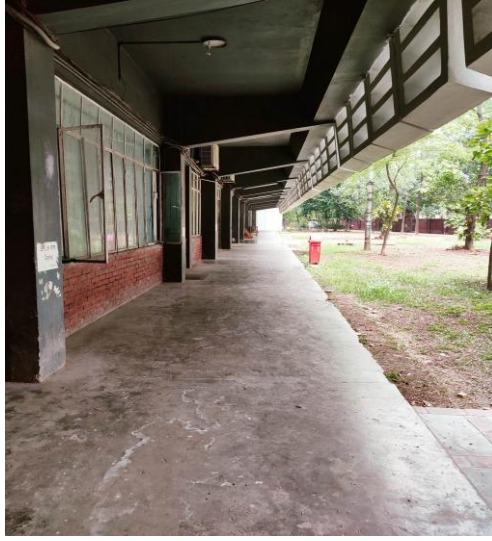
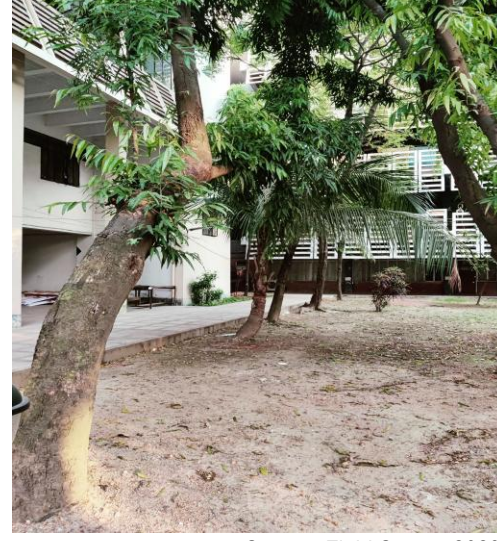
**Accessibility  
Indicator : Exterior  
Pathway**

Width	7.5 feet (Minimum Standard 4 feet)
Barrier free pathway	✓
Planting	✓
Lighting	Proper
Stable, strong, weatherproof	✓

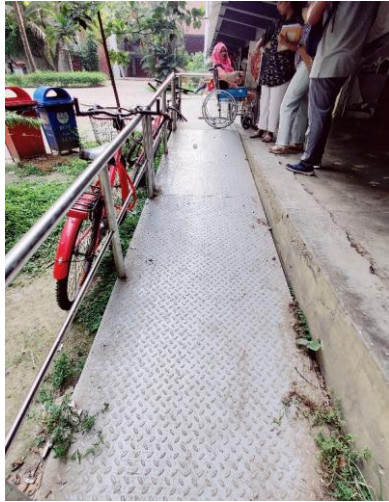
Difficulty in using the ramp for wheelchair users

Running Slope	1:9.5 ( <b>standard 1:12</b> , MoHPW, 2020)	Landings	<b>Uneven Surface</b>
Width	3.3ft	Presence of Guard	✓
Ramp Surface	Textured	Location	Front of Building
Ramp edges	✗	Lighting	Proper lighting during Night

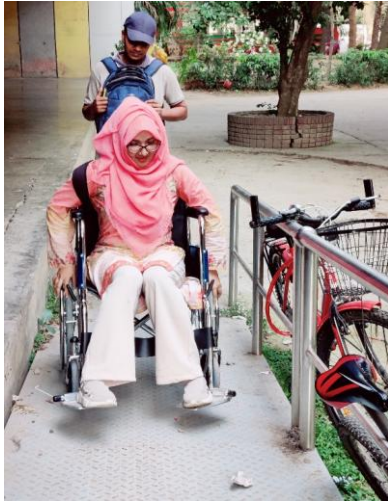
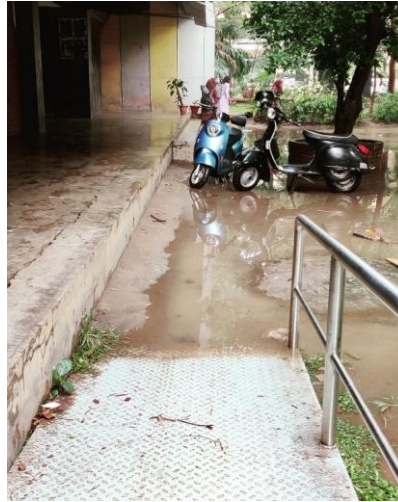
Water logged after rain

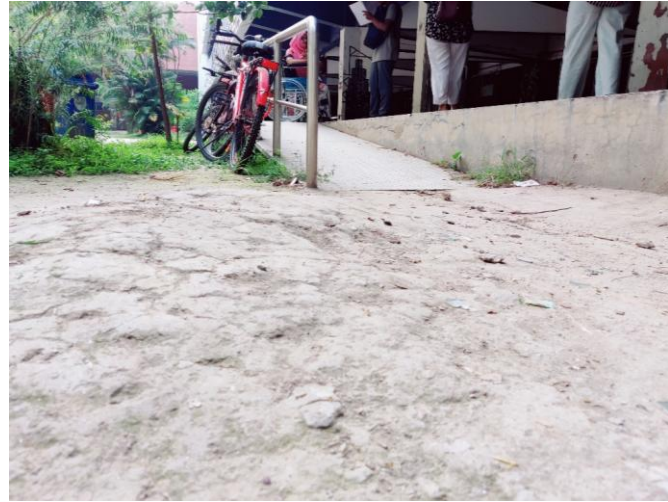
Uneven landings: Safety issue for wheelchair users

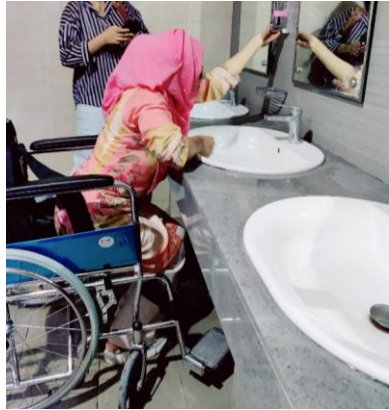
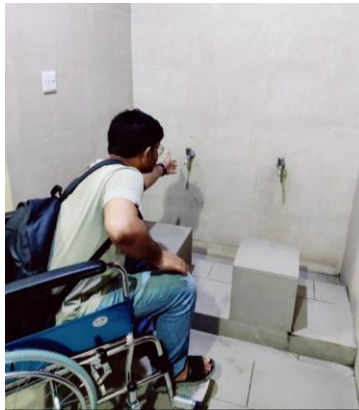
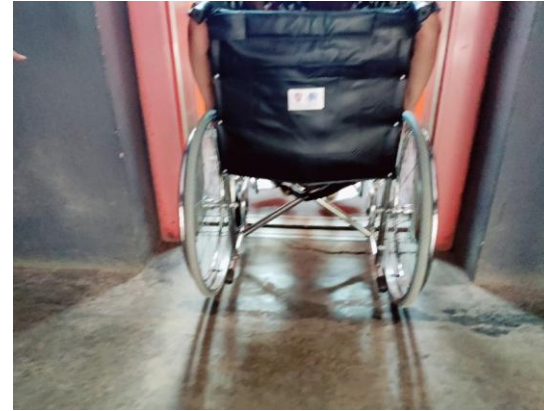
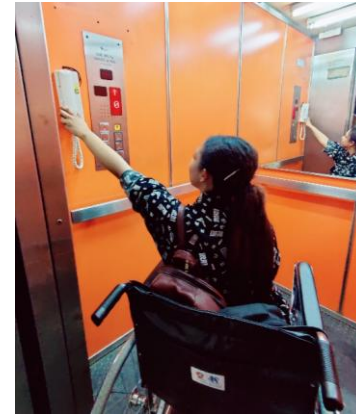
**Location :** Ground Floor, Department of Architecture, BUET

Number of Washroom	1
Signage, Flush Controls, Toilet Paper Dispenser, Mirror, Lighting	✓
Width	2.10 ft.
Door	One side revolving
Space around the toilet	✗
Ablution Space	Not reachable for physically disabled people

Weight Capacity	1050
Lift Platform	Raised
Operating Controls	Easily operable
Call-send controls	Operable
Lift Use	15 Seconds
Lift Entrance	Not easily accessible for wheelchair user

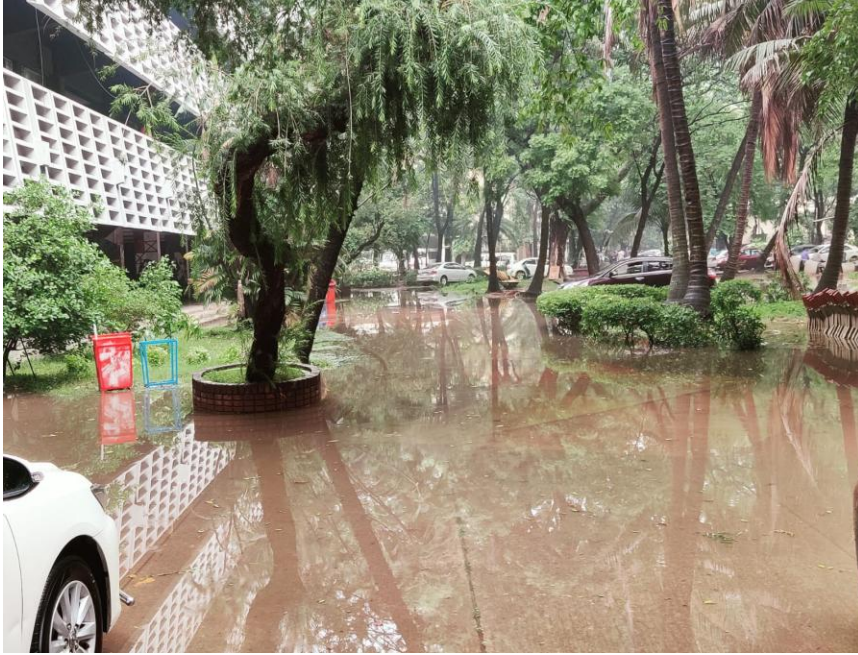
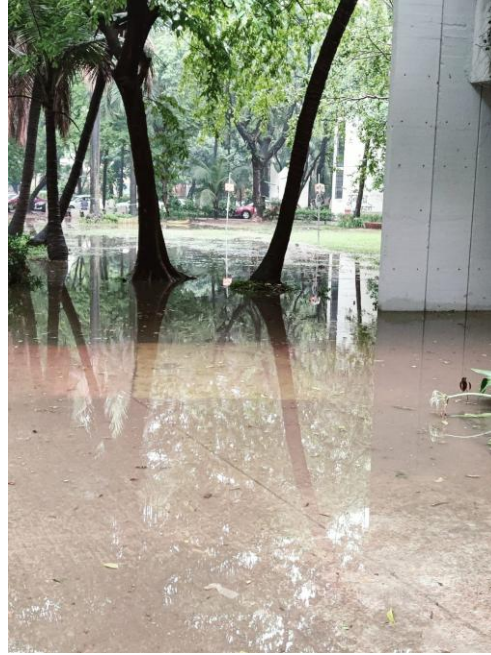
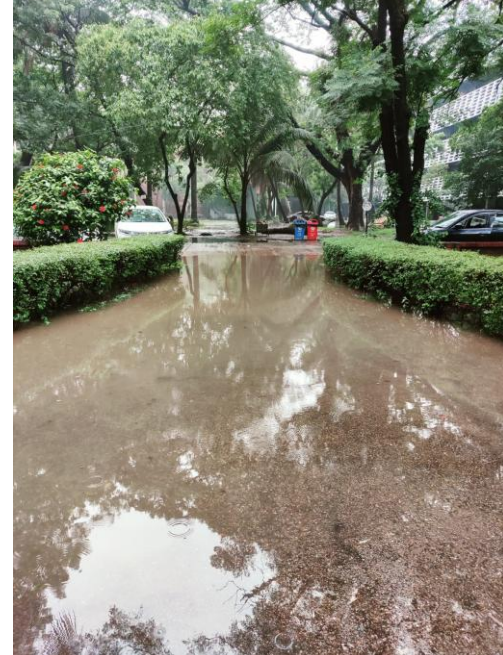
**Location :** In front of Department of Architecture, BUET

Water logged after rain

Drainage

Poor

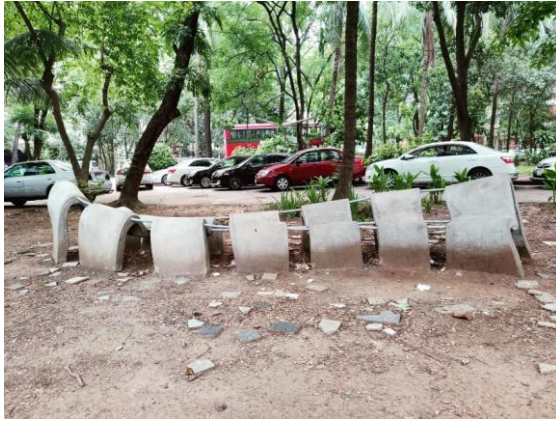
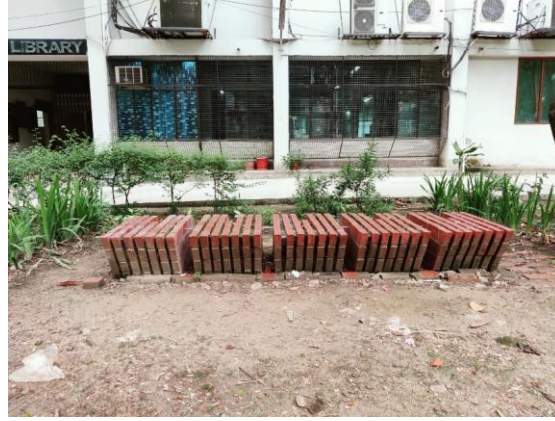
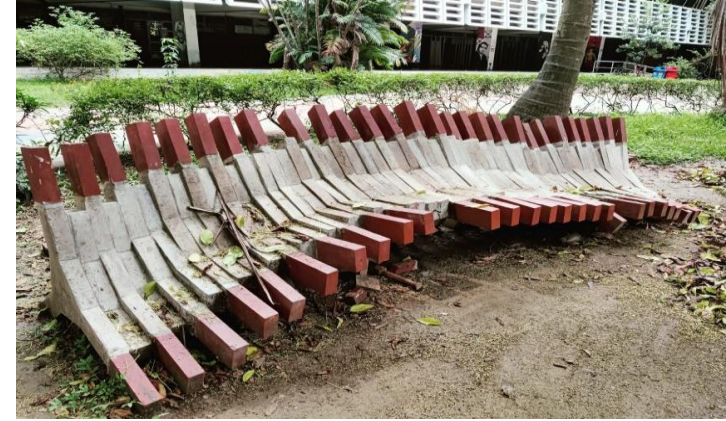
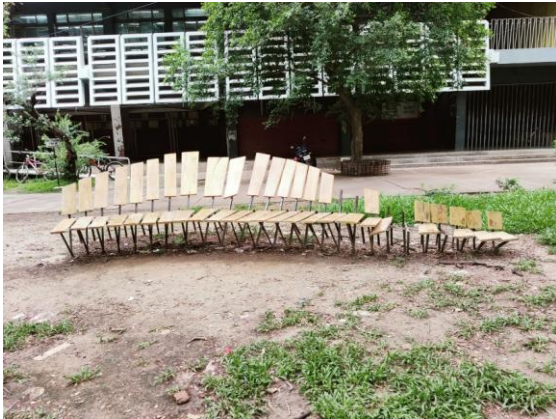
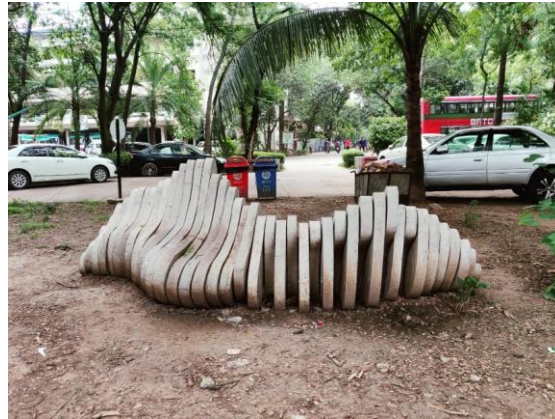
**Location :** In front of Department of Architecture, BUET and Central Library, BUET

## Accessibility Indicator: Exterior Furnishing

Number of seat arrangements	6
Seating Space	For 5/7 people
Surface height	Moderate
Pathway	Unpaved
Stability	Stable

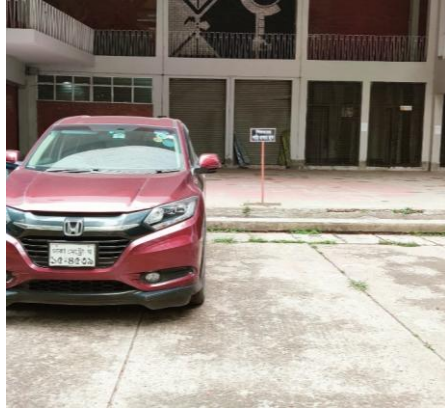
Signage of Parking

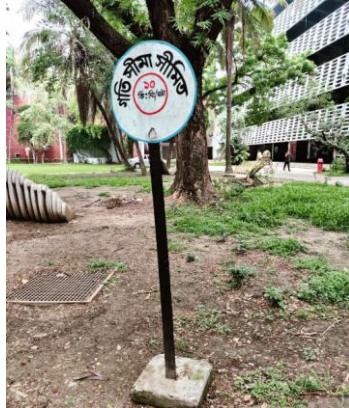
Speed Limit Sign

Roadway Width	17ft., 17.5ft.
Shoulder	×
Radial Bend of Roads	11 ft.
Road Surface	Textured
Speed limit sign	✓
Sign Readability	✓
Sign Locations	Beside Road

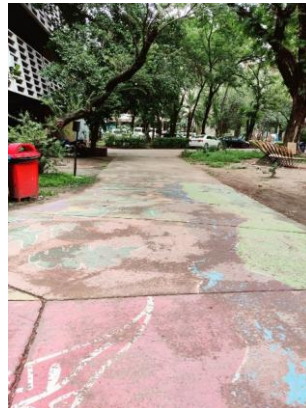
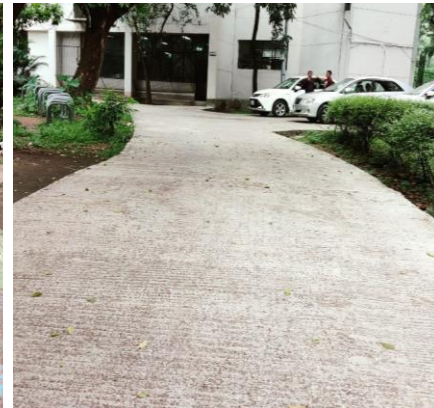
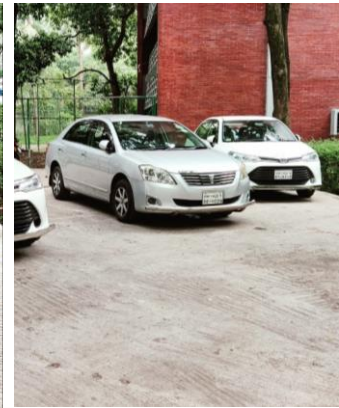
**Location :** In front of Department of Architecture, BUET

## Safety Indicators

Road markings	×
Street lighting	Not enough lighting during night
Overtaking facilities	×
Vehicle type restrictions	×
On street parking	✓
Designated Parking	✓

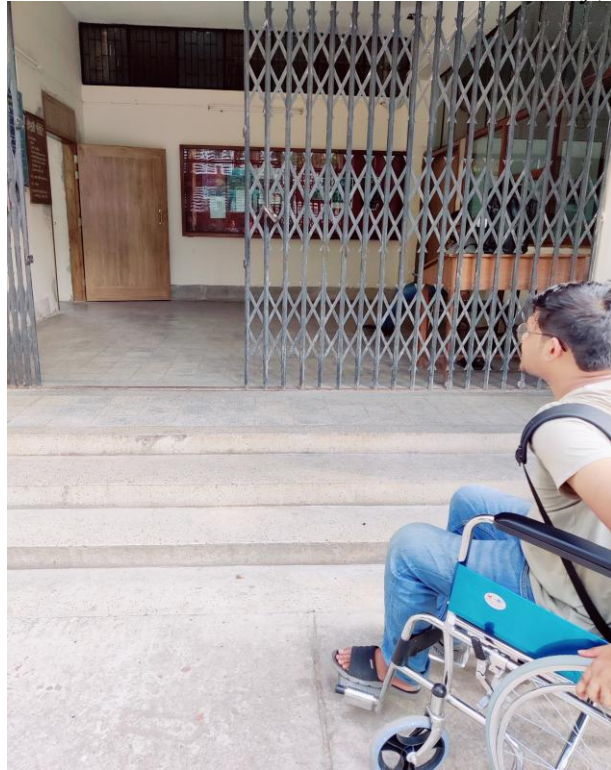
**Location :** In front of *Central Library, BUET*

Presence of Ramp	×
------------------	---

Central Library is not Accessible for Disable People

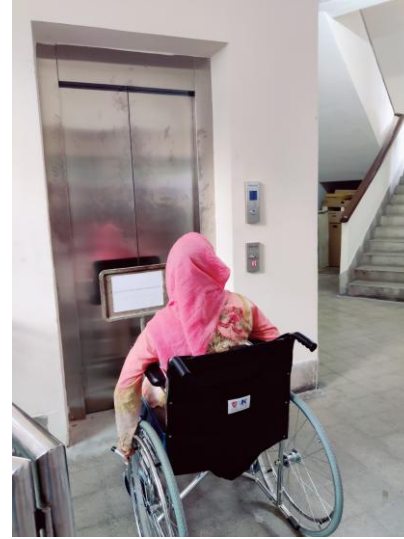
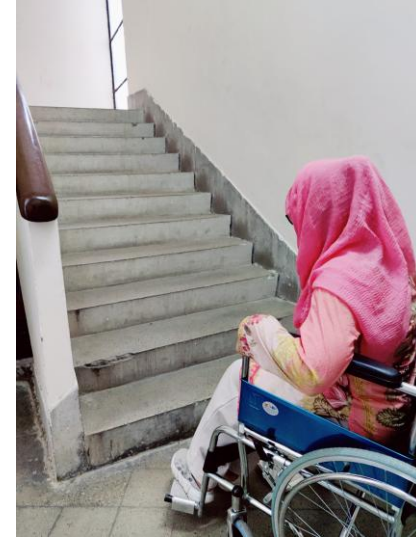
**Location :** Ground Floor, *Central Library, BUET*

Lift	Under Repair
Interior Ramp	×

*Central Library, BUET is not accessible for physically challenged people*

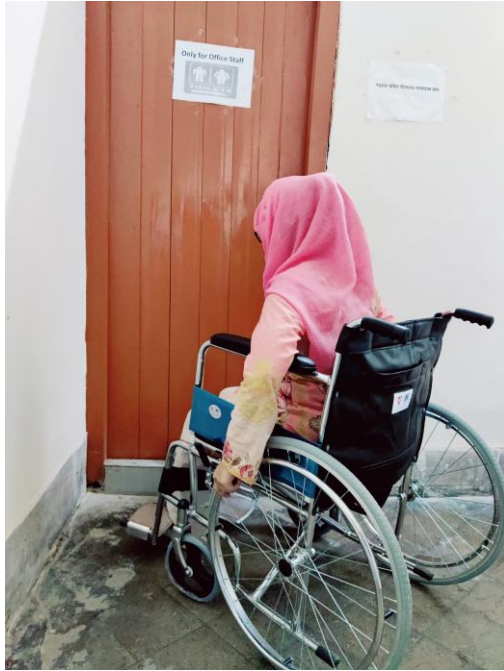
Washroom only accessible to Staffs

Number of Washroom	1
Entrance	Elevated
Signage	✓
Flush Controls	✓
Toilet Paper/ Dispenser	✓
Mirror, Lighting	✓
Width	Inadequate
Door	One sided revolving
Space around the toilet	✗
Ablution Space	Not reachable by physically disabled people

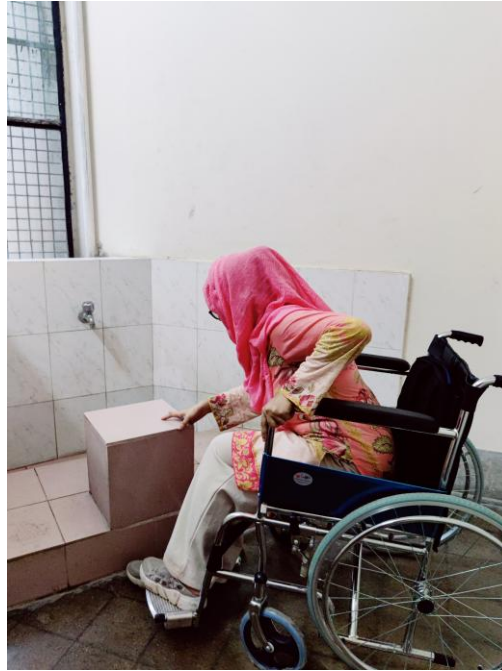
Unreachable

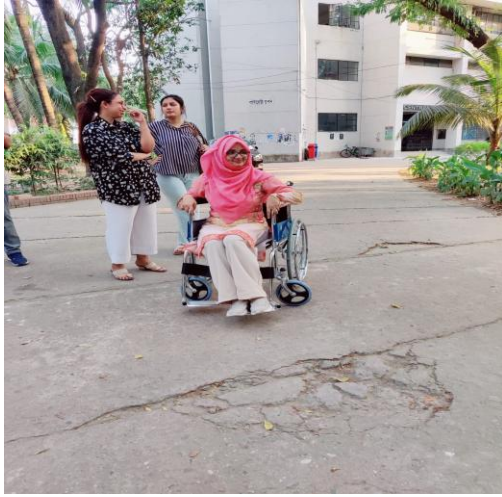
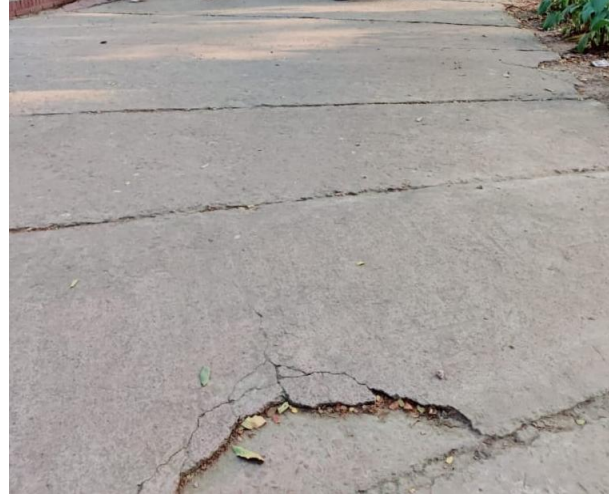
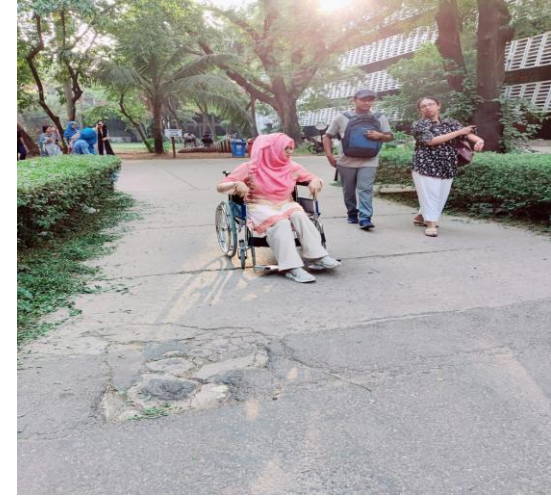
Figure 01: Broken Surface on Road

Figure 02: Rough surface

Figure 03: Difficulty while operating wheelchair

Roadway Width	11 feet
Shoulder	×
Speed Bump	×
Road Surface	Broken and rough Surface
Signs	Destination indicating Architecture and OAB

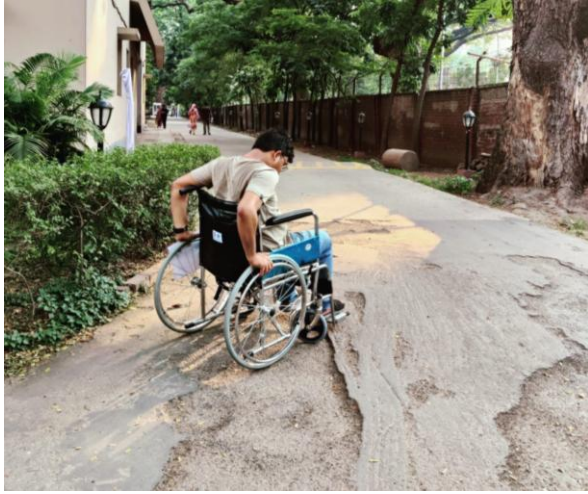
Figure 01: Broken Surface on Road

Roadway Width	15 ft.
Shoulder	×
Speed Bump	Trapezoidal, <b>not easily operable for wheelchairs</b>
Road Surface	<b>Broken Surface</b>
Signs	×

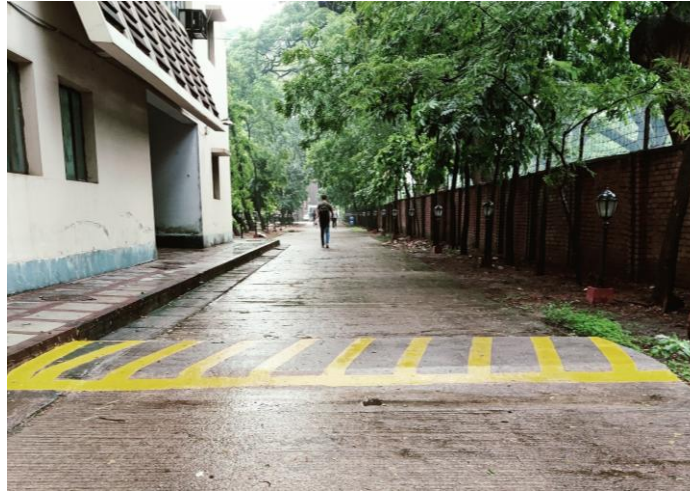
Figure 02: Trapezoidal Speed Bump

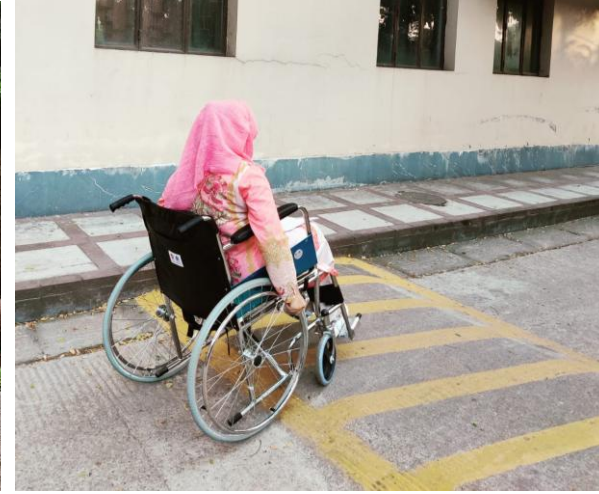
Figure 03: Difficulty while operating wheelchair

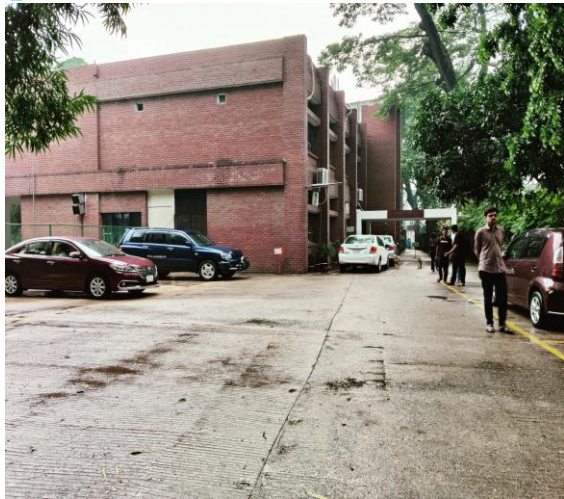
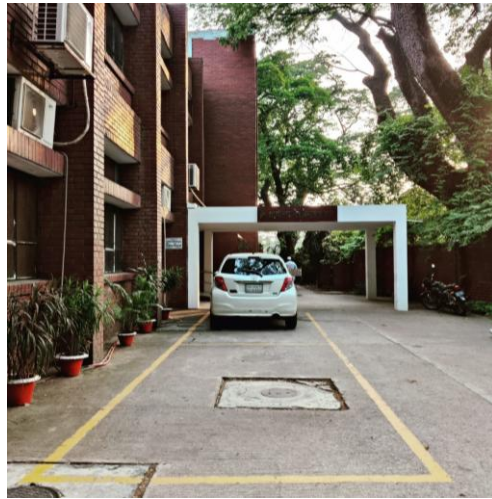
Designated Parking Area

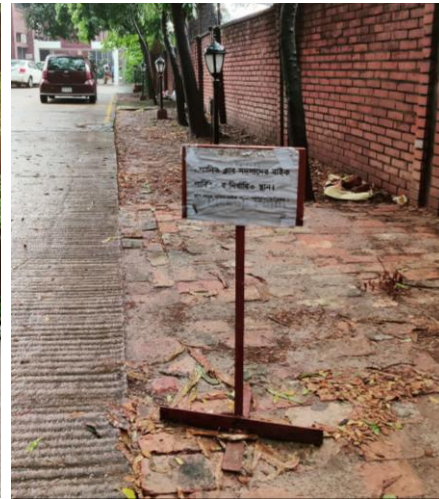
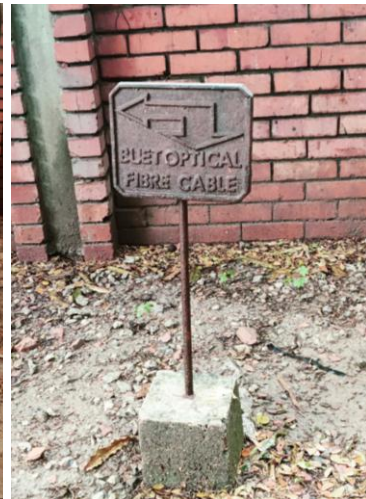
Improper signage: Not easily visible

Designated Parking	✓
Sign Locations	Beside Road
Sign Readability	Poor
Vehicle type restrictions	✗
Speed Limit	✗

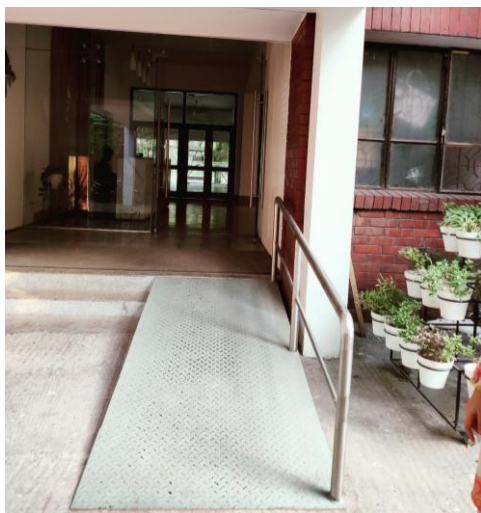
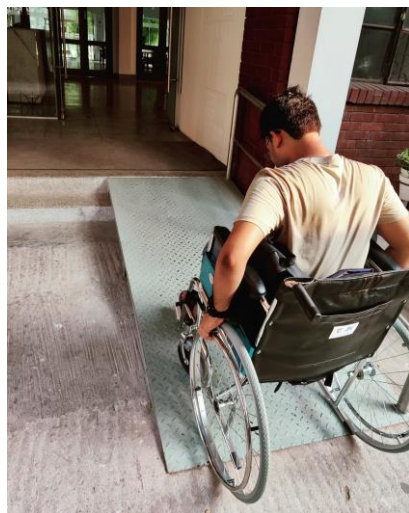
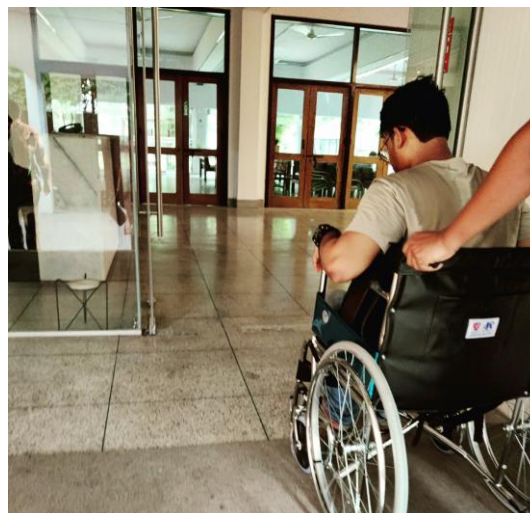
Entrance of Teachers Club: Difficulty in using the ramp for wheelchair users

Signage	×	Running Slope	1: 5.5 (standard 1:12, MoHPW, 2020)	Landings	Proper
Number of Entrances	1	Width	3	Presence of Guard	✓
Presence of Revolving Door	×	Ramp Surface	Textured	Lighting	Proper lighting during Night
		Ramp edges	×
