EQUITY BACKUP CALL-OUT REPORT

22nd FEBRUARY 2025

Site: Equity Bank Loitoktok Branch

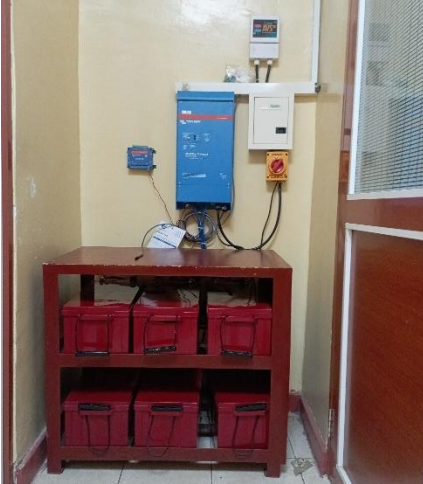
Figure 1: Existing System image

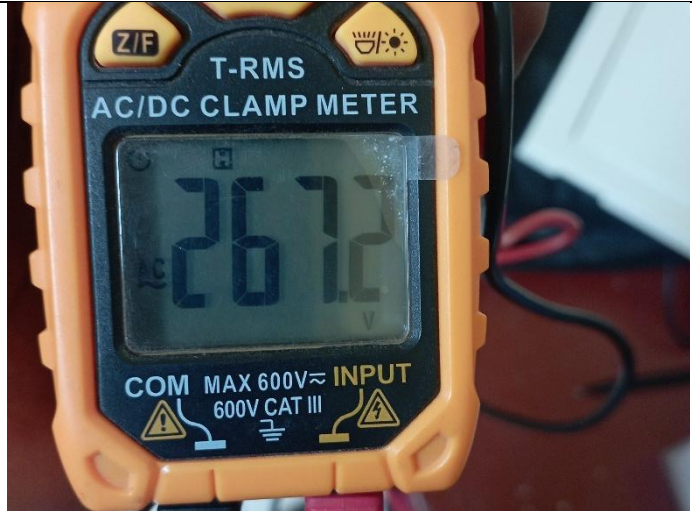
- The voltage on the input terminals of the AVS was measured and the reading was 260V. This value was higher than the initial limit of 250V set on the AVS. This is the reason why the AVS was disconnecting power from getting to the output side. The high voltage limit of the AVS was adjusted to 260V to accommodate the periods when power from the grid exceeds 240V.

Figure 2: Image of the voltage reading on the input side of the AVS

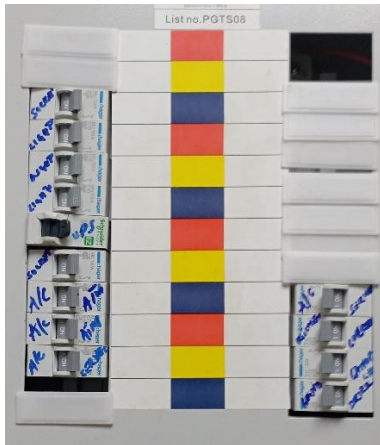
Figure 3: Image of the UPS MCB shifted to Red phase

- The MCB that supplies KPLC input from the distribution board to the backup system was shifted the Red phase which was more stable having constant 239V

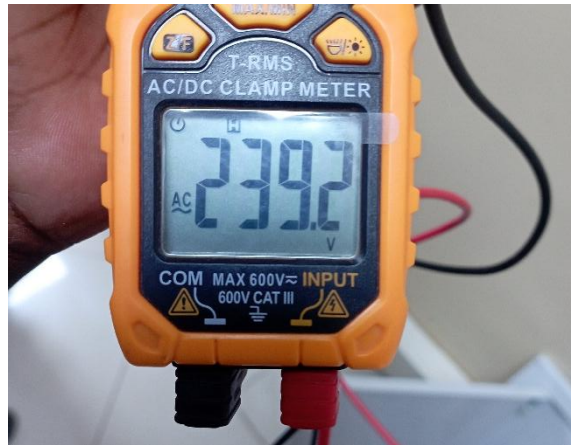
Figure 4: Image of the voltage reading of Red phase

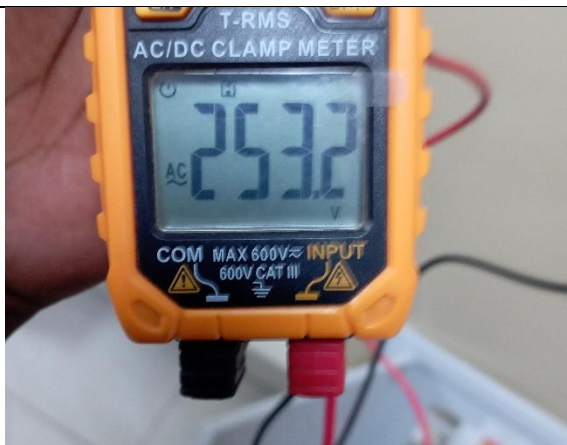
Figure 5: Image of the voltage reading of Yellow phase

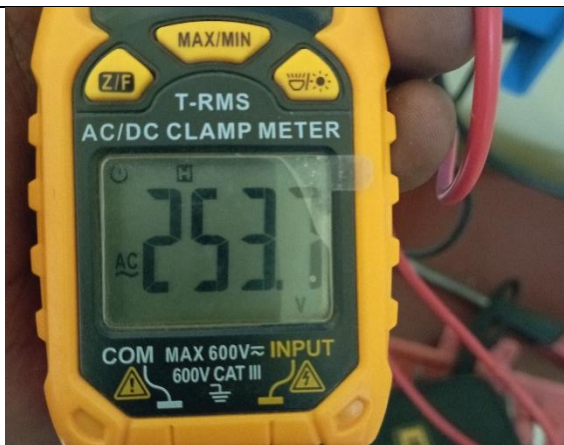
Figure 6: Image of voltage reading of Blue phase
