Inspection Report
Rosanna Danna

HomeBuyers Inspection
HBI

Address: 91142, East West Street, Red Bud, NC

Inspector: Russell Buchanan OR;OCHI 1180, WA; 864
122 Lyman Street Building 1
Asheville, NC 28801
828-254-2030
7/29/2015

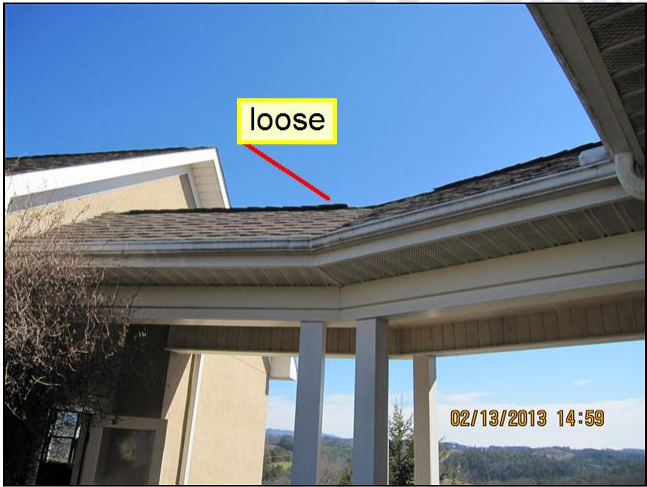
1.2 Item 1(Picture)

Ridge vent loose at end above breezeway and needs to be fastened. Nail head used to fasten should be sealed with sealant.

Ridge vent loose at end above breezeway and needs to be fastened. Nail head used to fasten should be sealed with sealant.

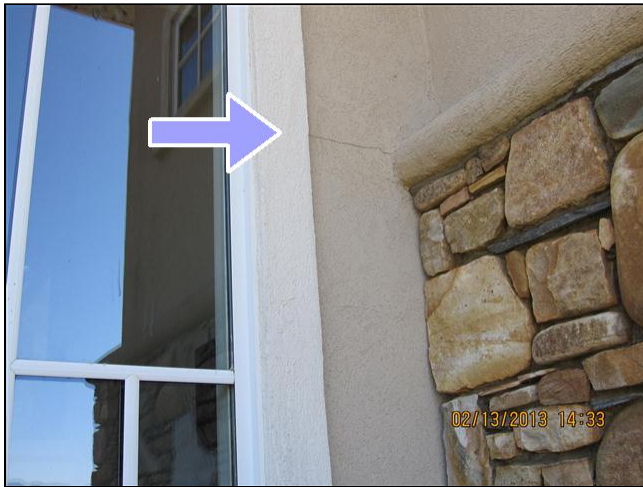
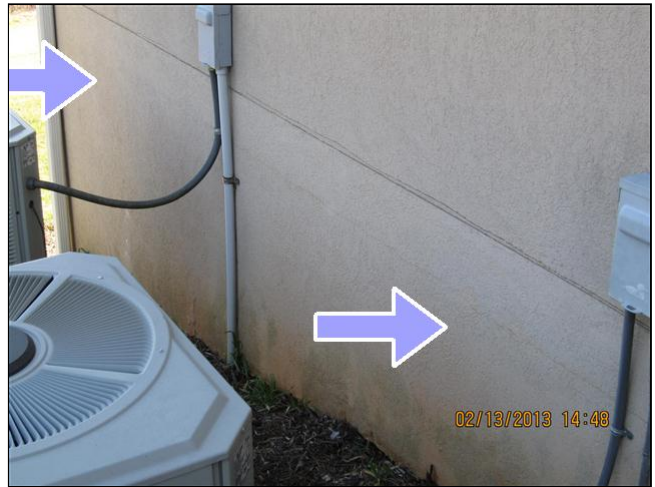
2.0 Item 1(Picture)

(1) Some hairline cracks in areas around home. These appear to be typical.

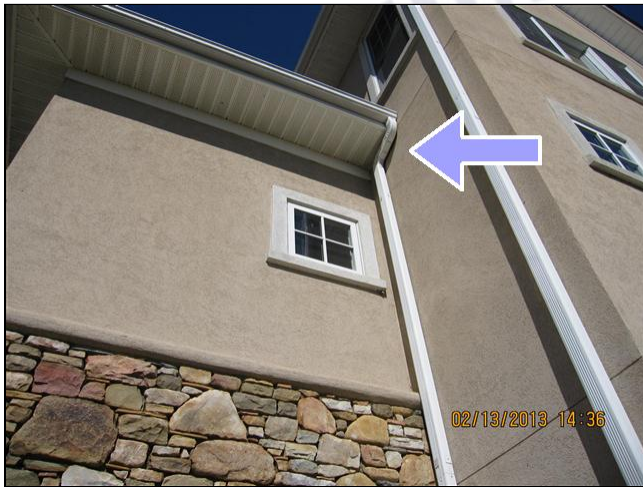
2.0 Item 3(Picture)

(2) Bird nest is wedged between downspout elbow and home should be removed and inspect further as animals can damage and allow water to get inside wall.

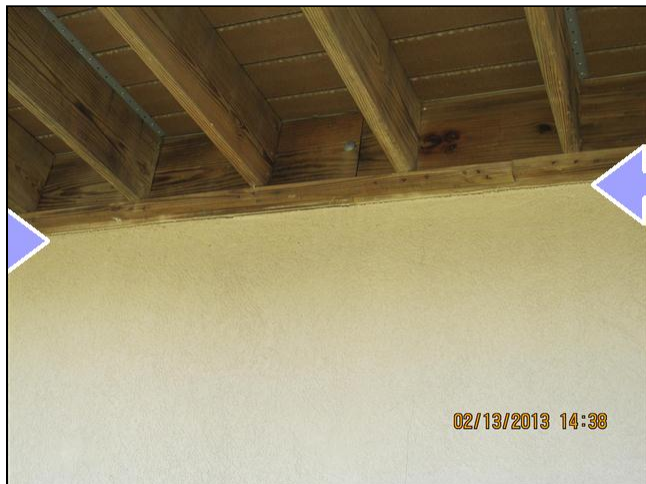
2.0 Item 4(Picture)

(3) A common seam where stucco and ledger meet under deck. I recommend silicone caulking to seal.

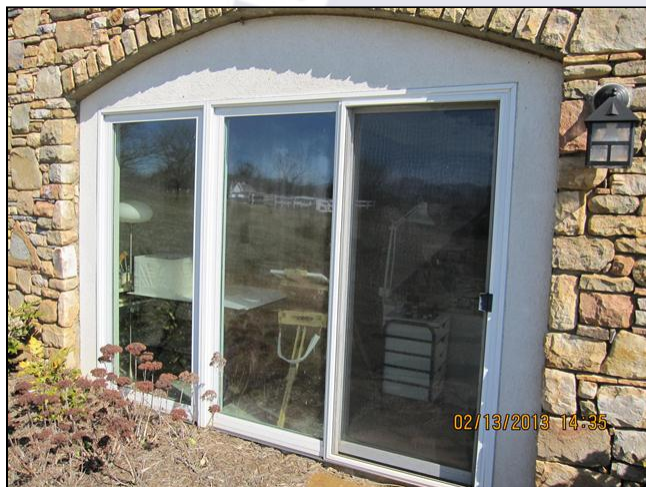
2.1 Item 1(Picture)

Glass panel doors/window at right side (facing front) cloudy or seal is broken. Glass panes that have lost their seal (cloudy) can usually be replaced without replacing the entire unit. A qualified contractor should inspect and repair as needed.

Glass panel doors/window at right side (facing front) cloudy or seal is broken. Glass panes that have lost their seal (cloudy) can usually be replaced without replacing the entire unit. A qualified contractor should inspect and repair as needed.

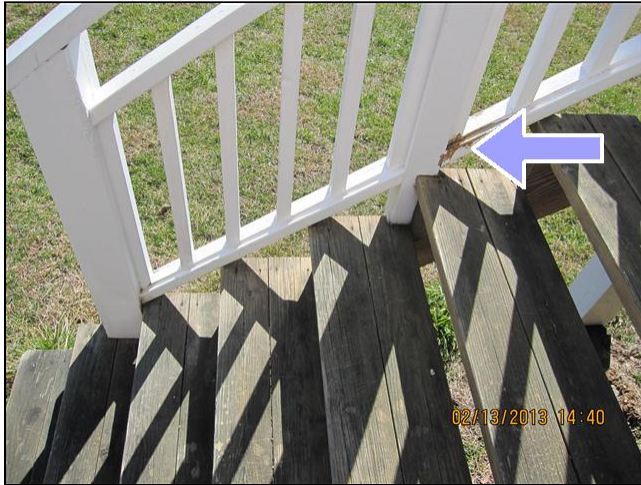
2.3 Item 1(Picture)

Bottom rail is soft or deteriorated in one area and other areas weathered. Needs prep and paint. Deck stairs need algae removed with a cleaner and seal with a non skid weather sealant.

Bottom rail is soft or deteriorated in one area and other areas weathered. Needs prep and paint. Deck stairs need algae removed with a cleaner and seal with a non skid weather sealant.

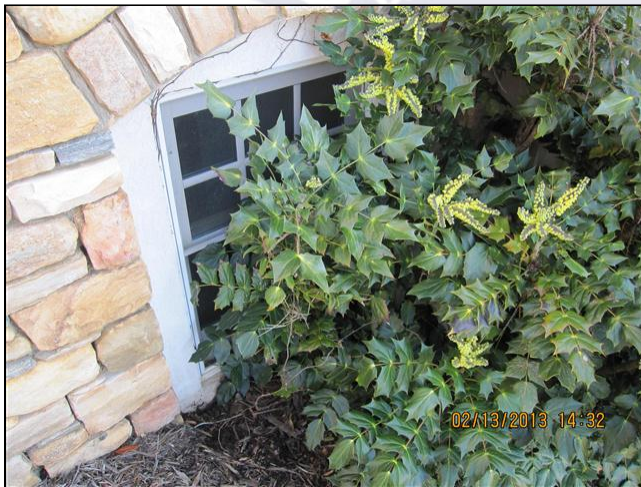
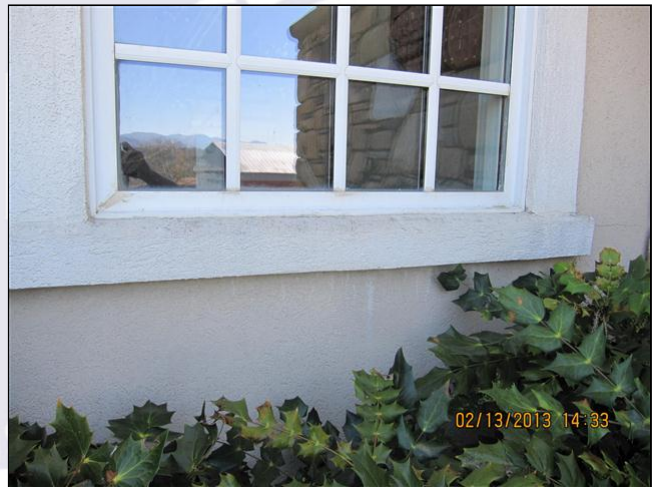
2.4 Item 1(Picture)

Thorny bushes or vegetation obstructing access and should be relocated to allow clearance from siding of home

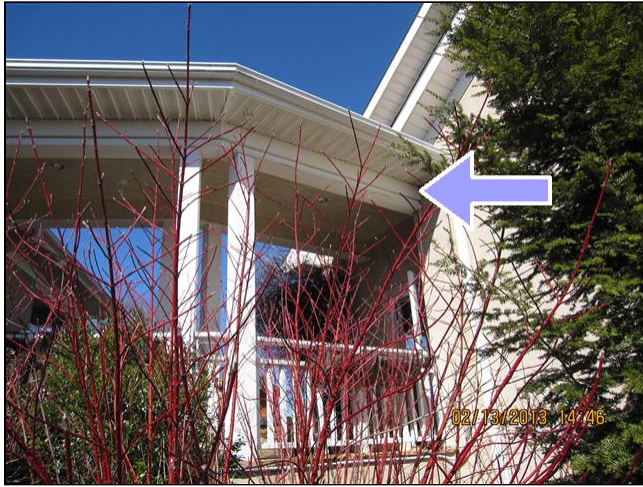
**2.5 Item 1(Picture)**

Some areas need prep and paint along breezeway at top fascia trim (cosmetic).

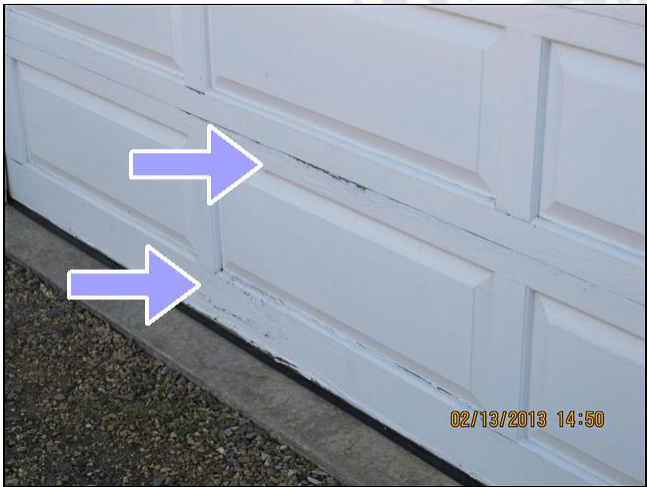
3.3 Item 1(Picture)
Weathered needs prep and paint at Garage door.

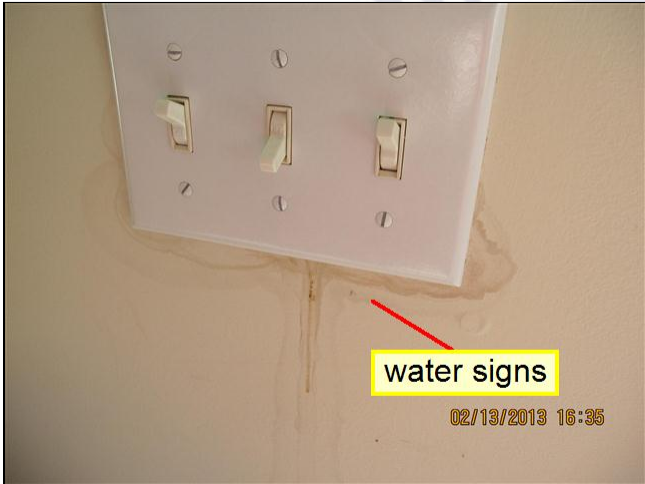
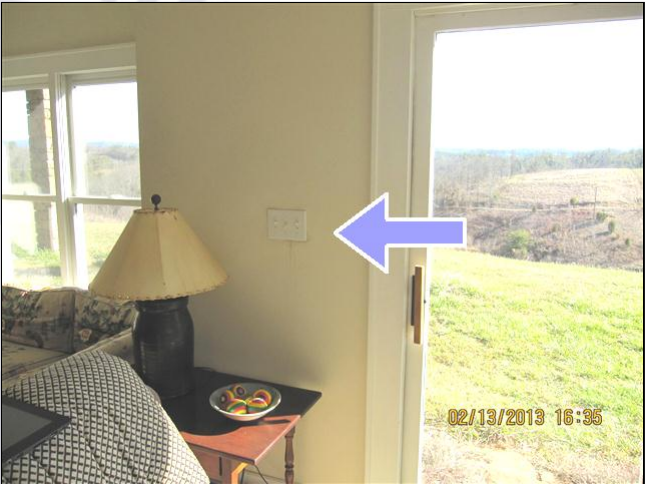
4.1 Item 1(Picture)

Wall switch at lower level shows evidence of water getting in from outside? There is a light fixture in relation to this wall switch and perhaps water is getting in there? i recommend further investigation to determine location and correct.

Wall switch at lower level shows evidence of water getting in from outside? There is a light fixture in relation to this wall switch and perhaps water is getting in there? i recommend further investigation to determine location and correct.

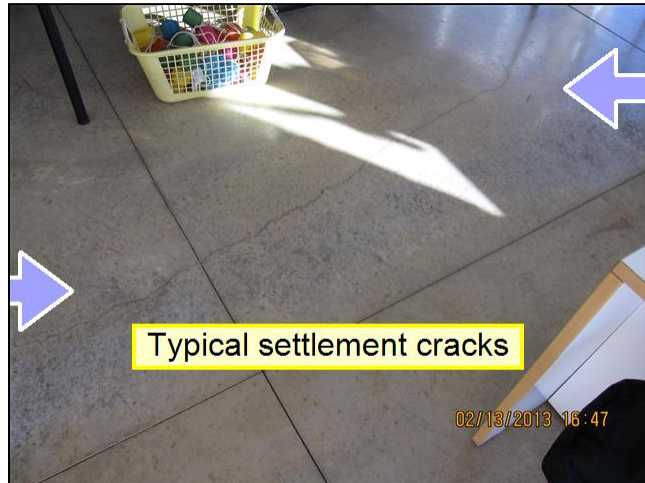
4.2 Item 1(Picture)

Lower level concrete has typical settlement cracks. We did not remove area rug or inspect underneath it.

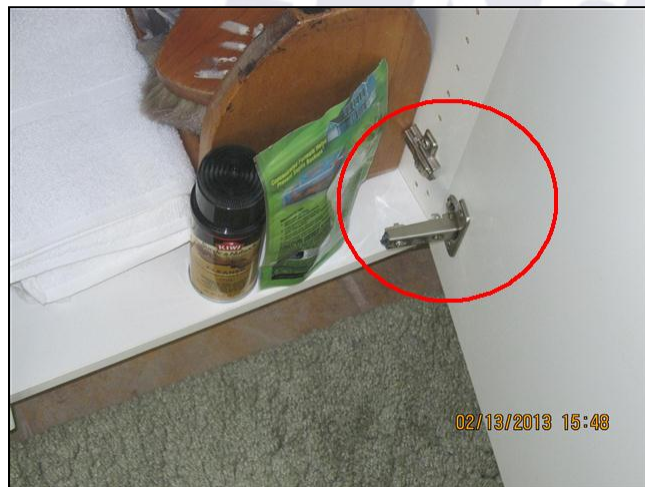
4.4 Item 1(Picture)

Hinge needs repair/replace at sink base in master bath.

Hinge needs repair/replace at sink base in master bath.

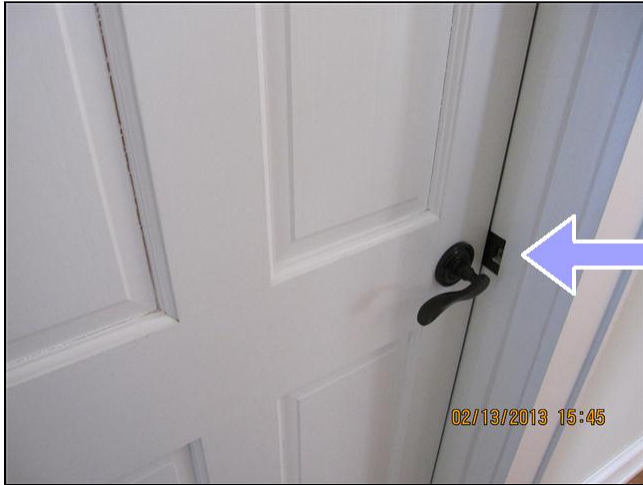
4.5 Item 1(Picture)

Master bedroom closet door (His) will not latch easily, needs adjustment

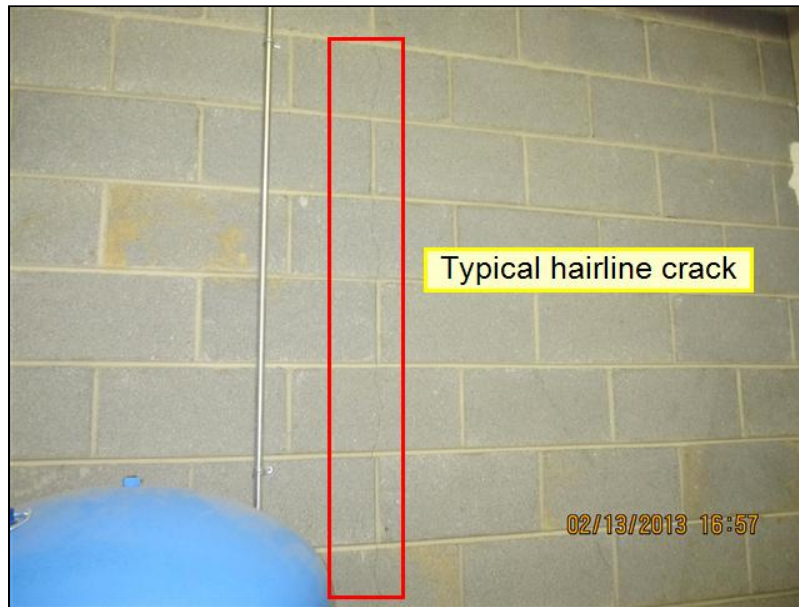
5.1 Item 1(Picture)

Hairline cracks in wall (typical).

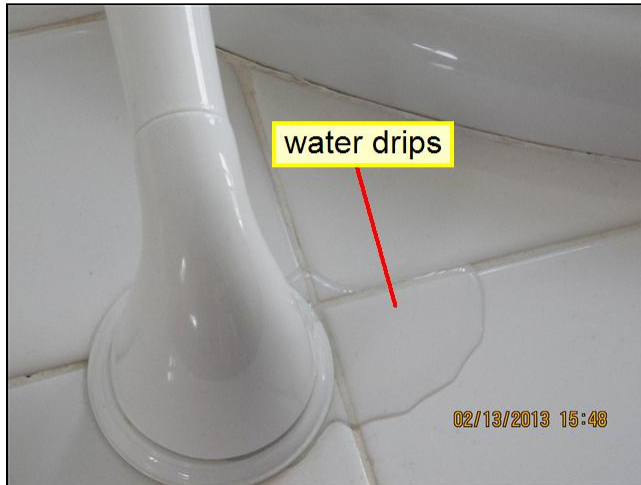
6.1 Item 1(Picture)

(1) Water drips from control knob on Jacuzzi brand tub. Also the lever to switch from spout to shower head works but feels weak when moved/turned and I am not sure if it is standard or loose? Recommend a plumber to inspect and repair as needed.

(1) Water drips from control knob on Jacuzzi brand tub. Also the lever to switch from spout to shower head works but feels weak when moved/turned and I am not sure if it is standard or loose? Recommend a plumber to inspect and repair as needed.

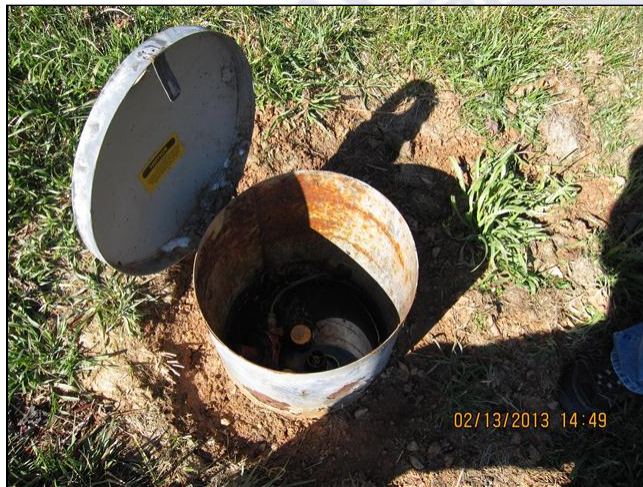
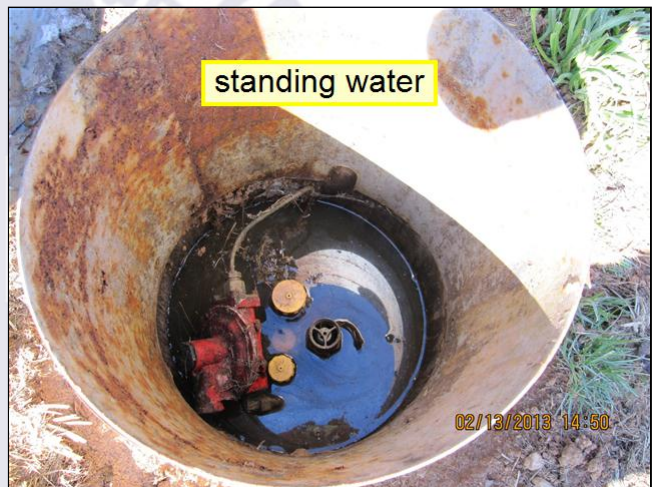
6.4 Item 1(Picture)

(1) Standing water should be removed and prevented from occurring at propane valves and meter access.

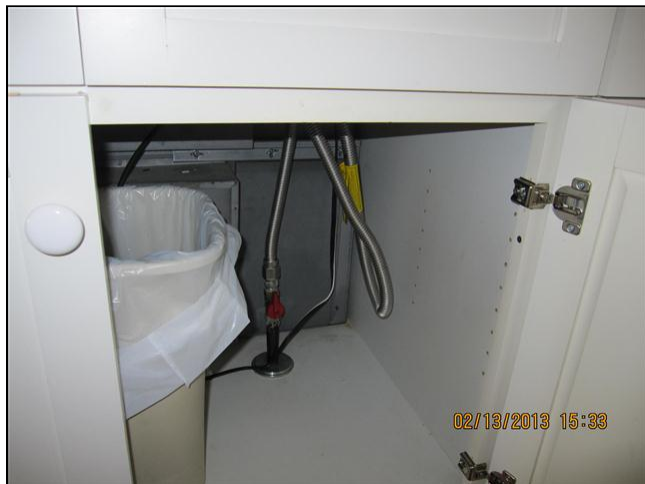
**6.4 Item 3(Picture)**

(2) Gas odor detected under range in kitchen and also upon entering into Equipment room downstairs where LP gas water heater is located. Note, there is a fresh air pipe connecting the equipment room to the outside air. Some energy pros may suggest that a mechanical fan would be more energy efficient than the passive vent installed.
