Report on the 5x5 Pixel Hadron Monitors for the NuMI Beamline

Abstract

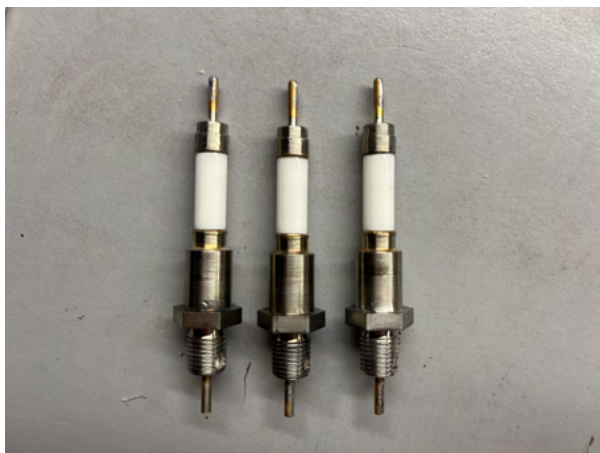
Figure 1: A close up of the feedthroughs as used for the hadron monitors.

- Each feedthrough is fitted with a custom gasket and then installed onto a respective monitor. Gold-coated ground posts are also installed onto the HMs.
- The monitors are sealed with a temporary silicon gasket and leak tested. Each feedthrough is ensured to be gas-tight before proceeding with the next steps.

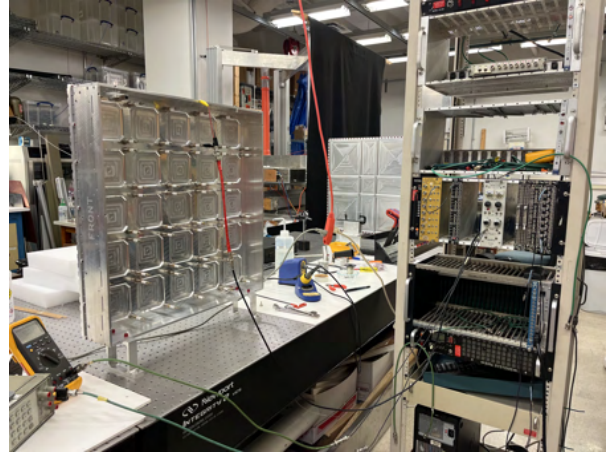
Figure 4: An image of the 3rd 5x5 pixel HM being HV tested in air.

- After installation, we measured the capacitance of each 3 plate capacitor to check that the plates at each pixel were properly connected. The theoretical capacitance of these 3 plate capacitors is approximately 137 pF.
- Following the capacitance tests, high voltage tests are conducted in air (e.g., the HMs are not filled with He). The HV tests allow us to check for electrical shorts. The resultant current was measured with a Fluke multimeter.
- No more than 300 V should be applied to any single pixel at a time.

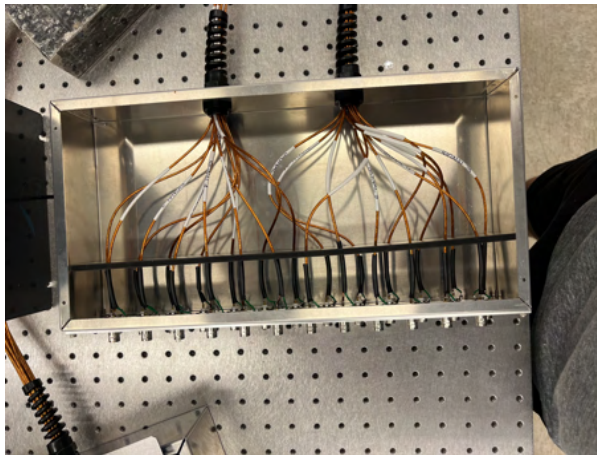
Figure 7: The inside of the 2nd HM's signal box.

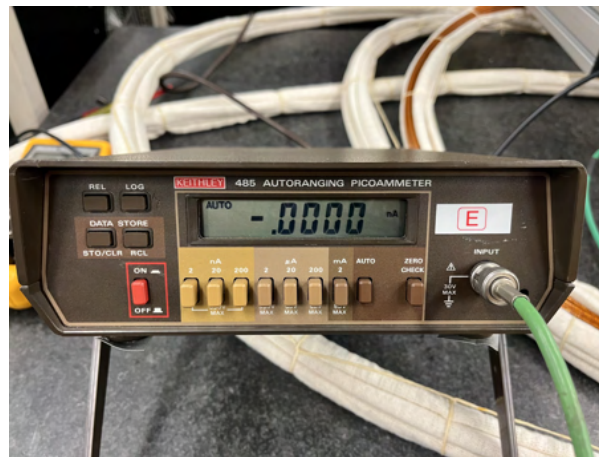
Figure 11: The Keithley picoammeter used for source testing.

- Finally, the functionality of the monitors was tested with an AmBe source.
- Each pixel was supplied with 161.9 V during testing.
- The current measurements were done with a Keithley picoammeter.
- Capacitance and HV tests are meant as simple quality checks throughout the HM manufacturing process and are thus not particularly meaningful post-production. Only source testing provides true information about HM performance capabilities.

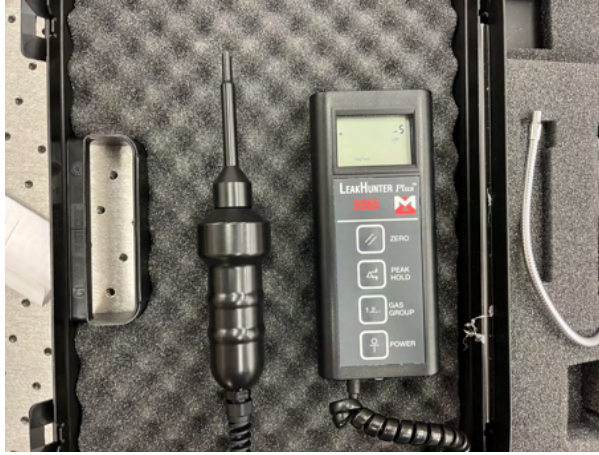
Figure 12: The device used to leak test the HMs.

During commissioning, helium was supplied to the monitors through 20 meters of Poly-Flo tubing. The inlet gas was set to a flow rate of approximately 100 cc/min with a pressure of 5 psi. Outgoing gas was released through another 20 meters of Poly-Flo placed into 2 inches of water. These parameters should not be exceeded and were carefully chosen to ensure safe pressure levels inside the HMs. We conducted two major leak tests on each HM, a feedthrough leak test before plate installation and a perimeter leak test after the final sealing. All three monitors were shown to be completely gas-tight.

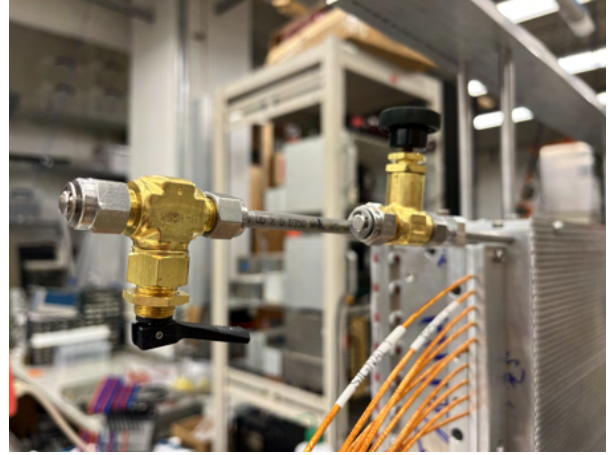
Figure 13: The gas pipes on HM #2 with their attached valves.

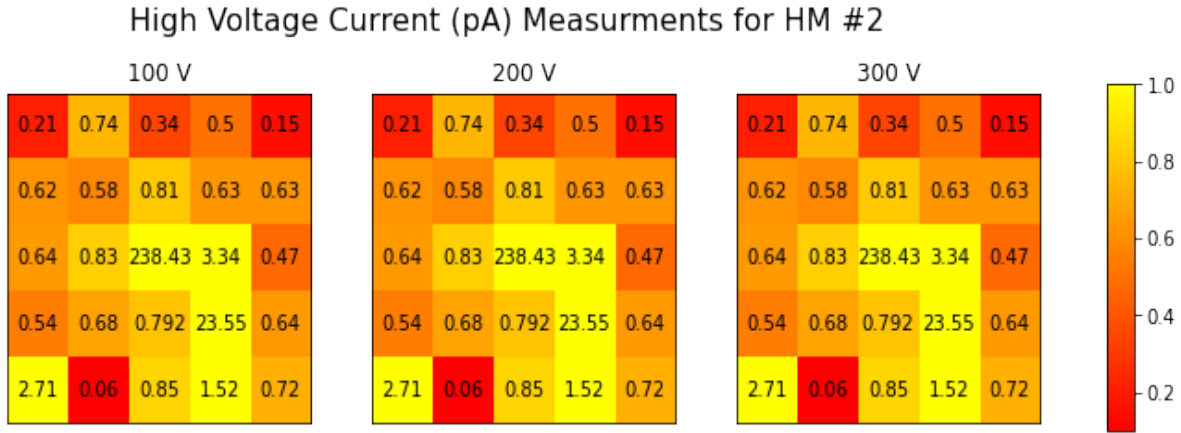
Figure 16: Current per pixel for HV tests in air for the 2nd HM.

Figures 15, 16, and 17 display HV tests in air at 100 V, 200 V and 300 V for HM #1, HM #2 and HM #3, respectively. The currents are volatile and inconsistent as expected in air but demonstrate that none of monitors have an electrical short.
