Ocean & Coastal Management 43 (2000) 51–64

Coastal erosion and village relocation: a Colombian case study

Ivan D. Correa*, Juan Luis Gonzalez

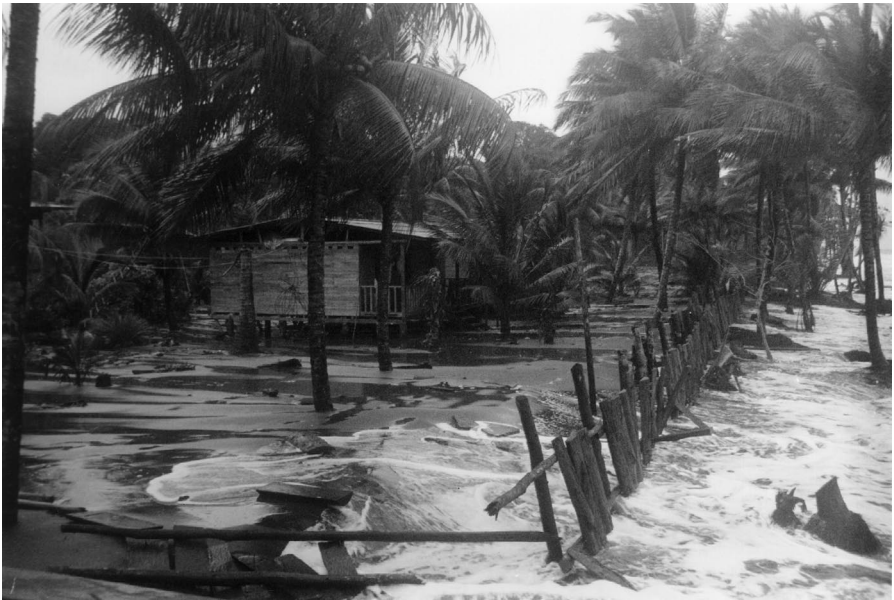
Fig. 2. Photograph of non-storm washover El Choncho. Note the lack of high waves in the Pacific or strong onshore winds.

Although less impressive, the impacts of long-term shoreline retreat are acquiring first-order socioeconomic importance along the Pacific littoral. Given the growing number of coastal villages exposed to marine erosion and the limited areas of high ground on the barrier islands, the need for implementing valid strategies to cope with the shoreline erosion and flooding problems is evident (Fig. 2). For the small and poor

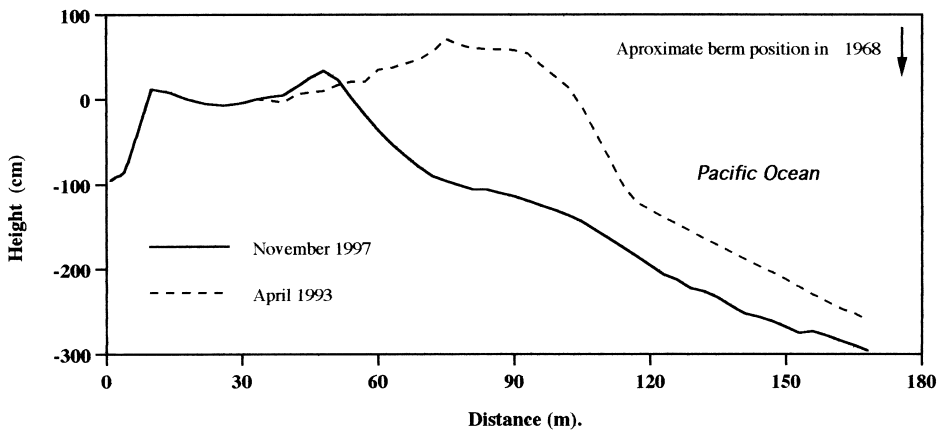
Fig. 7. Topographic beach profiles at the location of El Choncho village. A net retreat of 60 m of island front between April 1993 and November 1997 is clearly seen.

erosional conditions at that time. The development and emergence of the sandy cusped tidal flat on the northern end of the island predates the 1968 photographs; the tidal flat trapped the sand drift and promoted erosional conditions in a downcurrent direction on the island front. The normal annual cycle of beach changes on the island's central part was one of beach retreat during October–November, and partial beach recovery between January and April. Intense erosion affecting the seaside houses of El Choncho village was first measured in 1989, beach retreat of 15 m between October 1988 and September 1989 was well documented [15,16]. Erosion rates in front of El Choncho accelerated after the occurrence of the November 1991 magnitude 6 earthquake with epicenter just 40 km to the NW of the delta [17]. On El Choncho village, the direct effects of the shock included soil liquefaction, land cracking and water–soil expulsion. Although no quantitative estimates are available, land subsidence effects are evidenced by the fact that the frequency of overwash on the island increased two times a year (March and October during the highest tides) before the quake, to at least once a month after the shock. According to inhabitants, the normal beach cycle was disrupted by the event and erosional conditions prevailed throughout the year. Beach erosion between April 1993 and November 1997 is well documented by topographic profiles that show a net beach recession of 60 m with an average rate of 11 m/yr for this period (Fig. 7).

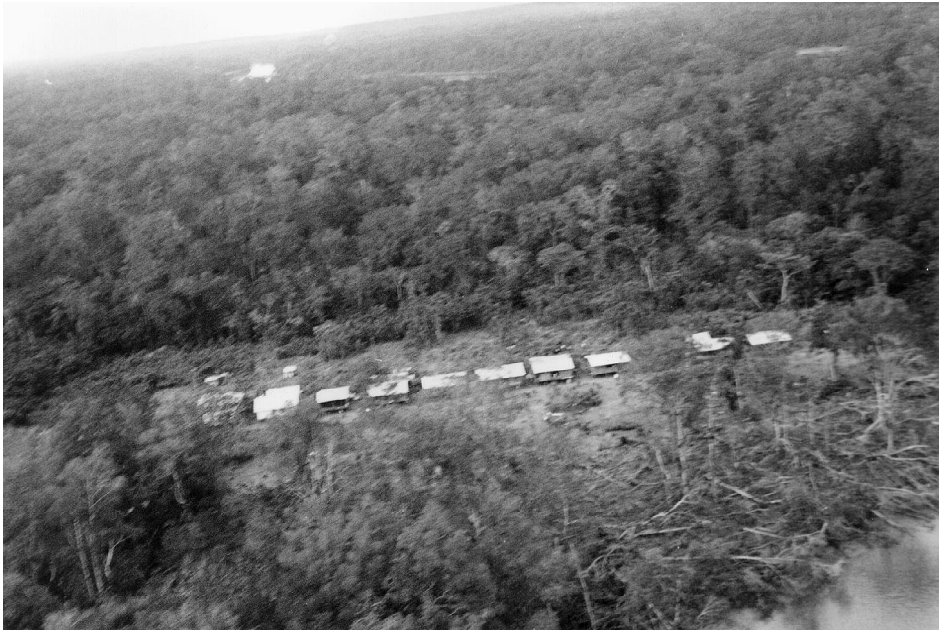
Fig. 8. Air view of the new El Choncho village 6 months after construction had started. Note the typical vegetation and well drain sands from the beach ridge complex contrasting with surrounding tropical rain forest and mangrove swamps. View is to the East.
