Unnamed tributary		wa-0710-r-001	Sedimentation Risk Index 56																																																																		
<u>Common:</u> 4.8mi NW of Mossy Head <u>Drainage:</u> Shoal River <u>GPS:</u> 30.783340, -86.381786 <u>Land owner:</u> William P. Corley-DS, James & Patricia Mixon-US		<u>County:</u> Walton <u>State:</u> Florida <u>PLSS(T-R-S):</u> 3N-21-06 <u>Parcel No.:</u> 11; 14 <u>Road Name:</u> W.T. Hulion Rd

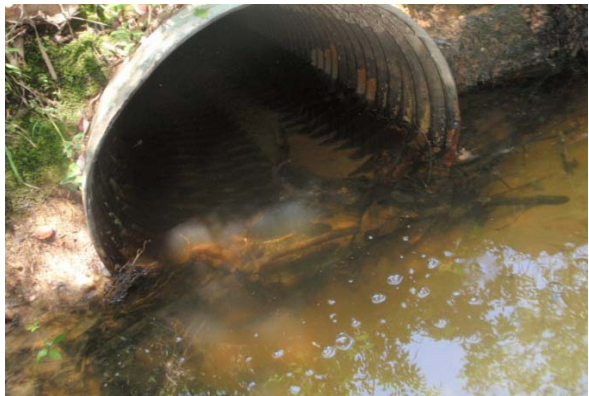
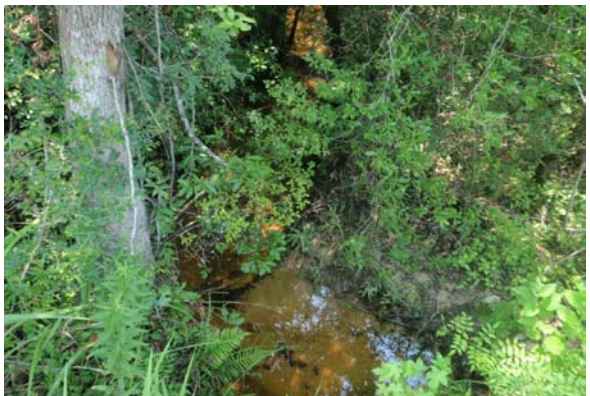
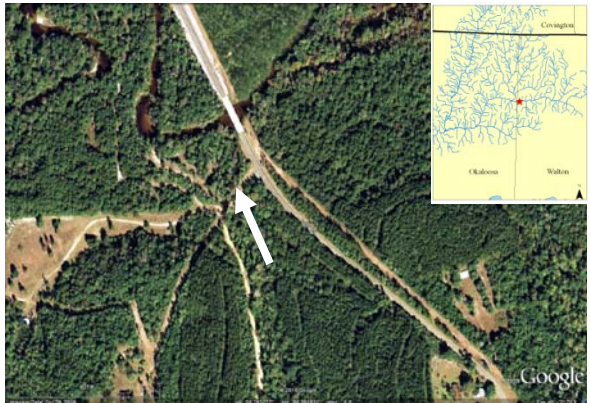
Crossing Structure: US		US																																																																			
<table border="1"> <thead> <tr> <th>Risk Factor</th> <th>Ranking</th> <th>Score</th> </tr> </thead> <tbody> <tr><td>US Channel Morph</td><td>C</td><td>5</td></tr> <tr><td>DS Channel Morph</td><td>C</td><td>5</td></tr> <tr><td>DS Bank Alteration</td><td>MINOR/PARTIAL</td><td>3</td></tr> <tr><td>Upstream Skew Angle</td><td>5-30°</td><td>3</td></tr> <tr><td>Crossing fill condition</td><td>Good/Vegetated</td><td>5</td></tr> <tr><td>Inlet/Outlet Condition</td><td>No Impairment</td><td>5</td></tr> <tr><td>Road Approach Material</td><td>All Aggregate</td><td>5</td></tr> <tr><td>Potential Eroded Volume Mean</td><td><21 y³</td><td>5</td></tr> <tr><td>Approach Slope Mean</td><td><2%</td><td>5</td></tr> <tr><td>Soil K Factor</td><td><0.20</td><td>5</td></tr> <tr><td>Upstream Rt Outlet</td><td>Vegetated</td><td>1</td></tr> <tr><td>Upstream Lt Outlet</td><td>Vegetated</td><td>1</td></tr> <tr><td>Upstream Rt Ditch</td><td>Vegetated</td><td>1</td></tr> <tr><td>Upstream Lt Ditch</td><td>Vegetated</td><td>1</td></tr> <tr><td>Downstream Rt Outlet</td><td>Vegetated</td><td>1</td></tr> <tr><td>Downstream Lt Outlet</td><td>Vegetated</td><td>1</td></tr> <tr><td>Downstream Rt Ditch</td><td>Vegetated</td><td>1</td></tr> <tr><td>Downstream Lt Ditch</td><td>Vegetated</td><td>1</td></tr> <tr><td>Outlet Total</td><td>Improved Outlet System</td><td>5</td></tr> <tr><td>Ditches Total</td><td>Improved Drainage System</td><td>5</td></tr> <tr><td>SRI Total</td><td>Low Risk</td><td>56</td></tr> </tbody> </table>		Risk Factor	Ranking	Score	US Channel Morph	C	5	DS Channel Morph	C	5	DS Bank Alteration	MINOR/PARTIAL	3	Upstream Skew Angle	5-30°	3	Crossing fill condition	Good/Vegetated	5	Inlet/Outlet Condition	No Impairment	5	Road Approach Material	All Aggregate	5	Potential Eroded Volume Mean	<21 y ³	5	Approach Slope Mean	<2%	5	Soil K Factor	<0.20	5	Upstream Rt Outlet	Vegetated	1	Upstream Lt Outlet	Vegetated	1	Upstream Rt Ditch	Vegetated	1	Upstream Lt Ditch	Vegetated	1	Downstream Rt Outlet	Vegetated	1	Downstream Lt Outlet	Vegetated	1	Downstream Rt Ditch	Vegetated	1	Downstream Lt Ditch	Vegetated	1	Outlet Total	Improved Outlet System	5	Ditches Total	Improved Drainage System	5	SRI Total	Low Risk	56

Notes: Rt approach paved.
