Yellow River			ok-0424-006		Severity Score 4	
<u>Common:</u> 3.4mi NW of Crestview <u>Drainage:</u> Blackwater Bay <u>GPS:</u> 30.776486, -86.6249 <u>Land owner:</u> RB: NFWFMD/ LB: John & Betty Carver			<u>County:</u> Okaloosa <u>PLSS(T-R-S):</u> 3N-24W-11 <u>Parcel No.:</u> 2/2.01		<u>State:</u> Florida

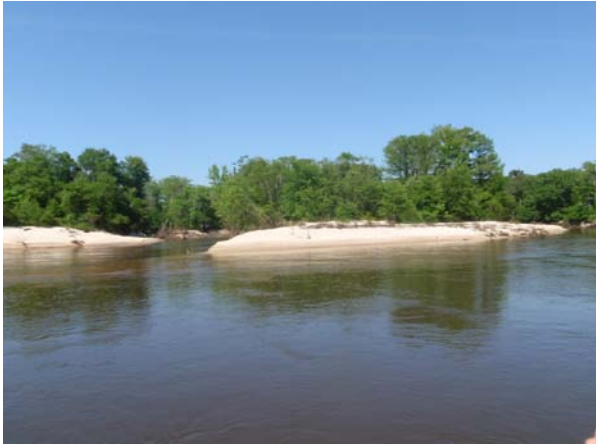
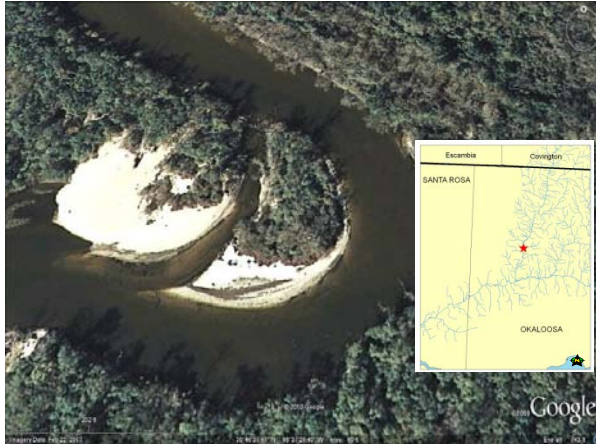
Notes: Vegetated island becoming oxbow. Largest sand bar seen on the entire Yellow River
 Private ATV trail leading down to site.
