Unnamed tributary		co-1103-r-017	Sedimentation Risk Index 44																																																																		
<u>Common:</u> 5.3mi E of Cedar Grove <u>Drainage:</u> Poley Creek GPS: 31.352183333, -86.238752688 <u>Land owner:</u> T. Ivey Powell & Sons INC North, Ruth Cain South		<u>County:</u> Covington <u>State:</u> Alabama <u>PLSS (T-R-S):</u> 5N-18E-34/4N-18E-3 <u>Parcel No.:</u> 3,3 <u>Road Name:</u> Cain Rd

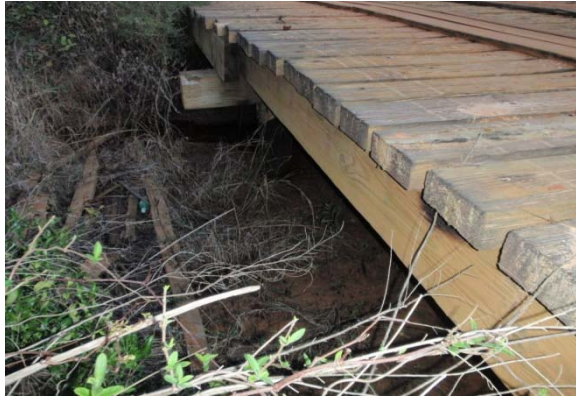
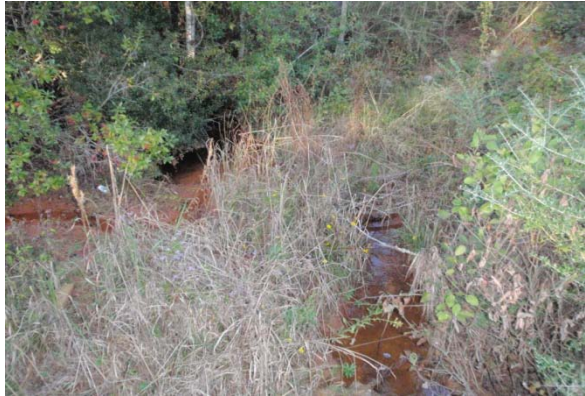
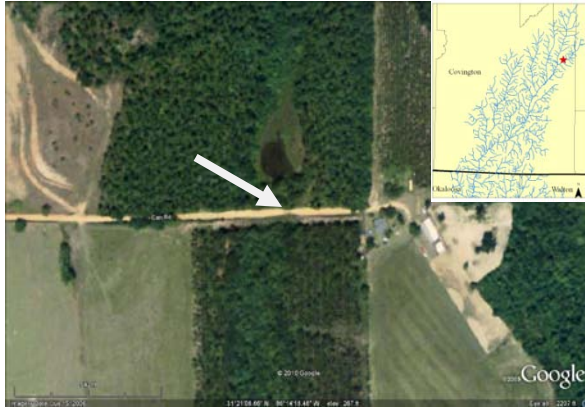
Crossing Structure: US		US																																																																			
<table border="1"> <thead> <tr> <th>Risk Factor</th> <th>Ranking</th> <th>Score</th> </tr> </thead> <tbody> <tr><td>US Channel Morph</td><td>DA</td><td>3</td></tr> <tr><td>DS Channel Morph</td><td>E</td><td>5</td></tr> <tr><td>DS Bank Alteration</td><td>NATURAL</td><td>5</td></tr> <tr><td>Upstream Skew Angle</td><td><5°</td><td>5</td></tr> <tr><td>Crossing fill condition</td><td>Good/Vegetated</td><td>5</td></tr> <tr><td>Inlet/Outlet Condition</td><td>No Impairment</td><td>5</td></tr> <tr><td>Road Approach Material</td><td>All Sand/Clay</td><td>3</td></tr> <tr><td>Potential Eroded Volume Mean</td><td>>40 y³</td><td>1</td></tr> <tr><td>Approach Slope Mean</td><td>>4%</td><td>1</td></tr> <tr><td>Soil K Factor</td><td><0.20</td><td>5</td></tr> <tr><td>Upstream Rt Outlet</td><td>Vegetated</td><td>1</td></tr> <tr><td>Upstream Lt Outlet</td><td>Vegetated</td><td>1</td></tr> <tr><td>Upstream Rt Ditch</td><td>Rip Rap</td><td>1</td></tr> <tr><td>Upstream Lt Ditch</td><td>Rip Rap</td><td>1</td></tr> <tr><td>Downstream Rt Outlet</td><td>Bare soil</td><td>0</td></tr> <tr><td>Downstream Lt Outlet</td><td>Bare soil</td><td>0</td></tr> <tr><td>Downstream Rt Ditch</td><td>Bare soil</td><td>0</td></tr> <tr><td>Downstream Lt Ditch</td><td>Bare soil</td><td>0</td></tr> <tr><td>Outlet Total</td><td>Partially Improved Outlet System</td><td>3</td></tr> <tr><td>Ditches Total</td><td>Partially Improved Drainage System</td><td>3</td></tr> <tr><td>SRI Total</td><td>Medium Risk</td><td>44</td></tr> </tbody> </table>		Risk Factor	Ranking	Score	US Channel Morph	DA	3	DS Channel Morph	E	5	DS Bank Alteration	NATURAL	5	Upstream Skew Angle	<5°	5	Crossing fill condition	Good/Vegetated	5	Inlet/Outlet Condition	No Impairment	5	Road Approach Material	All Sand/Clay	3	Potential Eroded Volume Mean	>40 y ³	1	Approach Slope Mean	>4%	1	Soil K Factor	<0.20	5	Upstream Rt Outlet	Vegetated	1	Upstream Lt Outlet	Vegetated	1	Upstream Rt Ditch	Rip Rap	1	Upstream Lt Ditch	Rip Rap	1	Downstream Rt Outlet	Bare soil	0	Downstream Lt Outlet	Bare soil	0	Downstream Rt Ditch	Bare soil	0	Downstream Lt Ditch	Bare soil	0	Outlet Total	Partially Improved Outlet System	3	Ditches Total	Partially Improved Drainage System	3	SRI Total	Medium Risk	44

Risk Factor	Ranking	Score																																																																			
US Channel Morph	DA	3																																																																			
DS Channel Morph	E	5																																																																			
DS Bank Alteration	NATURAL	5																																																																			
Upstream Skew Angle	<5°	5																																																																			
Crossing fill condition	Good/Vegetated	5																																																																			
Inlet/Outlet Condition	No Impairment	5																																																																			
Road Approach Material	All Sand/Clay	3																																																																			
Potential Eroded Volume Mean	>40 y ³	1																																																																			
Approach Slope Mean	>4%	1

Soil K Factor	<0.20	5																																																																			
Upstream Rt Outlet	Vegetated	1																																																																			
Upstream Lt Outlet	Vegetated	1																																																																			
Upstream Rt Ditch	Rip Rap	1																																																																			
Upstream Lt Ditch	Rip Rap	1																																																																			
Downstream Rt Outlet	Bare soil	0																																																																			
Downstream Lt Outlet	Bare soil	0																																																																			
Downstream Rt Ditch	Bare soil	0																																																																			
Downstream Lt Ditch	Bare soil	0																																																																			
Outlet Total	Partially Improved Outlet System	3

Ditches Total	Partially Improved Drainage System	3																																																																			
SRI Total	Medium Risk	44																																																																			
Additional Site Features <u>Crossing Type and Quantity:</u> Bridge, 1 <u>Crossing Materials:</u> Wood <u>Soil Types:</u> MBA, OrB, OrE, TrD <u>Rt Approach Prism Fill:</u> 0.5in <u>Lt Approach Prism Fill:</u> 0.5in		<table border="1"> <thead> <tr> <th>Feature</th> <th>Within Range</th> <th>Descriptive Field</th> </tr> </thead> <tbody> <tr> <td>303(d)</td> <td>No</td> <td>N/A</td> </tr> <tr> <td>Wetland Species</td> <td>No</td> <td>N/A</td> </tr> <tr> <td>Rare and Imperiled</td> <td>No</td> <td>N/A</td> </tr> <tr> <td>Land Use/ Cover</td> <td>Yes</td> <td>N/A/ EAST GULF COASTAL PLAIN SOUTHERN MESIC SLOPE FOREST, EAST GULF COASTAL PLAIN INTERIOR UPLAND LONGLEAF PINE WOODLAND-OFFSITE HARDWOOD MODIFIER</td> </tr> <tr> <td>Candidate Mussels</td> <td>No</td> <td>N/A</td> </tr> <tr> <td>Sturgeon C.H.</td> <td>No</td> <td>N/A</td> </tr> </tbody> </table>		Feature	Within Range	Descriptive Field	303(d)	No	N/A	Wetland Species	No	N/A	Rare and Imperiled	No	N/A	Land Use/ Cover	Yes	N/A/ EAST GULF COASTAL PLAIN SOUTHERN MESIC SLOPE FOREST, EAST GULF COASTAL PLAIN INTERIOR UPLAND LONGLEAF PINE WOODLAND-OFFSITE HARDWOOD MODIFIER	Candidate Mussels	No	N/A	Sturgeon C.H.	No	N/A
