Yellow River		co-1029-r-001	Sedimentation Risk Index <b>50</b>																																																																		
<u>Common:</u> 10.2mi NE of Andalusia <u>Drainage:</u> Blackwater Bay <u>GPS:</u> 31.380043682, -86.332556256 <u>Land owner:</u> Billy Henderson -US, Doris Henderson -DS		<u>County:</u> Covington <u>State:</u> Alabama <u>PLSS (T-R-S):</u> 5N-17E-27 <u>Parcel No.:</u> 1.01; 1 <u>Road Name:</u> Southwind Rd

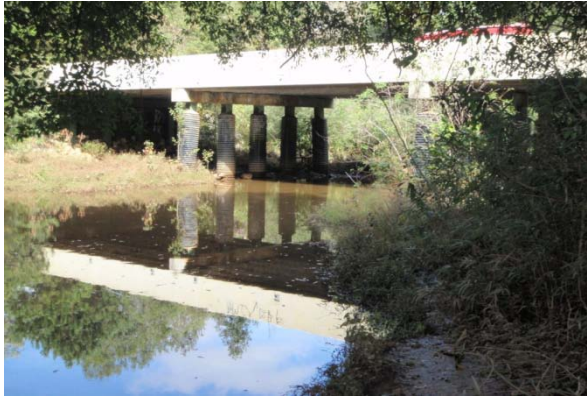
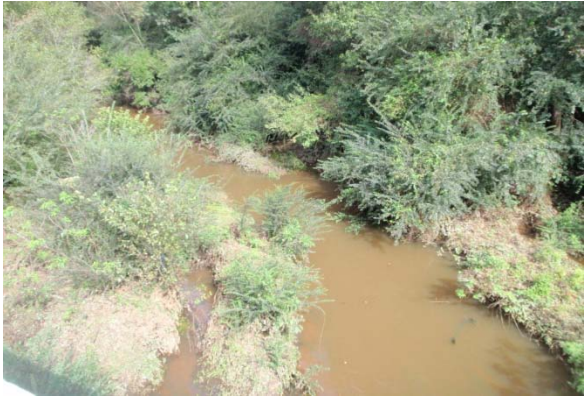
Crossing Structure: DS		US																																																																			
<table border="1"> <thead> <tr> <th>Risk Factor</th> <th>Ranking</th> <th>Score</th> </tr> </thead> <tbody> <tr><td>US Channel Morph</td><td>C</td><td>5</td></tr> <tr><td>DS Channel Morph</td><td>C</td><td>5</td></tr> <tr><td>DS Bank Alteration</td><td>MINOR/PARTIAL</td><td>3</td></tr> <tr><td>Upstream Skew Angle</td><td>&lt;5°</td><td>5</td></tr> <tr><td>Crossing fill condition</td><td>Fair/Rip Rap</td><td>3</td></tr> <tr><td>Inlet/Outlet Condition</td><td>No Impairment</td><td>5</td></tr> <tr><td>Road Approach Material</td><td>All Aggregate</td><td>5</td></tr> <tr><td>Potential Eroded Volume Mean</td><td>21-40 y<sup>3</sup></td><td>3</td></tr> <tr><td>Approach Slope Mean</td><td>2.1-4%</td><td>3</td></tr> <tr><td>Soil K Factor</td><td>&lt;0.20</td><td>5</td></tr> <tr><td>Upstream Rt Outlet</td><td>Vegetated</td><td>1</td></tr> <tr><td>Upstream Lt Outlet</td><td>Vegetated</td><td>1</td></tr> <tr><td>Upstream Rt Ditch</td><td>Vegetated</td><td>1</td></tr> <tr><td>Upstream Lt Ditch</td><td>Vegetated</td><td>1</td></tr> <tr><td>Downstream Rt Outlet</td><td>Vegetated</td><td>1</td></tr> <tr><td>Downstream Lt Outlet</td><td>Bare soil</td><td>0</td></tr> <tr><td>Downstream Rt Ditch</td><td>Vegetated</td><td>1</td></tr> <tr><td>Downstream Lt Ditch</td><td>Vegetated</td><td>1</td></tr> <tr><td>Outlet Total</td><td>Partially Improved Outlet System</td><td>3</td></tr> <tr><td>Ditches Total</td><td>Improved Drainage System</td><td>5</td></tr> <tr><td>SRI Total</td><td>Low Risk</td><td>50</td></tr> </tbody> </table>		Risk Factor	Ranking	Score	US Channel Morph	C	5	DS Channel Morph	C	5	DS Bank Alteration	MINOR/PARTIAL	3	Upstream Skew Angle	<5°	5	Crossing fill condition	Fair/Rip Rap	3	Inlet/Outlet Condition	No Impairment	5	Road Approach Material	All Aggregate	5	Potential Eroded Volume Mean	21-40 y <sup>3</sup>	3	Approach Slope Mean	2.1-4%	3	Soil K Factor	<0.20	5	Upstream Rt Outlet	Vegetated	1	Upstream Lt Outlet	Vegetated	1	Upstream Rt Ditch	Vegetated	1	Upstream Lt Ditch	Vegetated	1	Downstream Rt Outlet	Vegetated	1	Downstream Lt Outlet	Bare soil	0	Downstream Rt Ditch	Vegetated	1	Downstream Lt Ditch	Vegetated	1	Outlet Total	Partially Improved Outlet System	3	Ditches Total	Improved Drainage System	5	SRI Total	Low Risk	50

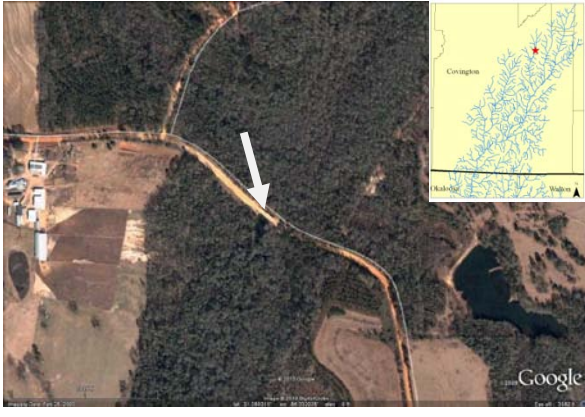
Soil K Factor	<0.20	5																																																																			
Upstream Rt Outlet	Vegetated	1																																																																			
Upstream Lt Outlet	Vegetated	1																																																																			
Upstream Rt Ditch	Vegetated	1																																																																			
Upstream Lt Ditch	Vegetated	1																																																																			
Downstream Rt Outlet	Vegetated	1																																																																			
Downstream Lt Outlet	Bare soil	0																																																																			
Downstream Rt Ditch	Vegetated	1																																																																			
Downstream Lt Ditch	Vegetated	1																																																																			
Outlet Total	Partially Improved Outlet System	3

Notes: Public access path leading to DS LT outlet.
