Clear Creek		co-0812-r-011		Sedimentation Risk Index 32																						
<u>Common:</u>	8.6mi N of Florala		<u>County:</u>	Covington																						
<u>Drainage:</u>	Yellow River	<u>GPS:</u> 31.128814, -86.319747	<u>PLSS (T-R-S):</u>	2N-17E-23																						
<u>Land owner:</u>	Avis McGouirk		<u>Parcel No.:</u>	4																						
			<u>Road Name:</u>	Buster Aplin Rd

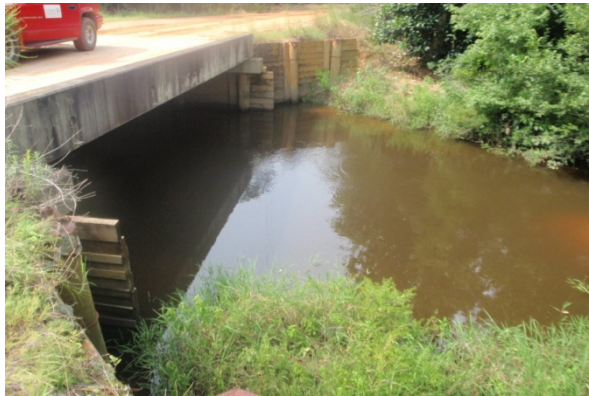
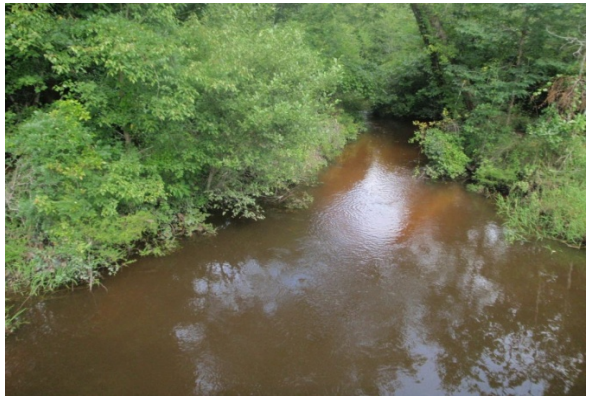
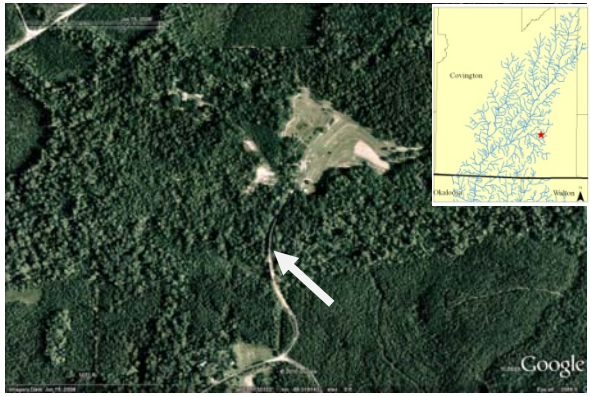
<i>US Channel Morph</i>	DA	3																								
<i>DS Channel Morph</i>	DA	3																								
<i>DS Bank Alteration</i>	MINOR/PARTIAL	3																								
<i>Upstream Skew Angle</i>	>30°	1																								
<i>Crossing fill condition</i>	Poor/Bare soil	1																								
<i>Inlet/Outlet Condition</i>	Sed Islands/Scouring	3																								
<i>Road Approach Material</i>	All Sand/Clay	3																								
<i>Potential Eroded Volume Mean</i>	21-40 y ³	3																								
<i>Approach Slope Mean</i>	2.1-4%	3																								
<i>Soil K Factor</i>	<0.20	5																								
<i>Upstream Rt Outlet</i>	Vegetated	1																								
<i>Upstream Lt Outlet</i>	Vegetated	1																								
<i>Upstream Rt Ditch</i>	Bare soil	0																								
<i>Upstream Lt Ditch</i>	Bare soil	0																								
<i>Downstream Rt Outlet</i>	Vegetated	1																								
<i>Downstream Lt Outlet</i>	Bare soil	0																								
<i>Downstream Rt Ditch</i>	Bare soil	0																								
<i>Downstream Lt Ditch</i>	Bare soil	0																								
<i>Outlet Total</i>	Partially Improved Outlet System	3
