Unnamed tributary		co-0901-r-001	Sedimentation Risk Index <b>42</b>																																																																		
<u>Common:</u> 6.6mi SE of Andalusia <u>Drainage:</u> Five Runs Creek <u>GPS:</u> 31.220477682, -86.437669425 <u>Land owner:</u> Harold Powell - US, Byron & Linda Kilpatrick -DS		<u>County:</u> Covington <u>State:</u> Alabama <u>PLSS (T-R-S):</u> 3N-16E-15 <u>Parcel No.:</u> 3.05; 3.06 <u>Road Name:</u> Eddie Cannon Rd

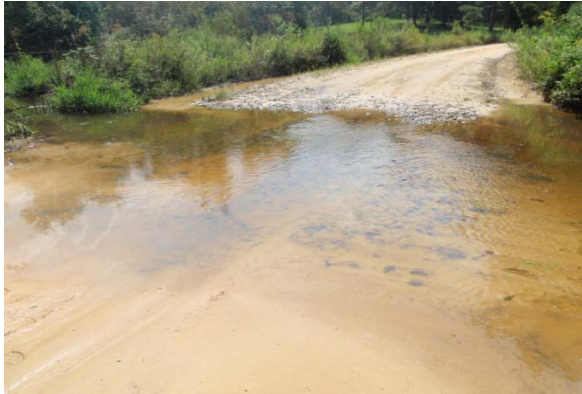
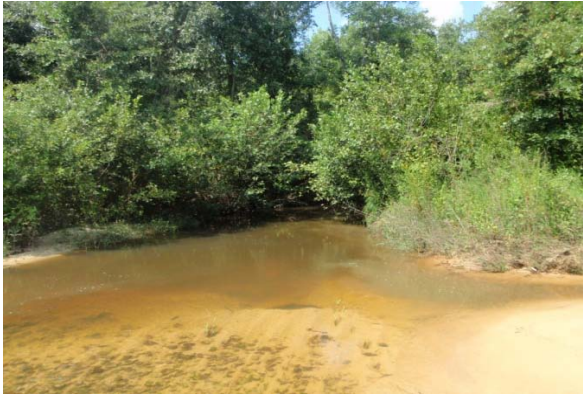
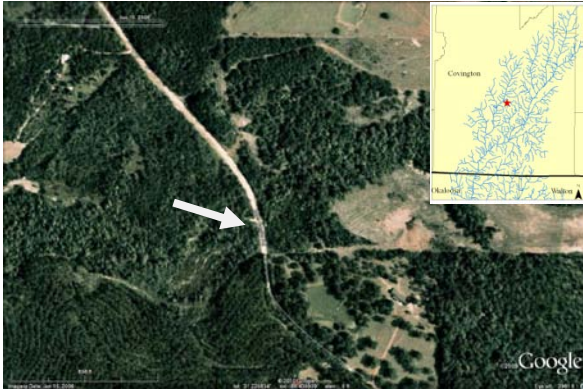
Crossing Structure: Rt Approach		US																																																																			
<table border="1"> <thead> <tr> <th>Risk Factor</th> <th>Ranking</th> <th>Score</th> </tr> </thead> <tbody> <tr><td>US Channel Morph</td><td>C</td><td>5</td></tr> <tr><td>DS Channel Morph</td><td>C</td><td>5</td></tr> <tr><td>DS Bank Alteration</td><td>MINOR/PARTIAL</td><td>3</td></tr> <tr><td>Upstream Skew Angle</td><td>5-30°</td><td>3</td></tr> <tr><td>Crossing fill condition</td><td>Good/Vegetated</td><td>5</td></tr> <tr><td>Inlet/Outlet Condition</td><td>No Impairment</td><td>5</td></tr> <tr><td>Road Approach Material</td><td>All Native Soil</td><td>1</td></tr> <tr><td>Potential Eroded Volume Mean</td><td>&gt;40 y<sup>3</sup></td><td>1</td></tr> <tr><td>Approach Slope Mean</td><td>&lt;2%</td><td>5</td></tr> <tr><td>Soil K Factor</td><td>&lt;0.20</td><td>5</td></tr> <tr><td>Upstream Rt Outlet</td><td>Vegetated</td><td>1</td></tr> <tr><td>Upstream Lt Outlet</td><td>Vegetated</td><td>1</td></tr> <tr><td>Upstream Rt Ditch</td><td>Bare soil</td><td>0</td></tr> <tr><td>Upstream Lt Ditch</td><td>Bare soil</td><td>0</td></tr> <tr><td>Downstream Rt Outlet</td><td>Bare soil</td><td>0</td></tr> <tr><td>Downstream Lt Outlet</td><td>Bare soil</td><td>0</td></tr> <tr><td>Downstream Rt Ditch</td><td>Bare soil</td><td>0</td></tr> <tr><td>Downstream Lt Ditch</td><td>Bare soil</td><td>0</td></tr> <tr><td>Outlet Total</td><td>Partially Improved Outlet System</td><td>3</td></tr> <tr><td>Ditches Total</td><td>Unimproved Drainage System</td><td>1</td></tr> <tr><td><b>SRI Total</b></td><td><b>Medium Risk</b></td><td><b>42</b></td></tr> </tbody> </table>		Risk Factor	Ranking	Score	US Channel Morph	C	5	DS Channel Morph	C	5	DS Bank Alteration	MINOR/PARTIAL	3	Upstream Skew Angle	5-30°	3	Crossing fill condition	Good/Vegetated	5	Inlet/Outlet Condition	No Impairment	5	Road Approach Material	All Native Soil	1	Potential Eroded Volume Mean	>40 y <sup>3</sup>	1	Approach Slope Mean	<2%	5	Soil K Factor	<0.20	5	Upstream Rt Outlet	Vegetated	1	Upstream Lt Outlet	Vegetated	1	Upstream Rt Ditch	Bare soil	0	Upstream Lt Ditch	Bare soil	0	Downstream Rt Outlet	Bare soil	0	Downstream Lt Outlet	Bare soil	0	Downstream Rt Ditch	Bare soil	0	Downstream Lt Ditch	Bare soil	0	Outlet Total	Partially Improved Outlet System	3	Ditches Total	Unimproved Drainage System	1	<b>SRI Total</b>	<b>Medium Risk</b>	<b>42</b>

Notes: Some old gravel present in crossing.
