Shoal River		ok-0421-003		Severity Score 3.5	
<u>Common:</u> 5.7mi SW of Crestview <u>Drainage:</u> Yellow River <u>GPS:</u> 30.690948407, -86.619695355 <u>Land owner:</u> USA – Eglin AFB		<u>County:</u> Okaloosa <u>PLSS(T-R-S):</u> 2N-24W-11 <u>Parcel No.:</u> 1		<u>State:</u> Florida

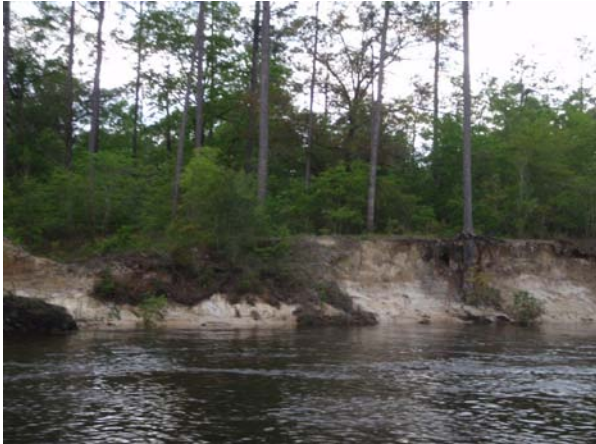
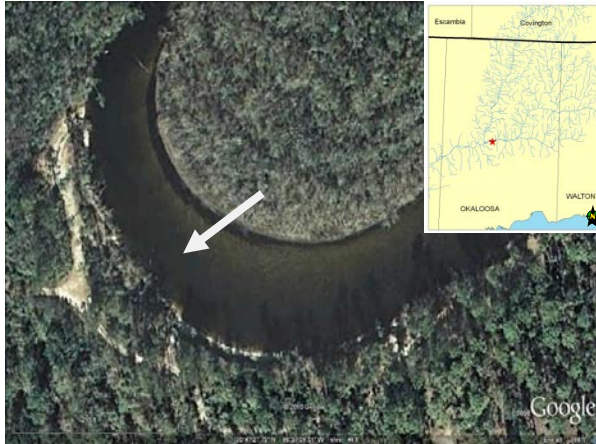
LB					
Risk Factor	Ranking	Score	Feature	Within Range	Descriptive Field
Channel Stability	Fair	1	303(d)	No	N/A
Channel Alteration	None	0	Wetland Species	Yes	1-3 FOCAL SPECIES IN UPLAND AREAS
Bank Erosion	Not eroding	0	Rare and Imperiled	Yes	GOLDSTRIPE DARTER, IRONCOLOR SHINER, SPECKLED CHUB
BEHI	High	1	Land Use/Cover	Yes	N/A/ STREAMS AND WATERWAYS
Local NPSP	No Evidence	0	Candidate Mussels	No	N/A
Shoring Structures	Not Present	0	Sturgeon C.H.	Yes	N/A
Pipe Discharge	Not Present	0			
Water Odors	Not Present	0			
Fish Passage Barrier	Not Present	0			
RB: Riparian Buffer	100+ ft	0			
LB: Riparian Buffer	0-29 ft	0.75

RB: Floodplain Access	Full	0			
LB: Floodplain Access	None	0.75			
River Threat Index:		3.5	Additional Site Features <u>Stream Channel Woody Material:</u> Moderate <u>Impoundments:</u> None <u>Substrate Composition:</u> Medium Sand <u>Bank Material:</u> Sand

Notes: Road adjacent to eroded bank, contributing
