Little Horse Creek		ok-0526-r-005		Sedimentation Risk Index 38																																																																			
<u>Common:</u> 3.6mi NE of Blackman <u>Drainage:</u> Big Horse Creek <u>GPS:</u> 30.966150, -86.603157 <u>Land owner:</u> Charles & Wanda Baston		<u>County:</u> Okaloosa <u>PLSS(T-R-S):</u> 5N-24-01 <u>Parcel No.:</u> 4 <u>Road Name:</u> Johnson Rd		<u>State:</u> Florida

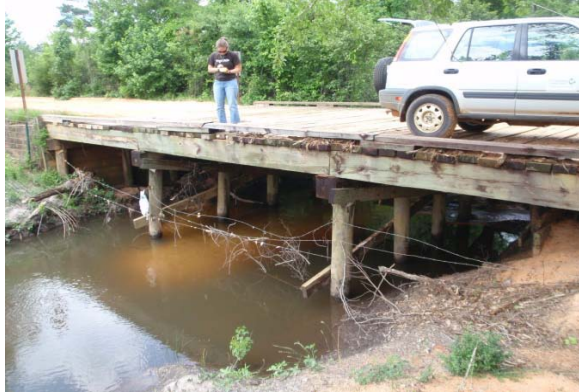
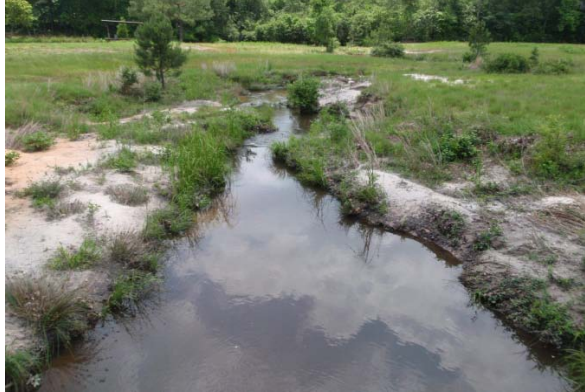
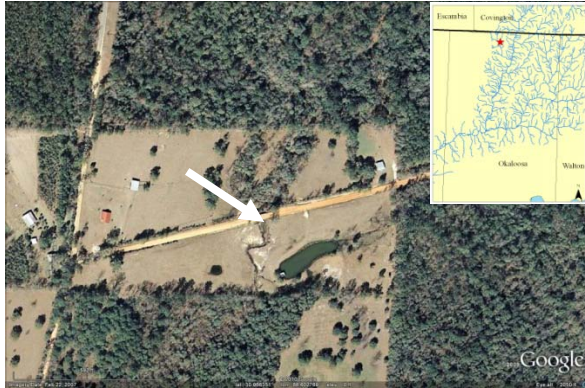
Crossing Structure: DS		DS																																																																					
<table border="1"> <thead> <tr> <th>Risk Factor</th> <th>Ranking</th> <th>Score</th> </tr> </thead> <tbody> <tr><td>US Channel Morph</td><td>DA</td><td>3</td></tr> <tr><td>DS Channel Morph</td><td>C</td><td>5</td></tr> <tr><td>DS Bank Alteration</td><td>HIGH</td><td>1</td></tr> <tr><td>Upstream Skew Angle</td><td>>30°</td><td>1</td></tr> <tr><td>Crossing fill condition</td><td>Poor/Bare soil</td><td>1</td></tr> <tr><td>Inlet/Outlet Condition</td><td>No Impairment</td><td>5</td></tr> <tr><td>Road Approach Material</td><td>All Sand/Clay</td><td>3</td></tr> <tr><td>Potential Eroded Volume Mean</td><td>21-40 y³</td><td>3</td></tr> <tr><td>Approach Slope Mean</td><td><2%</td><td>5</td></tr> <tr><td>Soil K Factor</td><td><0.20</td><td>5</td></tr> <tr><td>Upstream Rt Outlet</td><td>Vegetated</td><td>1</td></tr> <tr><td>Upstream Lt Outlet</td><td>Vegetated</td><td>1</td></tr> <tr><td>Upstream Rt Ditch</td><td>Bare soil</td><td>0</td></tr> <tr><td>Upstream Lt Ditch</td><td>Bare soil</td><td>0</td></tr> <tr><td>Downstream Rt Outlet</td><td>Vegetated</td><td>1</td></tr> <tr><td>Downstream Lt Outlet</td><td>Bare soil</td><td>0</td></tr> <tr><td>Downstream Rt Ditch</td><td>Vegetated</td><td>1</td></tr> <tr><td>Downstream Lt Ditch</td><td>Bare soil</td><td>0</td></tr> <tr><td>Outlet Total</td><td>Partially Improved Outlet System</td><td>3</td></tr> <tr><td>Ditches Total</td><td>Partially Improved Drainage System</td><td>3</td></tr> <tr><td>SRI Total</td><td>Medium Risk</td><td>38</td></tr> </tbody> </table>		Risk Factor	Ranking	Score	US Channel Morph	DA	3	DS Channel Morph	C	5	DS Bank Alteration	HIGH	1	Upstream Skew Angle	>30°	1	Crossing fill condition	Poor/Bare soil	1	Inlet/Outlet Condition	No Impairment	5	Road Approach Material	All Sand/Clay	3	Potential Eroded Volume Mean	21-40 y ³	3	Approach Slope Mean	<2%	5	Soil K Factor	<0.20	5	Upstream Rt Outlet	Vegetated	1	Upstream Lt Outlet	Vegetated	1	Upstream Rt Ditch	Bare soil	0	Upstream Lt Ditch	Bare soil	0	Downstream Rt Outlet	Vegetated	1	Downstream Lt Outlet	Bare soil	0	Downstream Rt Ditch	Vegetated	1	Downstream Lt Ditch	Bare soil	0	Outlet Total	Partially Improved Outlet System	3	Ditches Total	Partially Improved Drainage System	3	SRI Total	Medium Risk	38

Notes: Wire spanning under bridge. DS.
