| Horsehead Creek | | ok-0528-r-004 | Sedimentation Risk Index<br><b>44</b> |
| <u>Common:</u> | 2.9mi SE of Laurel Hill | | <u>County:</u> Okaloosa |
| <u>Drainage:</u> | Pond Creek | <u>GPS:</u> 30.927819, -86.436811 | <u>State:</u> Florida |

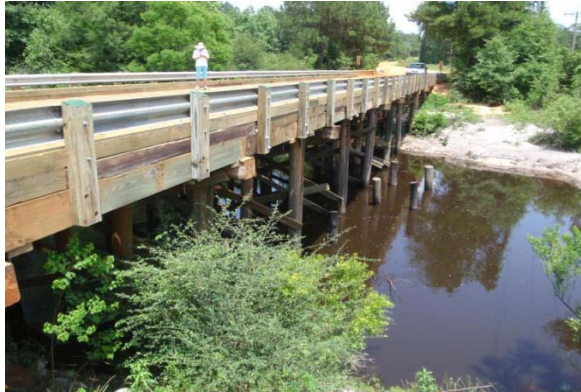
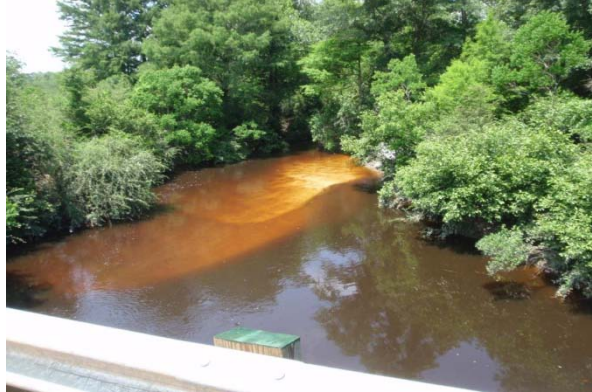
| Horsehead Creek | | ok-0528-r-004 | Sedimentation Risk Index<br><b>44</b> |
|---|---|--|---|
| Crossing Structure: DS | | US | |

Notes: Appears to be sediment loading from US? Source unknown
