Yellow River			ok-0225-003		Severity Score 3.5
<u>Common:</u> 12.2mi SW of Crestview, .2mi DS Tarwick Creek <u>Drainage:</u> Yellow River <u>GPS:</u> 30.671957, -86.748319 <u>Land owner:</u> RB: Joe Livingston/ LB: USA- Eglin AFB			<u>County:</u> Okaloosa <u>State:</u> Florida <u>PLSS(T-R-S):</u> 16-2N-25 <u>Parcel No.:</u> 6.003F/ LB: 2

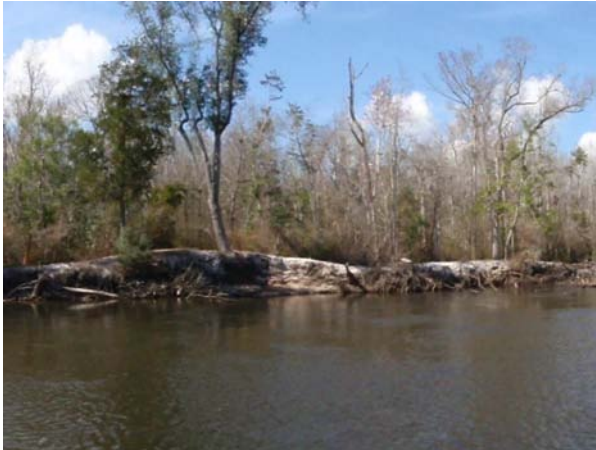
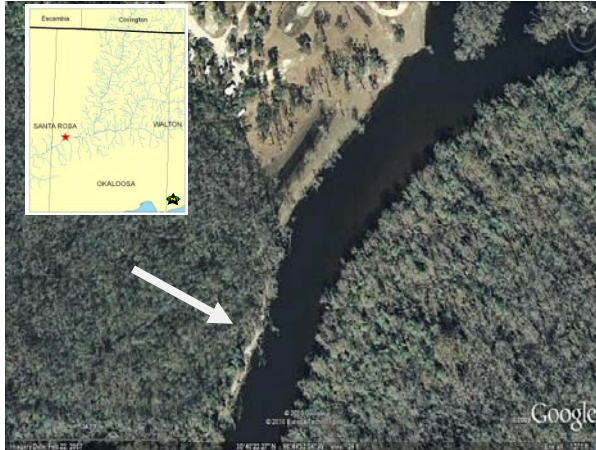
RB					
Risk Factor	Ranking	Score	Feature	Within Range	Descriptive Field
Channel Stability	Fair	1	303(d)	No	N/A
Channel Alteration	None	0	Wetland Species	Yes	1-3 FOCAL SPECIES IN UPLAND AREAS
Bank Erosion	Active	1	Rare and Imperiled	Yes	ALABAMA SHAD, ALLIGATOR GAR, BLUENOSE SHINER, GULF STURGEON, SPECKLED CHUB, IRONCOLOR SHINER, SPOTTED BULLHEAD, SPECKLED DARTER
BEHI	High	1	Land Use/ Cover	Yes	N/A/ STREAMS AND WATERWAYS
Local NPSP	Slight	0.5	Candidate Mussels	No	N/A
Shoring Structures	Not Present	0	Sturgeon C.H.	Yes	N/A
Pipe Discharge	Not Present	0	Additional Site Features <u>Stream Channel Woody Material:</u> Moderate <u>Impoundments:</u> None <u>Substrate Composition:</u> Medium Sand <u>Bank Material:</u> Sand

Water Odors	Not Present	0			
Fish Passage Barrier	Not Present	0			
RB: Riparian Buffer	100+ ft	0			
LB: Riparian Buffer	100+ ft	0			
RB: Floodplain Access	Full	0			
LB: Floodplain Access	Full	0			
River Threat Index:		3.5

Notes: This site is the south end of a foot path coming from the River's Edge Campground, pictured in the northeast corner of the aerial photo.
