Shoal River			ok-0423-003		Severity Score 7
<u>Common:</u> 3.5mi E of Crestview, Piney Woods Creek confluence <u>Drainage:</u> Shoal River <u>GPS:</u> 30.747224508, -86.515099394 <u>Land owner:</u> RB: Purl G Adams Jr. / LB: George & Essie Mack			<u>County:</u> Okaloosa <u>PLSS(T-R-S):</u> 3N-23W-23 <u>Parcel No.:</u> 1/ 1.0140		<u>State:</u> Florida

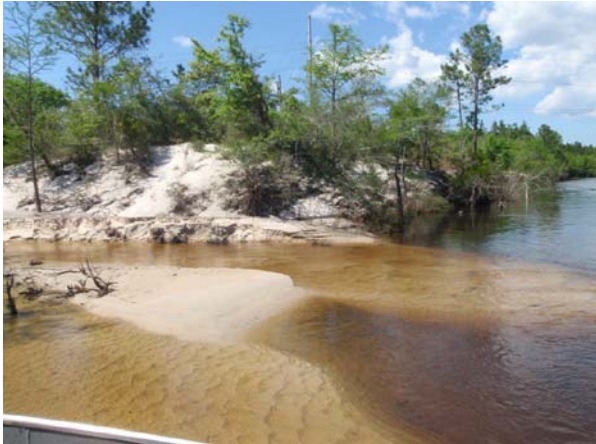
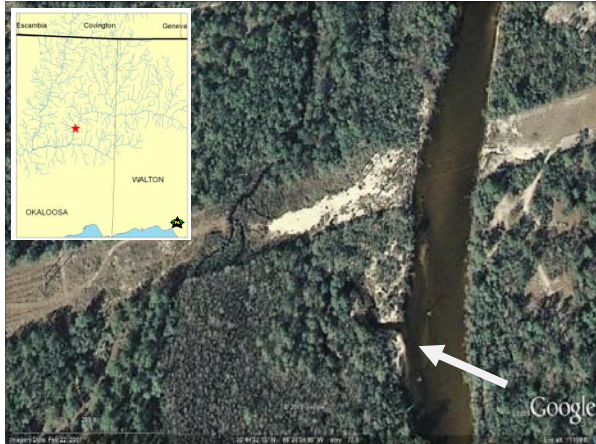
Notes: Residence on left bank across from site. Site adjacent to power line crossing and below Hwy 90. Dead mussels found at this site. Live corbicula also found.
