Unnamed tributary		co-0810-r-010		Sedimentation Risk Index <b>48</b>																																																																			
<u>Common:</u> 13.1mi NW of Florala <u>Drainage:</u> Five Runs Creek <u>GPS:</u> 31.141211, -86.479211 <u>Land owner:</u> USA- Conecuh National Forest		<u>County:</u> Covington <u>PLSS (T-R-S):</u> 2N-16E-17 <u>Parcel No.:</u> 5 <u>Road Name:</u> Shiloh Cemetery Rd		<u>State:</u> Alabama

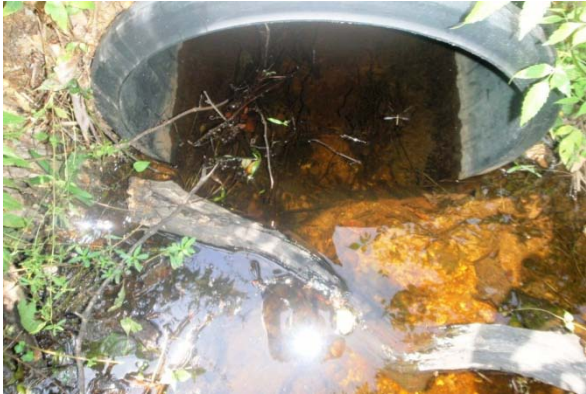
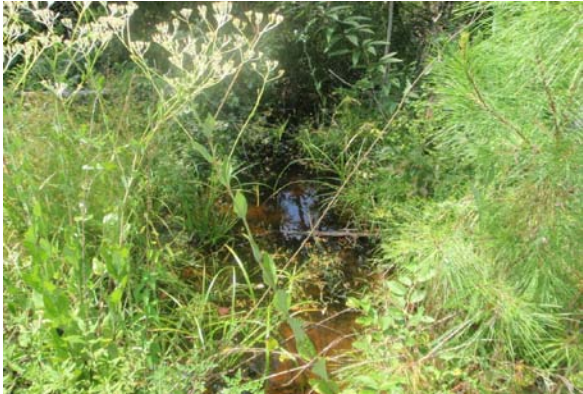
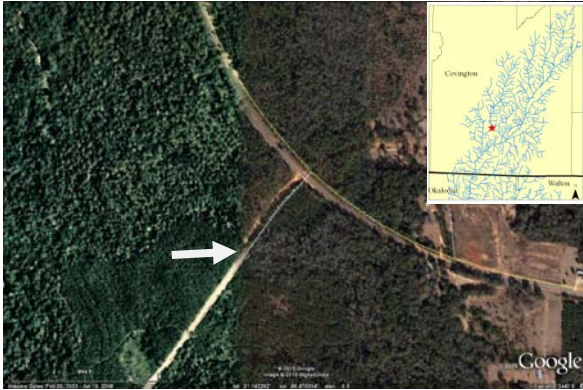
Crossing Structure: DS		DS																																																																					
<table border="1"> <thead> <tr> <th>Risk Factor</th> <th>Ranking</th> <th>Score</th> </tr> </thead> <tbody> <tr><td>US Channel Morph</td><td>C</td><td>5</td></tr> <tr><td>DS Channel Morph</td><td>C</td><td>5</td></tr> <tr><td>DS Bank Alteration</td><td>MINOR/PARTIAL</td><td>3</td></tr> <tr><td>Upstream Skew Angle</td><td>5-30°</td><td>3</td></tr> <tr><td>Crossing fill condition</td><td>Good/Vegetated</td><td>5</td></tr> <tr><td>Inlet/Outlet Condition</td><td>No Impairment</td><td>5</td></tr> <tr><td>Road Approach Material</td><td>All Sand/Clay</td><td>3</td></tr> <tr><td>Potential Eroded Volume Mean</td><td>21-40 y<sup>3</sup></td><td>3</td></tr> <tr><td>Approach Slope Mean</td><td>&lt;2%</td><td>5</td></tr> <tr><td>Soil K Factor</td><td>&lt;0.20</td><td>5</td></tr> <tr><td>Upstream Rt Outlet</td><td>Vegetated</td><td>1</td></tr> <tr><td>Upstream Lt Outlet</td><td>Vegetated</td><td>1</td></tr> <tr><td>Upstream Rt Ditch</td><td>Bare soil</td><td>0</td></tr> <tr><td>Upstream Lt Ditch</td><td>Bare soil</td><td>0</td></tr> <tr><td>Downstream Rt Outlet</td><td>Vegetated</td><td>1</td></tr> <tr><td>Downstream Lt Outlet</td><td>Vegetated</td><td>1</td></tr> <tr><td>Downstream Rt Ditch</td><td>Bare soil</td><td>0</td></tr> <tr><td>Downstream Lt Ditch</td><td>Bare soil</td><td>0</td></tr> <tr><td>Outlet Total</td><td>Improved Outlet System</td><td>5</td></tr> <tr><td>Ditches Total</td><td>Unimproved Drainage System</td><td>1</td></tr> <tr><td><b>SRI Total</b></td><td><b>Low Risk</b></td><td><b>48</b></td></tr> </tbody> </table>		Risk Factor	Ranking	Score	US Channel Morph	C	5	DS Channel Morph	C	5	DS Bank Alteration	MINOR/PARTIAL	3	Upstream Skew Angle	5-30°	3	Crossing fill condition	Good/Vegetated	5	Inlet/Outlet Condition	No Impairment	5	Road Approach Material	All Sand/Clay	3	Potential Eroded Volume Mean	21-40 y <sup>3</sup>	3	Approach Slope Mean	<2%	5	Soil K Factor	<0.20	5	Upstream Rt Outlet	Vegetated	1	Upstream Lt Outlet	Vegetated	1	Upstream Rt Ditch	Bare soil	0	Upstream Lt Ditch	Bare soil	0	Downstream Rt Outlet	Vegetated	1	Downstream Lt Outlet	Vegetated	1	Downstream Rt Ditch	Bare soil	0	Downstream Lt Ditch	Bare soil	0	Outlet Total	Improved Outlet System	5	Ditches Total	Unimproved Drainage System	1	<b>SRI Total</b>	<b>Low Risk</b>	<b>48</b>
