Shoal River		ok-0615-014		Severity Score 4.25	
<u>Common:</u> 8mi NE of Crestview <u>Drainage:</u> Yellow River <u>GPS:</u> 30.786030551, -86.492481863 <u>Land owner:</u> LB: Haiseal Timber Co/ RB: Seagull Inc		<u>County:</u> Okaloosa <u>PLSS(T-R-S):</u> 3N-23W-1 <u>Parcel No.:</u> 1/1.001		<u>State:</u> Florida

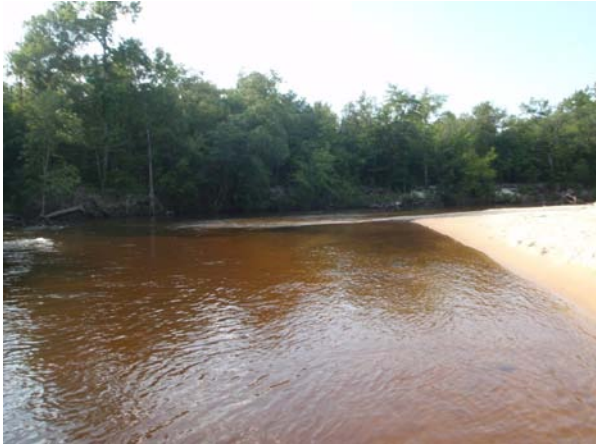
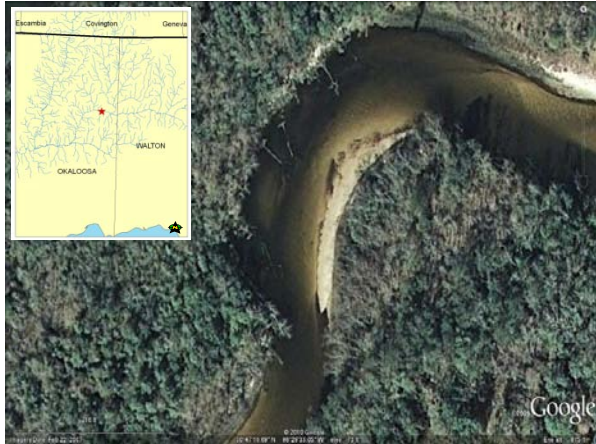
RB: Riparian Buffer	0-29 ft	0.75			
LB: Riparian Buffer	0-29 ft	0.75			
RB: Floodplain Access	Partial	0.25			
LB: Floodplain Access	Full	0			
<b>River Threat Index:</b>		<b>4.25</b>	<b>Additional Site Features</b> <u>Stream Channel Woody Material:</u> Moderate <u>Impoundments:</u> None <u>Substrate Composition:</u> Medium Sand <u>Bank Material:</u> Medium Sand

Notes: Public access, ATV trail to water, picnic table, and trash present.

LB historically clear cut. Spotty riparian coverage.
