Yellow River			ok-0225-002		Severity Score <b>6.75</b>	
<u>Common:</u> 12mi SW of Crestview, .05mi DS of Tarwick Creek <u>Drainage:</u> Yellow River <u>GPS:</u> 30.674048, -86.746883 <u>Land owner:</u> Rivers Edge Campground			<u>County:</u> Okaloosa <u>PLSS(T-R-S):</u> 2N-25W-16 <u>Parcel No.:</u> 6.003E		<u>State:</u> Florida

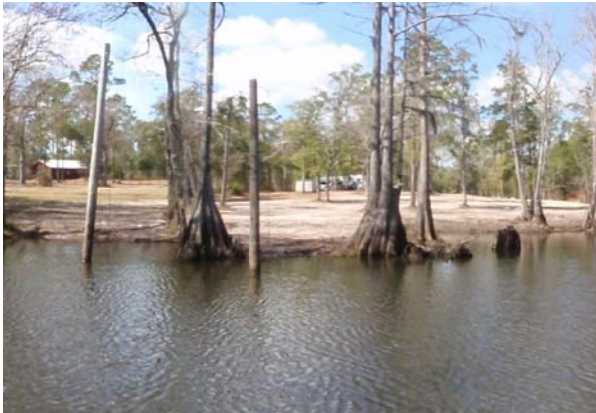
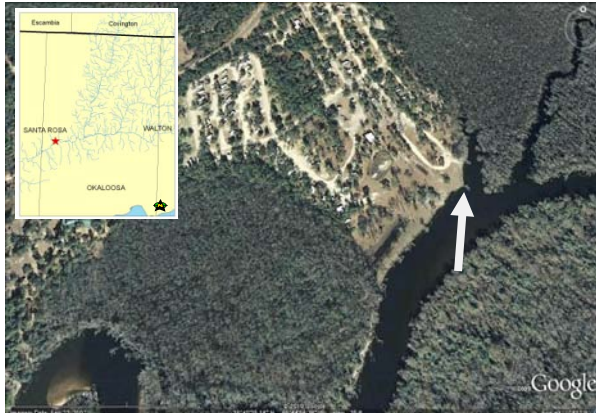
Notes: River's edge camp ground. Concrete boat launch and wooden sea-wall retaining RB. Old Log Lake Bridge site (historic, Google earth). Pipe discharge to DS.
