Caney Creek		wa-0714-r-011	Sedimentation Risk Index <b>46</b>																																																																		
<u>Common:</u> 10.3mi SE of Florala <u>Drainage:</u> Big Swamp Creek <u>GPS:</u> 30.899538, -86.210733 <u>Land owner:</u> Angus Andrews Jr		<u>County:</u> Walton <u>State:</u> Florida <u>PLSS(T-R-S):</u> 5N-20-26 <u>Parcel No.:</u> 3 <u>Road Name:</u> Royce Gill Rd

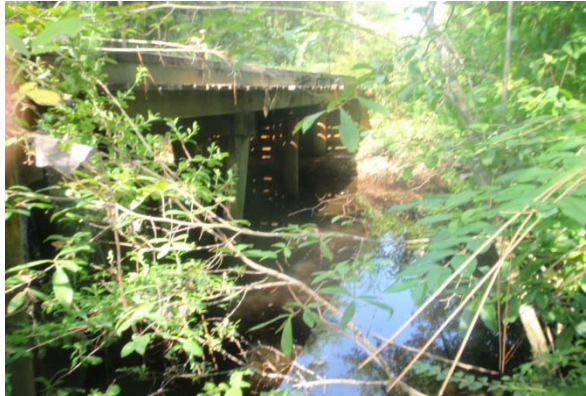
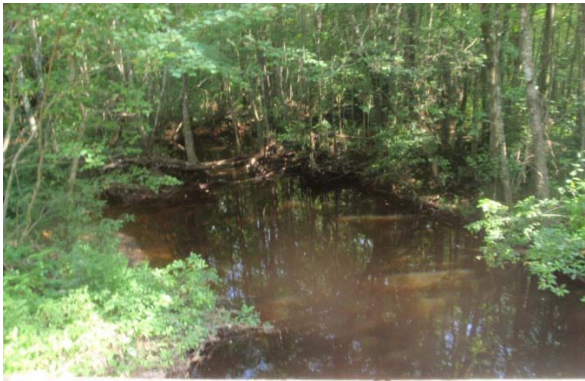
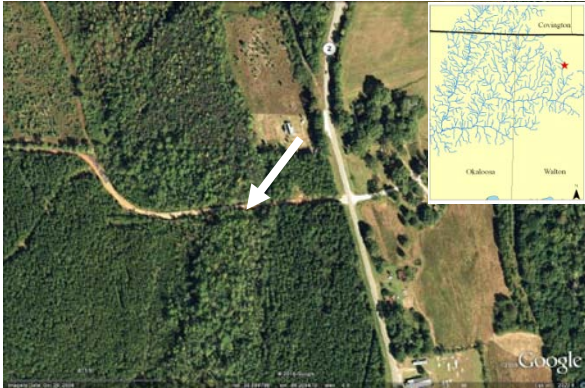
Crossing Structure: DS		DS																																																																			
<table border="1"> <thead> <tr> <th>Risk Factor</th> <th>Ranking</th> <th>Score</th> </tr> </thead> <tbody> <tr><td>US Channel Morph</td><td>E</td><td>5</td></tr> <tr><td>DS Channel Morph</td><td>DA</td><td>3</td></tr> <tr><td>DS Bank Alteration</td><td>MINOR/PARTIAL</td><td>3</td></tr> <tr><td>Upstream Skew Angle</td><td>&lt;5°</td><td>5</td></tr> <tr><td>Crossing fill condition</td><td>Good/Vegetated</td><td>5</td></tr> <tr><td>Inlet/Outlet Condition</td><td>No Impairment</td><td>5</td></tr> <tr><td>Road Approach Material</td><td>All Sand/Clay</td><td>3</td></tr> <tr><td>Potential Eroded Volume Mean</td><td>21-40 y<sup>3</sup></td><td>3</td></tr> <tr><td>Approach Slope Mean</td><td>2.1-4%</td><td>3</td></tr> <tr><td>Soil K Factor</td><td>0.21-0.40</td><td>3</td></tr> <tr><td>Upstream Rt Outlet</td><td>Vegetated</td><td>1</td></tr> <tr><td>Upstream Lt Outlet</td><td>Vegetated</td><td>1</td></tr> <tr><td>Upstream Rt Ditch</td><td>Vegetated</td><td>1</td></tr> <tr><td>Upstream Lt Ditch</td><td>Bare soil</td><td>0</td></tr> <tr><td>Downstream Rt Outlet</td><td>Vegetated</td><td>1</td></tr> <tr><td>Downstream Lt Outlet</td><td>Vegetated</td><td>1</td></tr> <tr><td>Downstream Rt Ditch</td><td>Bare soil</td><td>0</td></tr> <tr><td>Downstream Lt Ditch</td><td>Bare soil</td><td>0</td></tr> <tr><td>Outlet Total</td><td>Improved Outlet System</td><td>5</td></tr> <tr><td>Ditches Total</td><td>Partially Improved Drainage System</td><td>3</td></tr> <tr><td><b>SRI Total</b></td><td><b>Low Risk</b></td><td><b>46</b></td></tr> </tbody> </table>		Risk Factor	Ranking	Score	US Channel Morph	E	5	DS Channel Morph	DA	3	DS Bank Alteration	MINOR/PARTIAL	3	Upstream Skew Angle	<5°	5	Crossing fill condition	Good/Vegetated	5	Inlet/Outlet Condition	No Impairment	5	Road Approach Material	All Sand/Clay	3	Potential Eroded Volume Mean	21-40 y <sup>3</sup>	3	Approach Slope Mean	2.1-4%	3	Soil K Factor	0.21-0.40	3	Upstream Rt Outlet	Vegetated	1	Upstream Lt Outlet	Vegetated	1	Upstream Rt Ditch	Vegetated	1	Upstream Lt Ditch	Bare soil	0	Downstream Rt Outlet	Vegetated	1	Downstream Lt Outlet	Vegetated	1	Downstream Rt Ditch	Bare soil	0	Downstream Lt Ditch	Bare soil	0	Outlet Total	Improved Outlet System	5	Ditches Total	Partially Improved Drainage System	3	<b>SRI Total</b>	<b>Low Risk</b>	<b>46</b>

Notes: Approaches in bad condition; not drivable.
