Unnamed tributary		co-1027-r-008	Sedimentation Risk Index 40																																																																		
<u>Common:</u> 5.9mi NW of Opp <u>Drainage:</u> Poley Creek <u>GPS:</u> 31.356190939, -86.305929163 <u>Land owner:</u> Billy & Mary Ashberry		<u>County:</u> Covington <u>State:</u> Alabama <u>PLSS (T-R-S):</u> 5N-17E-36 <u>Parcel No.:</u> 5 <u>Road Name:</u> Gardeners Chapel Rd

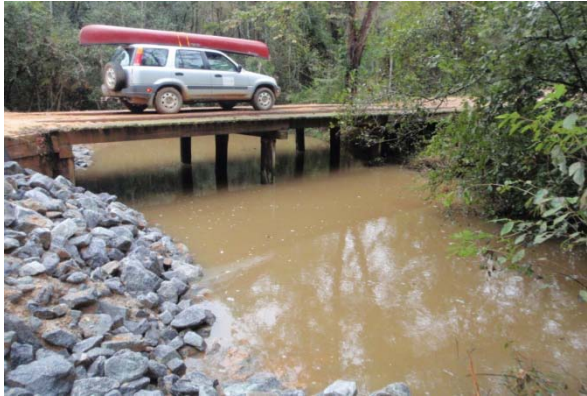
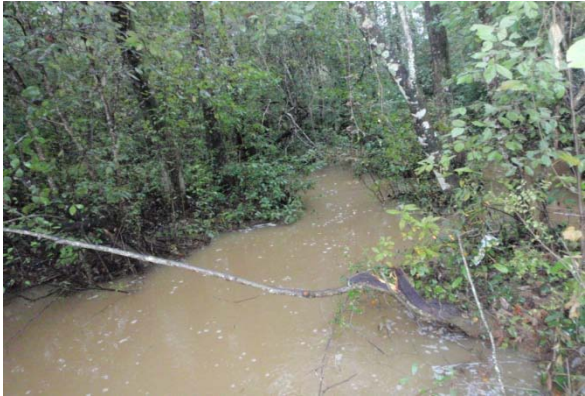
Crossing Structure: US		US																																																																			
<table border="1"> <thead> <tr> <th>Risk Factor</th> <th>Ranking</th> <th>Score</th> </tr> </thead> <tbody> <tr><td>US Channel Morph</td><td>DA</td><td>3</td></tr> <tr><td>DS Channel Morph</td><td>E</td><td>5</td></tr> <tr><td>DS Bank Alteration</td><td>HIGH</td><td>1</td></tr> <tr><td>Upstream Skew Angle</td><td><5°</td><td>5</td></tr> <tr><td>Crossing fill condition</td><td>Fair/Rip Rap</td><td>3</td></tr> <tr><td>Inlet/Outlet Condition</td><td>No Impairment</td><td>5</td></tr> <tr><td>Road Approach Material</td><td>All Sand/Clay</td><td>3</td></tr> <tr><td>Potential Eroded Volume Mean</td><td>>40 y³</td><td>1</td></tr> <tr><td>Approach Slope Mean</td><td>>4%</td><td>1</td></tr> <tr><td>Soil K Factor</td><td><0.20</td><td>5</td></tr> <tr><td>Upstream Rt Outlet</td><td>Vegetated</td><td>1</td></tr> <tr><td>Upstream Lt Outlet</td><td>Rip Rap</td><td>1</td></tr> <tr><td>Upstream Rt Ditch</td><td>Bare soil</td><td>0</td></tr> <tr><td>Upstream Lt Ditch</td><td>Rip Rap</td><td>1</td></tr> <tr><td>Downstream Rt Outlet</td><td>Vegetated</td><td>1</td></tr> <tr><td>Downstream Lt Outlet</td><td>Rip Rap</td><td>1</td></tr> <tr><td>Downstream Rt Ditch</td><td>Vegetated</td><td>1</td></tr> <tr><td>Downstream Lt Ditch</td><td>Bare soil</td><td>0</td></tr> <tr><td>Outlet Total</td><td>Improved Outlet System</td><td>5</td></tr> <tr><td>Ditches Total</td><td>Partially Improved Drainage System</td><td>3</td></tr> <tr><td>SRI Total</td><td>Medium Risk</td><td>40</td></tr> </tbody> </table>				Risk Factor	Ranking	Score	US Channel Morph	DA	3	DS Channel Morph	E	5	DS Bank Alteration	HIGH	1	Upstream Skew Angle	<5°	5	Crossing fill condition	Fair/Rip Rap	3	Inlet/Outlet Condition	No Impairment	5	Road Approach Material	All Sand/Clay	3	Potential Eroded Volume Mean	>40 y ³	1	Approach Slope Mean	>4%	1	Soil K Factor	<0.20	5	Upstream Rt Outlet	Vegetated	1	Upstream Lt Outlet	Rip Rap	1	Upstream Rt Ditch	Bare soil	0	Upstream Lt Ditch	Rip Rap	1	Downstream Rt Outlet	Vegetated	1	Downstream Lt Outlet	Rip Rap	1	Downstream Rt Ditch	Vegetated	1	Downstream Lt Ditch	Bare soil	0	Outlet Total	Improved Outlet System	5	Ditches Total	Partially Improved Drainage System	3	SRI Total	Medium Risk	40

Notes: Large, new rip rap placed in ditches.
