Yellow River			ok-0319-006		Severity Score 4.75
<u>Common:</u> 10.3mi SW of Crestview <u>Drainage:</u> Blackwater Bay <u>GPS:</u> 30.670433, -86.709917 <u>Land owner:</u> RB: NFWFMD/ LB: USA			<u>County:</u> Okaloosa <u>PLSS(T-R-S):</u> 2N-25W-14 <u>Parcel No.:</u> 1/2		<u>State:</u> Florida

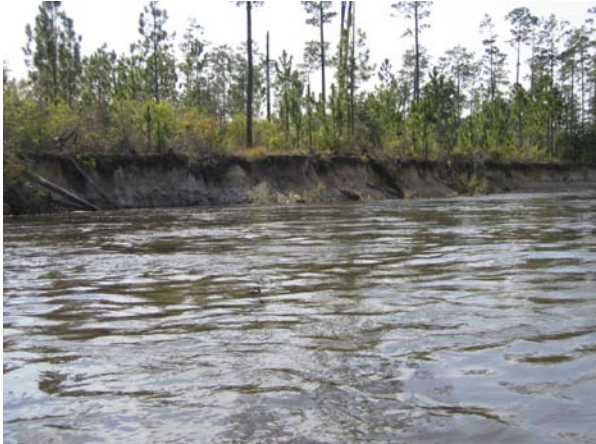
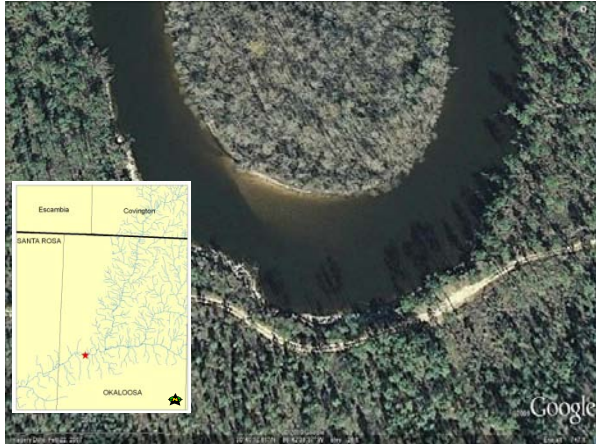
Notes: Roots and new trees showing recent repair of riparian buffer, but bare banks. Logging road 33ft from rivers edge on the left bank. Former clear cut evident in historical aerial (1994).
