Unnamed tributary		co-0811-r-005	Sedimentation Risk Index <b>42</b>																																																																		
<u>Common:</u> 6.7mi S of Andalusia <u>Drainage:</u> Five Runs Creek <u>GPS:</u> 31.210694, -86.485814 <u>Land owner:</u> W&C Maddox -US, S&J Anderson -DS		<u>County:</u> Covington <u>State:</u> Alabama <u>PLSS (T-R-S):</u> 3N-16E-19 <u>Parcel No.:</u> 8.01; 5 <u>Road Name:</u> Bass Bridge Rd

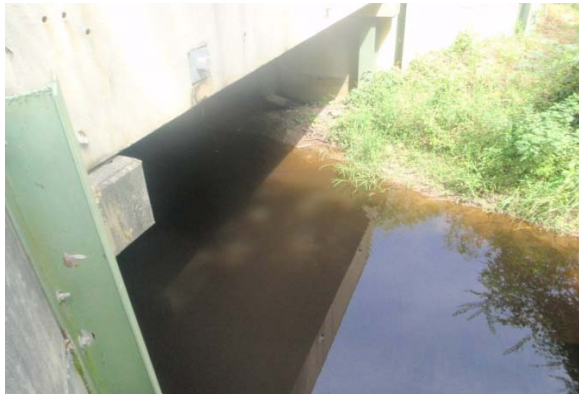
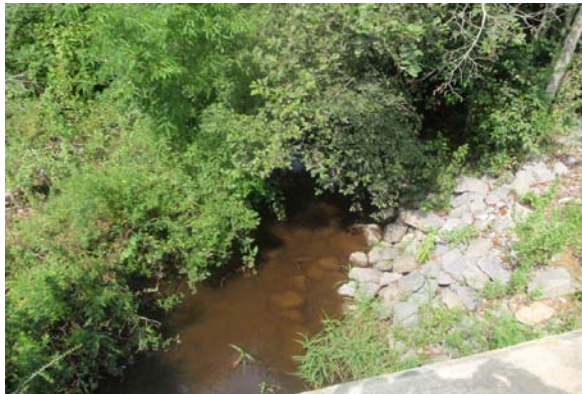
Crossing Structure: DS		US																																																																			
<table border="1"> <thead> <tr> <th>Risk Factor</th> <th>Ranking</th> <th>Score</th> </tr> </thead> <tbody> <tr><td>US Channel Morph</td><td>WETLAND</td><td>5</td></tr> <tr><td>DS Channel Morph</td><td>D</td><td>1</td></tr> <tr><td>DS Bank Alteration</td><td>HIGH</td><td>1</td></tr> <tr><td>Upstream Skew Angle</td><td>5-30°</td><td>3</td></tr> <tr><td>Crossing fill condition</td><td>Good/Vegetated</td><td>5</td></tr> <tr><td>Inlet/Outlet Condition</td><td>No Impairment</td><td>5</td></tr> <tr><td>Road Approach Material</td><td>All Sand/Clay</td><td>3</td></tr> <tr><td>Potential Eroded Volume Mean</td><td>&lt;21 y<sup>3</sup></td><td>5</td></tr> <tr><td>Approach Slope Mean</td><td>&lt;2%</td><td>5</td></tr> <tr><td>Soil K Factor</td><td>&lt;0.20</td><td>5</td></tr> <tr><td>Upstream Rt Outlet</td><td>Vegetated</td><td>1</td></tr> <tr><td>Upstream Lt Outlet</td><td>Rip Rap</td><td>1</td></tr> <tr><td>Upstream Rt Ditch</td><td>Bare soil</td><td>0</td></tr> <tr><td>Upstream Lt Ditch</td><td>Bare soil</td><td>0</td></tr> <tr><td>Downstream Rt Outlet</td><td>Vegetated</td><td>1</td></tr> <tr><td>Downstream Lt Outlet</td><td>Bare soil</td><td>0</td></tr> <tr><td>Downstream Rt Ditch</td><td>Bare soil</td><td>0</td></tr> <tr><td>Downstream Lt Ditch</td><td>Bare soil</td><td>0</td></tr> <tr><td>Outlet Total</td><td>Partially Improved Outlet System</td><td>3</td></tr> <tr><td>Ditches Total</td><td>Unimproved Drainage System</td><td>1</td></tr> <tr><td><b>SRI Total</b></td><td><b>Medium Risk</b></td><td><b>42</b></td></tr> </tbody> </table>		Risk Factor	Ranking	Score	US Channel Morph	WETLAND	5	DS Channel Morph	D	1	DS Bank Alteration	HIGH	1	Upstream Skew Angle	5-30°	3	Crossing fill condition	Good/Vegetated	5	Inlet/Outlet Condition	No Impairment	5	Road Approach Material	All Sand/Clay	3	Potential Eroded Volume Mean	<21 y <sup>3</sup>	5	Approach Slope Mean	<2%	5	Soil K Factor	<0.20	5	Upstream Rt Outlet	Vegetated	1	Upstream Lt Outlet	Rip Rap	1	Upstream Rt Ditch	Bare soil	0	Upstream Lt Ditch	Bare soil	0	Downstream Rt Outlet	Vegetated	1	Downstream Lt Outlet	Bare soil	0	Downstream Rt Ditch	Bare soil	0	Downstream Lt Ditch	Bare soil	0	Outlet Total	Partially Improved Outlet System	3	Ditches Total	Unimproved Drainage System	1	<b>SRI Total</b>	<b>Medium Risk</b>	<b>42</b>

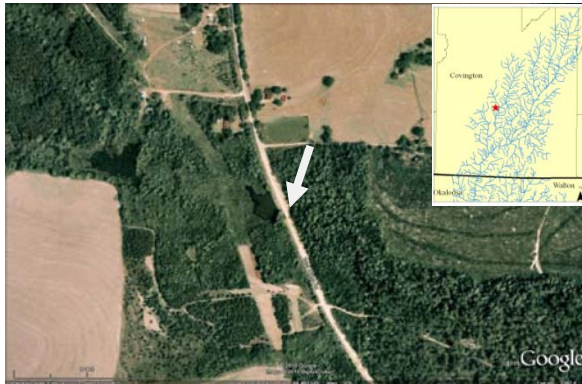
Risk Factor	Ranking	Score																																																																			
US Channel Morph	WETLAND	5																																																																			
DS Channel Morph	D	1																																																																			
DS Bank Alteration	HIGH	1																																																																			
Upstream Skew Angle	5-30°	3																																																																			
Crossing fill condition	Good/Vegetated	5																																																																			
Inlet/Outlet Condition	No Impairment	5																																																																			
Road Approach Material	All Sand/Clay	3																																																																			
Potential Eroded Volume Mean	<21 y <sup>3</sup>	5																																																																			
Approach Slope Mean	<2%	5

Soil K Factor	<0.20	5																																																																			
Upstream Rt Outlet	Vegetated	1																																																																			
Upstream Lt Outlet	Rip Rap	1																																																																			
Upstream Rt Ditch	Bare soil	0																																																																			
Upstream Lt Ditch	Bare soil	0																																																																			
Downstream Rt Outlet	Vegetated	1																																																																			
Downstream Lt Outlet	Bare soil	0																																																																			
Downstream Rt Ditch	Bare soil	0																																																																			
Downstream Lt Ditch	Bare soil	0																																																																			
Outlet Total	Partially Improved Outlet System	3

Ditches Total	Unimproved Drainage System	1																																																																			
<b>SRI Total</b>	<b>Medium Risk</b>	<b>42</b>																																																																			
<b>Additional Site Features</b> <u>Crossing Type and Quantity:</u> Bridge, 1 <u>Crossing Materials:</u> Reinforced Concrete <u>Soil Types:</u> BoB,BoC,CdC,DmB,FoA,MBA <u>Rt Approach Prism Fill:</u> 0.15in <u>Lt Approach Prism Fill:</u> 0.15in		<table border="1"> <thead> <tr> <th>Feature</th> <th>Within Range</th> <th>Descriptive Field</th> </tr> </thead> <tbody> <tr><td>303(d)</td><td>No</td><td>N/A</td></tr> <tr><td>Wetland Species</td><td>No</td><td>N/A</td></tr> <tr><td>Rare and Imperiled</td><td>No</td><td>N/A</td></tr> <tr><td>Land Use/Cover</td><td>Yes</td><td>N/A/ EAST GULF COASTAL PLAIN INTERIOR UPLAND LONGLEAF PINE WOODLAND-OFFSITE HARDWOOD MOD</td></tr> <tr><td>Candidate Mussels</td><td>No</td><td>N/A</td></tr> <tr><td>Sturgeon C.H.</td><td>No</td><td>N/A</td></tr> </tbody> </table>		Feature	Within Range	Descriptive Field	303(d)	No	N/A	Wetland Species	No	N/A	Rare and Imperiled	No	N/A	Land Use/Cover	Yes	N/A/ EAST GULF COASTAL PLAIN INTERIOR UPLAND LONGLEAF PINE WOODLAND-OFFSITE HARDWOOD MOD	Candidate Mussels	No	N/A	Sturgeon C.H.	No	N/A

Notes: US wetland visible from aerial.
