Shoal River			ok-0616-002		Severity Score 4
<u>Common:</u> 4.4mi NE of Crestview <u>Drainage:</u> Yellow River <u>GPS:</u> 30.777450186, -86.498332723 <u>Land owner:</u> Rita Chimiak			<u>County:</u> Okaloosa <u>State:</u> Florida <u>PLSS(T-R-S):</u> 3N-23W-12 <u>Parcel No.:</u> 2

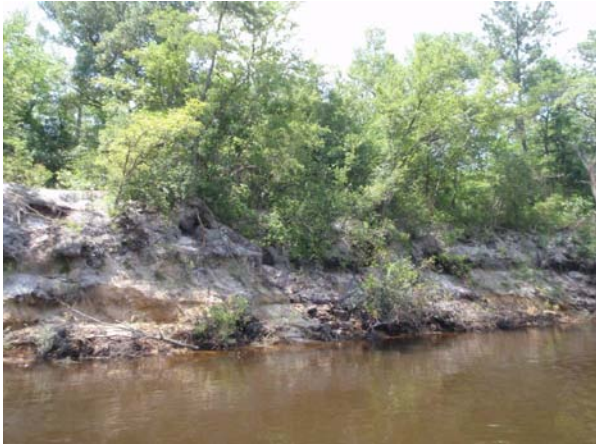
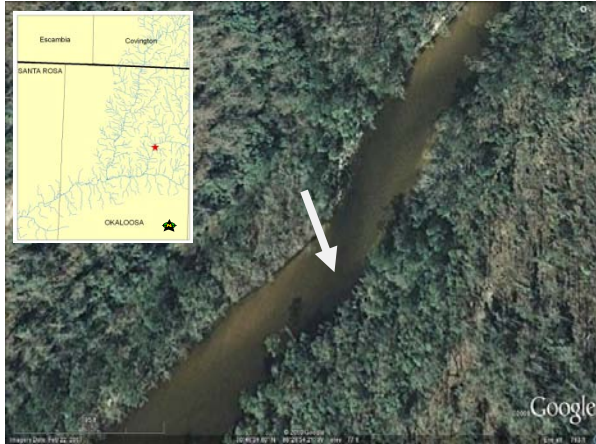
Notes: New growth on eroding bank may indicate historic erosion. However bank still appears to be degrading.  
 Unpaved road on both banks. Aerials show evidence of past logging/clear cutting.
