Craw Pond		co-0812-r-007		Sedimentation Risk Index 48																																																																			
<u>Common:</u> 9.8mi N of Florala <u>Drainage:</u> Clear Creek <u>GPS:</u> 31.146472, -86.343528 <u>Land owner:</u> Albert & James Cravey		<u>County:</u> Covington <u>PLSS (T-R-S):</u> 2N-17E-15 <u>Parcel No.:</u> 2 <u>Road Name:</u> New Hope Rd		<u>State:</u> Alabama

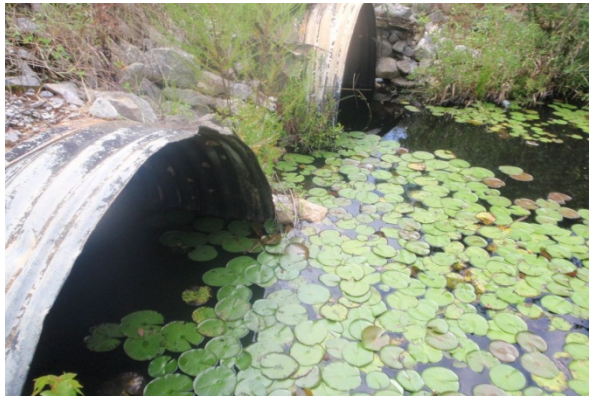
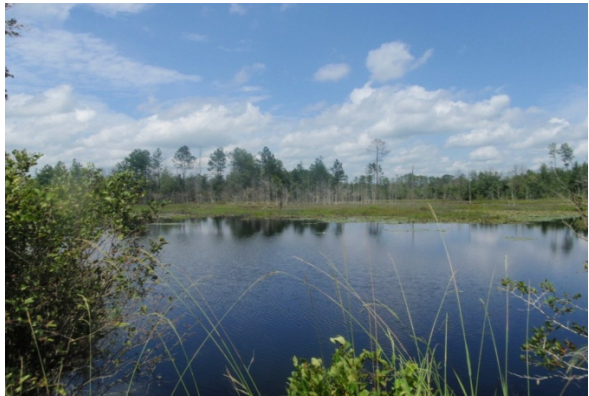
Crossing Structure: DS		US																																																																					
<table border="1"> <thead> <tr> <th>Risk Factor</th> <th>Ranking</th> <th>Score</th> </tr> </thead> <tbody> <tr><td>US Channel Morph</td><td>BEAVER DAM</td><td>3</td></tr> <tr><td>DS Channel Morph</td><td>PONDED</td><td>1</td></tr> <tr><td>DS Bank Alteration</td><td>MINOR/PARTIAL</td><td>3</td></tr> <tr><td>Upstream Skew Angle</td><td><5°</td><td>5</td></tr> <tr><td>Crossing fill condition</td><td>Good/Vegetated</td><td>5</td></tr> <tr><td>Inlet/Outlet Condition</td><td>No Impairment</td><td>5</td></tr> <tr><td>Road Approach Material</td><td>All Sand/Clay</td><td>3</td></tr> <tr><td>Potential Eroded Volume Mean</td><td><21 y³</td><td>5</td></tr> <tr><td>Approach Slope Mean</td><td><2%</td><td>5</td></tr> <tr><td>Soil K Factor</td><td><0.20</td><td>5</td></tr> <tr><td>Upstream Rt Outlet</td><td>Vegetated</td><td>1</td></tr> <tr><td>Upstream Lt Outlet</td><td>Vegetated</td><td>1</td></tr> <tr><td>Upstream Rt Ditch</td><td>Vegetated</td><td>1</td></tr> <tr><td>Upstream Lt Ditch</td><td>Vegetated</td><td>1</td></tr> <tr><td>Downstream Rt Outlet</td><td>Vegetated</td><td>1</td></tr> <tr><td>Downstream Lt Outlet</td><td>Vegetated</td><td>1</td></tr> <tr><td>Downstream Rt Ditch</td><td>Vegetated</td><td>1</td></tr> <tr><td>Downstream Lt Ditch</td><td>Bare soil</td><td>0</td></tr> <tr><td>Outlet Total</td><td>Improved Outlet System</td><td>5</td></tr> <tr><td>Ditches Total</td><td>Partially Improved Drainage System</td><td>3</td></tr> <tr><td>SRI Total</td><td>Low Risk</td><td>48</td></tr> </tbody> </table>		Risk Factor	Ranking	Score	US Channel Morph	BEAVER DAM	3	DS Channel Morph	PONDED	1	DS Bank Alteration	MINOR/PARTIAL	3	Upstream Skew Angle	<5°	5	Crossing fill condition	Good/Vegetated	5	Inlet/Outlet Condition	No Impairment	5	Road Approach Material	All Sand/Clay	3	Potential Eroded Volume Mean	<21 y ³	5	Approach Slope Mean	<2%	5	Soil K Factor	<0.20	5	Upstream Rt Outlet	Vegetated	1	Upstream Lt Outlet	Vegetated	1	Upstream Rt Ditch	Vegetated	1	Upstream Lt Ditch	Vegetated	1	Downstream Rt Outlet	Vegetated	1	Downstream Lt Outlet	Vegetated	1	Downstream Rt Ditch	Vegetated	1	Downstream Lt Ditch	Bare soil	0	Outlet Total	Improved Outlet System	5	Ditches Total	Partially Improved Drainage System	3	SRI Total	Low Risk	48

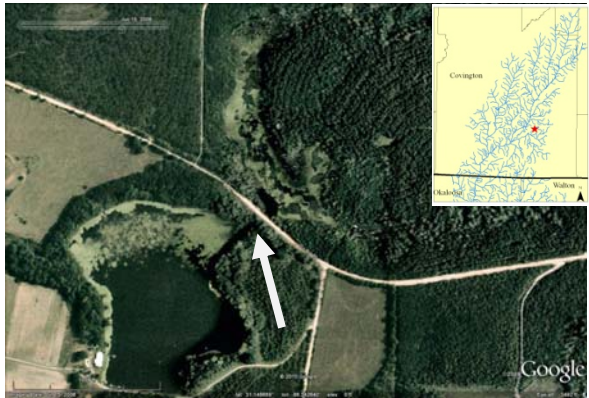
Risk Factor	Ranking	Score																																																																					
US Channel Morph	BEAVER DAM	3																																																																					
DS Channel Morph	PONDED	1																																																																					
DS Bank Alteration	MINOR/PARTIAL	3																																																																					
Upstream Skew Angle	<5°	5																																																																					
Crossing fill condition	Good/Vegetated	5																																																																					
Inlet/Outlet Condition	No Impairment	5																																																																					
Road Approach Material	All Sand/Clay	3																																																																					
Potential Eroded Volume Mean	<21 y ³	5

Approach Slope Mean	<2%	5																																																																					
Soil K Factor	<0.20	5																																																																					
Upstream Rt Outlet	Vegetated	1																																																																					
Upstream Lt Outlet	Vegetated	1																																																																					
Upstream Rt Ditch	Vegetated	1																																																																					
Upstream Lt Ditch	Vegetated	1																																																																					
Downstream Rt Outlet	Vegetated	1																																																																					
Downstream Lt Outlet	Vegetated	1																																																																					
Downstream Rt Ditch	Vegetated	1																																																																					
Downstream Lt Ditch	Bare soil	0

Outlet Total	Improved Outlet System	5																																																																					
Ditches Total	Partially Improved Drainage System	3																																																																					
SRI Total	Low Risk	48																																																																					
Additional Site Features <u>Crossing Type and Quantity:</u> Culvert, 2 <u>Crossing Materials:</u> Metal <u>Soil Types:</u> CdC,DmB,FoA,FuB,MBA <u>Rt Approach Prism Fill:</u> 0.25in <u>Lt Approach Prism Fill:</u> 0.25in		<table border="1"> <thead> <tr> <th>Feature</th> <th>Within Range</th> <th>Descriptive Field</th> </tr> </thead> <tbody> <tr> <td>303(d)</td> <td>No</td> <td>N/A</td> </tr> <tr> <td>Wetland Species</td> <td>No</td> <td>N/A</td> </tr> <tr> <td>Rare and Imperiled</td> <td>No</td> <td>N/A</td> </tr> <tr> <td>Land Use/ Cover</td> <td>Yes</td> <td>N/A/ DEVELOPED OPEN SPACE</td> </tr> <tr> <td>Candidate Mussels</td> <td>No</td> <td>N/A</td> </tr> <tr> <td>Sturgeon C.H.</td> <td>No</td> <td>N/A</td> </tr> </tbody> </table>				Feature	Within Range	Descriptive Field	303(d)	No	N/A	Wetland Species	No	N/A	Rare and Imperiled	No	N/A	Land Use/ Cover	Yes	N/A/ DEVELOPED OPEN SPACE	Candidate Mussels	No	N/A	Sturgeon C.H.	No	N/A
