Gum Creek		wa-1026-001	Severity Score 10.5																																				
<u>Common:</u> 7.3mi NE of De Funiak Springs, .04mi DS HWY 331 <u>Drainage:</u> Shoal River <u>GPS:</u> 30.801519827, -86.194956251 <u>Land owner:</u> Christopher Marshall		<u>County:</u> Walton <u>State:</u> Florida <u>PLSS(T-R-S):</u> 4N-20W-36 <u>Parcel No.:</u> 1

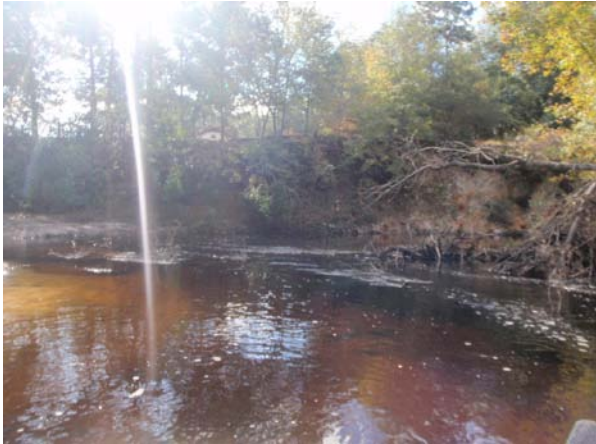
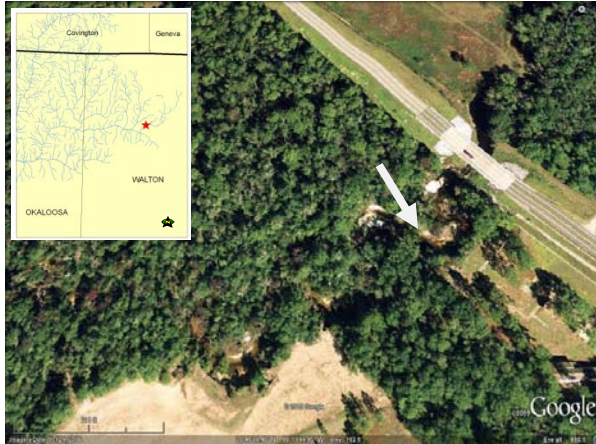
Notes: Rip rap has been used as a shoring structure around the bridge and large quantities have fallen in the stream channel causing a fish passage blockage during low flow stages. A house nearby is also noted as a source of NSPS.
