Unnamed Tributary		ok-0226-r-006	Sedimentation Risk Index 52
<u>Common:</u> 4.2mi SW of Crestview <u>Drainage:</u> Yellow River <u>GPS:</u> 30.665139, -86.761744 <u>Land owner:</u> The Nature Conservancy		<u>County:</u> Okaloosa <u>State:</u> Florida <u>PLSS (T-R-S):</u> 20-2N-24 <u>Parcel No.:</u> 1 <u>Road Name:</u> Log Lake Rd

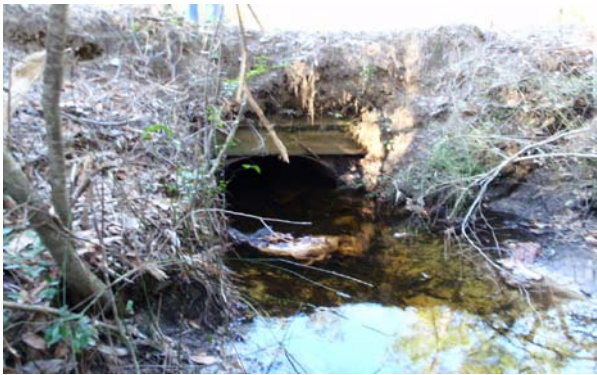
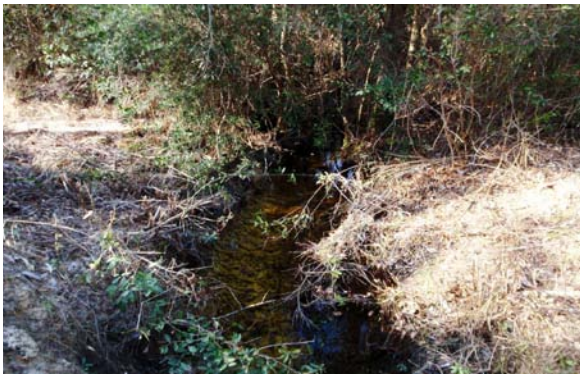
Crossing Structure- DS		US	
Risk Factor	Ranking	Score	
US Channel Morph	E	5	
DS Channel Morph	E	5	
DS Bank Alteration	NATURAL	5	
Upstream Skew Angle	<5°	5	
Crossing fill condition	Good/Vegetated	5	
Inlet/Outlet Condition	No Impairment	5	
Road Approach Material	All Sand/Clay	3	
Potential Eroded Volume Mean	<21 y ³	5	
Approach Slope Mean	<2%	5	
Soil K Factor	<0.20	5	
Upstream Rt Outlet	Vegetated	1	
Upstream Lt Outlet	Vegetated	1	
Upstream Rt Ditch	Bare soil	0	
Upstream Lt Ditch	Bare soil	0	
Downstream Rt Outlet	Bare soil	0	
Downstream Lt Outlet	Bare soil	0	
Downstream Rt Ditch	Bare soil	0

Notes: Receives a lot of sediment when the road is grated. Culvert undersized.
