Pond Creek		wa-0625-r-005a	Sedimentation Risk Index 44																																																																		
<u>Common:</u> 1.7mi SW of Florala <u>Drainage:</u> Shoal River <i>GPS:</i> 30.987175, -86.348881 <u>Land owner:</u> Neal Hart- US, Thalon & Peggy Hobbs-DS		<u>County:</u> Walton <i>State:</i> Florida <u>PLSS(T-R-S):</u> 6N-21-28 <u>Parcel No.:</u> 18; 18.002 <u>Road Name:</u> Double Bridge Rd

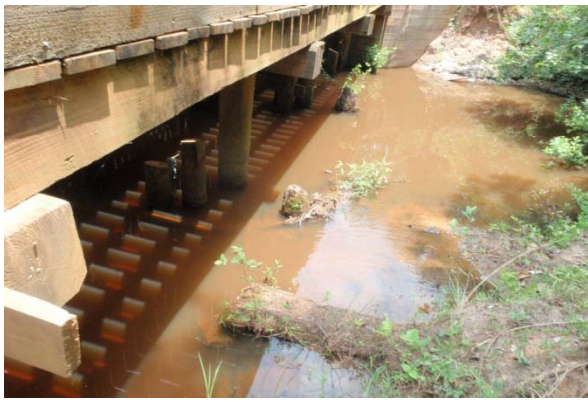
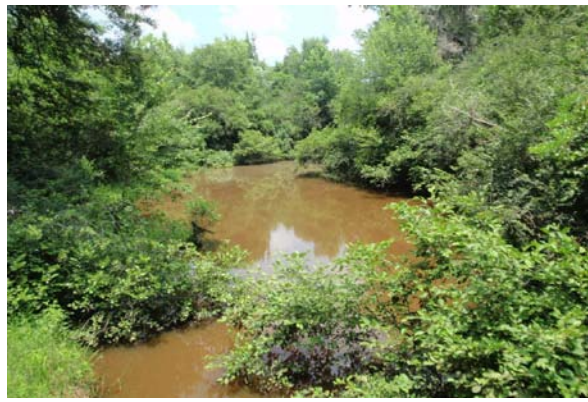
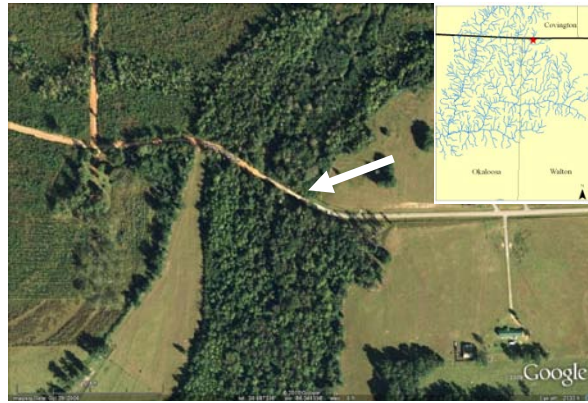
Crossing Structure: DS		US																																																																			
<table border="1"> <thead> <tr> <th>Risk Factor</th> <th>Ranking</th> <th>Score</th> </tr> </thead> <tbody> <tr><td>US Channel Morph</td><td>DA</td><td>3</td></tr> <tr><td>DS Channel Morph</td><td>DA</td><td>3</td></tr> <tr><td>DS Bank Alteration</td><td>NATURAL</td><td>5</td></tr> <tr><td>Upstream Skew Angle</td><td><5°</td><td>5</td></tr> <tr><td>Crossing fill condition</td><td>Poor/Bare soil</td><td>1</td></tr> <tr><td>Inlet/Outlet Condition</td><td>No Impairment</td><td>5</td></tr> <tr><td>Road Approach Material</td><td>All Aggregate</td><td>5</td></tr> <tr><td>Potential Eroded Volume Mean</td><td><21 y³</td><td>5</td></tr> <tr><td>Approach Slope Mean</td><td>>4%</td><td>1</td></tr> <tr><td>Soil K Factor</td><td><0.20</td><td>5</td></tr> <tr><td>Upstream Rt Outlet</td><td>Vegetated</td><td>1</td></tr> <tr><td>Upstream Lt Outlet</td><td>Vegetated</td><td>1</td></tr> <tr><td>Upstream Rt Ditch</td><td>Vegetated</td><td>1</td></tr> <tr><td>Upstream Lt Ditch</td><td>Bare soil</td><td>0</td></tr> <tr><td>Downstream Rt Outlet</td><td>Bare soil</td><td>0</td></tr> <tr><td>Downstream Lt Outlet</td><td>Vegetated</td><td>1</td></tr> <tr><td>Downstream Rt Ditch</td><td>Vegetated</td><td>1</td></tr> <tr><td>Downstream Lt Ditch</td><td>Vegetated</td><td>1</td></tr> <tr><td>Outlet Total</td><td>Partially Improved Outlet System</td><td>3</td></tr> <tr><td>Ditches Total</td><td>Partially Improved Drainage System</td><td>3</td></tr> <tr><td>SRI Total</td><td>Medium Risk</td><td>44</td></tr> </tbody> </table>		Risk Factor	Ranking	Score	US Channel Morph	DA	3	DS Channel Morph	DA	3	DS Bank Alteration	NATURAL	5	Upstream Skew Angle	<5°	5	Crossing fill condition	Poor/Bare soil	1	Inlet/Outlet Condition	No Impairment	5	Road Approach Material	All Aggregate	5	Potential Eroded Volume Mean	<21 y ³	5	Approach Slope Mean	>4%	1	Soil K Factor	<0.20	5	Upstream Rt Outlet	Vegetated	1	Upstream Lt Outlet	Vegetated	1	Upstream Rt Ditch	Vegetated	1	Upstream Lt Ditch	Bare soil	0	Downstream Rt Outlet	Bare soil	0	Downstream Lt Outlet	Vegetated	1	Downstream Rt Ditch	Vegetated	1	Downstream Lt Ditch	Vegetated	1	Outlet Total	Partially Improved Outlet System	3	Ditches Total	Partially Improved Drainage System	3	SRI Total	Medium Risk	44

Notes: Two bridges crossing this same system.
