Unnamed tributary		co-0731-r-009	Sedimentation Risk Index 46																																																																		
<u>Common:</u> 4.1mi NW of Florala <u>Drainage:</u> Horsehead Creek <i>GPS:</i> 31.039039, -86.382572 <u>Land owner:</u> Rayonier Forest Resources LP		<u>County:</u> Covington <i>State:</i> Alabama <u>PLSS (T-R-S):</u> 1N-17E-19 <u>Parcel No.:</u> 1 <u>Road Name:</u> Chance Rd

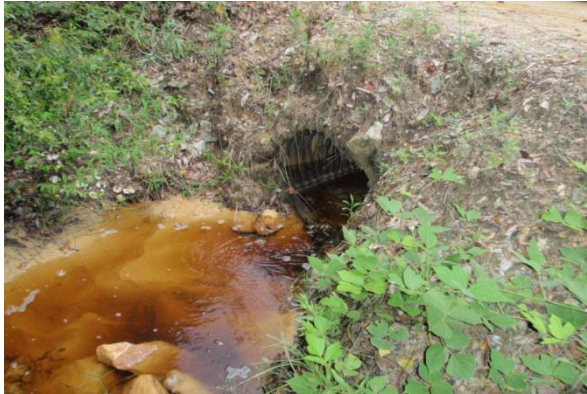
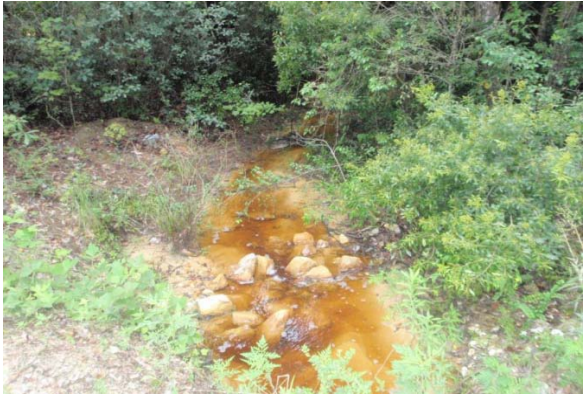
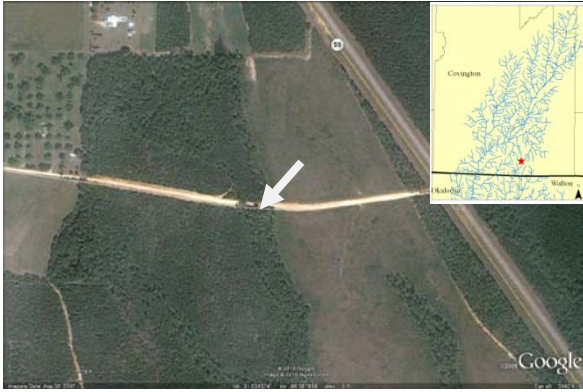
Crossing Structure: DS		US																																																																			
<table border="1"> <thead> <tr> <th>Risk Factor</th> <th>Ranking</th> <th>Score</th> </tr> </thead> <tbody> <tr><td>US Channel Morph</td><td>E</td><td>5</td></tr> <tr><td>DS Channel Morph</td><td>E</td><td>5</td></tr> <tr><td>DS Bank Alteration</td><td>MINOR/PARTIAL</td><td>3</td></tr> <tr><td>Upstream Skew Angle</td><td><5°</td><td>5</td></tr> <tr><td>Crossing fill condition</td><td>Poor/Bare soil</td><td>1</td></tr> <tr><td>Inlet/Outlet Condition</td><td>No Impairment</td><td>5</td></tr> <tr><td>Road Approach Material</td><td>All Native Soil</td><td>1</td></tr> <tr><td>Potential Eroded Volume Mean</td><td><21 y³</td><td>5</td></tr> <tr><td>Approach Slope Mean</td><td>2.1-4%</td><td>3</td></tr> <tr><td>Soil K Factor</td><td><0.20</td><td>5</td></tr> <tr><td>Upstream Rt Outlet</td><td>Vegetated</td><td>1</td></tr> <tr><td>Upstream Lt Outlet</td><td>Vegetated</td><td>1</td></tr> <tr><td>Upstream Rt Ditch</td><td>Vegetated</td><td>1</td></tr> <tr><td>Upstream Lt Ditch</td><td>Vegetated</td><td>1</td></tr> <tr><td>Downstream Rt Outlet</td><td>Vegetated</td><td>1</td></tr> <tr><td>Downstream Lt Outlet</td><td>Vegetated</td><td>1</td></tr> <tr><td>Downstream Rt Ditch</td><td>Bare soil</td><td>0</td></tr> <tr><td>Downstream Lt Ditch</td><td>Bare soil</td><td>0</td></tr> <tr><td>Outlet Total</td><td>Improved Outlet System</td><td>5</td></tr> <tr><td>Ditches Total</td><td>Partially Improved Drainage System</td><td>3</td></tr> <tr><td>SRI Total</td><td>Low Risk</td><td>46</td></tr> </tbody> </table>		Risk Factor	Ranking	Score	US Channel Morph	E	5	DS Channel Morph	E	5	DS Bank Alteration	MINOR/PARTIAL	3	Upstream Skew Angle	<5°	5	Crossing fill condition	Poor/Bare soil	1	Inlet/Outlet Condition	No Impairment	5	Road Approach Material	All Native Soil	1	Potential Eroded Volume Mean	<21 y ³	5	Approach Slope Mean	2.1-4%	3	Soil K Factor	<0.20	5	Upstream Rt Outlet	Vegetated	1	Upstream Lt Outlet	Vegetated	1	Upstream Rt Ditch	Vegetated	1	Upstream Lt Ditch	Vegetated	1	Downstream Rt Outlet	Vegetated	1	Downstream Lt Outlet	Vegetated	1	Downstream Rt Ditch	Bare soil	0	Downstream Lt Ditch	Bare soil	0	Outlet Total	Improved Outlet System	5	Ditches Total	Partially Improved Drainage System	3	SRI Total	Low Risk	46

Notes: Rip rap in stream bed.
