Unnamed tributary		co-0810-r-011	Sedimentation Risk Index <b>48</b>																																																																		
<u>Common:</u> 10.1mi NW of Floala <u>Drainage:</u> Yellow River <u>GPS:</u> 31.095753, -86.462847 <u>Land owner:</u> Catherine Dixon Roland		<u>County:</u> Covington <u>State:</u> Alabama <u>PLSS (T-R-S):</u> 2N-16E-33 <u>Parcel No.:</u> 2.01 <u>Road Name:</u> Drip Rock Rd

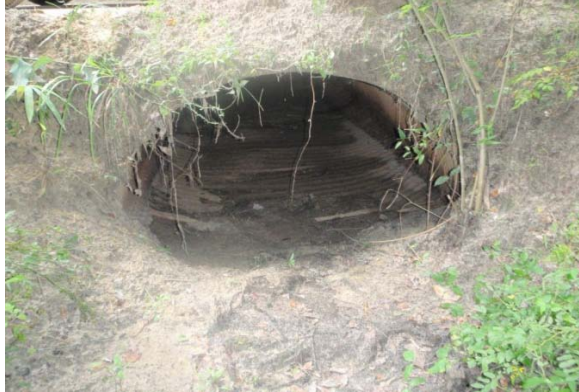
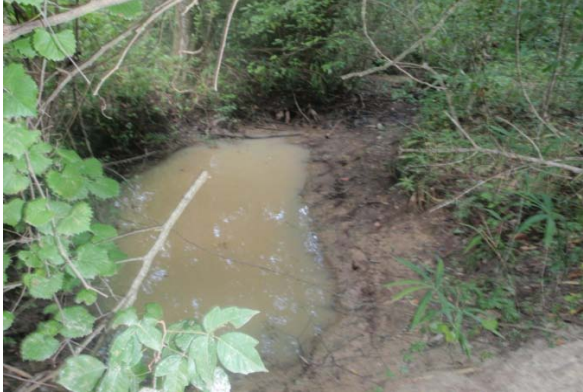
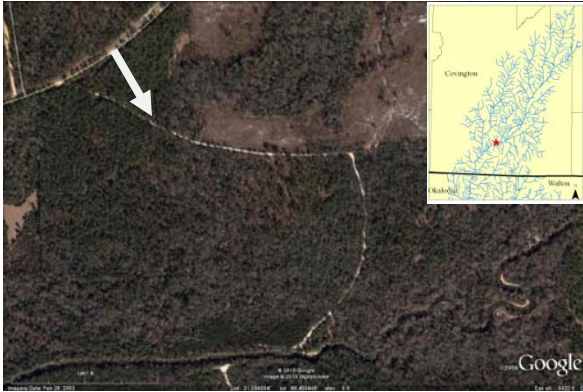
Crossing Structure: US		DS																																																																			
<table border="1"> <thead> <tr> <th>Risk Factor</th> <th>Ranking</th> <th>Score</th> </tr> </thead> <tbody> <tr><td>US Channel Morph</td><td>E</td><td>5</td></tr> <tr><td>DS Channel Morph</td><td>E</td><td>5</td></tr> <tr><td>DS Bank Alteration</td><td>MINOR/PARTIAL</td><td>3</td></tr> <tr><td>Upstream Skew Angle</td><td>&lt;5°</td><td>5</td></tr> <tr><td>Crossing fill condition</td><td>Poor/Bare soil</td><td>1</td></tr> <tr><td>Inlet/Outlet Condition</td><td>No Impairment</td><td>5</td></tr> <tr><td>Road Approach Material</td><td>All Sand/Clay</td><td>3</td></tr> <tr><td>Potential Eroded Volume Mean</td><td>&lt;21 y<sup>3</sup></td><td>5</td></tr> <tr><td>Approach Slope Mean</td><td>&lt;2%</td><td>5</td></tr> <tr><td>Soil K Factor</td><td>&lt;0.20</td><td>5</td></tr> <tr><td>Upstream Rt Outlet</td><td>Vegetated</td><td>1</td></tr> <tr><td>Upstream Lt Outlet</td><td>Vegetated</td><td>1</td></tr> <tr><td>Upstream Rt Ditch</td><td>Bare soil</td><td>0</td></tr> <tr><td>Upstream Lt Ditch</td><td>Bare soil</td><td>0</td></tr> <tr><td>Downstream Rt Outlet</td><td>Vegetated</td><td>1</td></tr> <tr><td>Downstream Lt Outlet</td><td>Vegetated</td><td>1</td></tr> <tr><td>Downstream Rt Ditch</td><td>Bare soil</td><td>0</td></tr> <tr><td>Downstream Lt Ditch</td><td>Bare soil</td><td>0</td></tr> <tr><td>Outlet Total</td><td>Improved Outlet System</td><td>5</td></tr> <tr><td>Ditches Total</td><td>Unimproved Drainage System</td><td>1</td></tr> <tr><td><b>SRI Total</b></td><td><b>Low Risk</b></td><td><b>48</b></td></tr> </tbody> </table>		Risk Factor	Ranking	Score	US Channel Morph	E	5	DS Channel Morph	E	5	DS Bank Alteration	MINOR/PARTIAL	3	Upstream Skew Angle	<5°	5	Crossing fill condition	Poor/Bare soil	1	Inlet/Outlet Condition	No Impairment	5	Road Approach Material	All Sand/Clay	3	Potential Eroded Volume Mean	<21 y <sup>3</sup>	5	Approach Slope Mean	<2%	5	Soil K Factor	<0.20	5	Upstream Rt Outlet	Vegetated	1	Upstream Lt Outlet	Vegetated	1	Upstream Rt Ditch	Bare soil	0	Upstream Lt Ditch	Bare soil	0	Downstream Rt Outlet	Vegetated	1	Downstream Lt Outlet	Vegetated	1	Downstream Rt Ditch	Bare soil	0	Downstream Lt Ditch	Bare soil	0	Outlet Total	Improved Outlet System	5	Ditches Total	Unimproved Drainage System	1	<b>SRI Total</b>	<b>Low Risk</b>	<b>48</b>

Notes: Dripping rock road. Feeds DS of sturgeon on YR main stem.
