Dry Creek		co-0812-r-004		Sedimentation Risk Index 46																																																																			
<u>Common:</u> 8.5mi N of Florala <u>Drainage:</u> Clear Creek <u>GPS:</u> 31.122884, -86.363344 <u>Land owner:</u> Rayonier Forest Resources LP		<u>County:</u> Covington <u>PLSS (T-R-S):</u> 2N-17E-20 <u>Parcel No.:</u> 6 <u>Road Name:</u> Swimming Hole Rd		<u>State:</u> Alabama

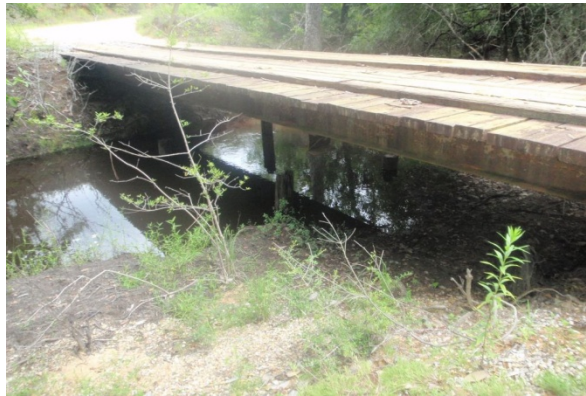
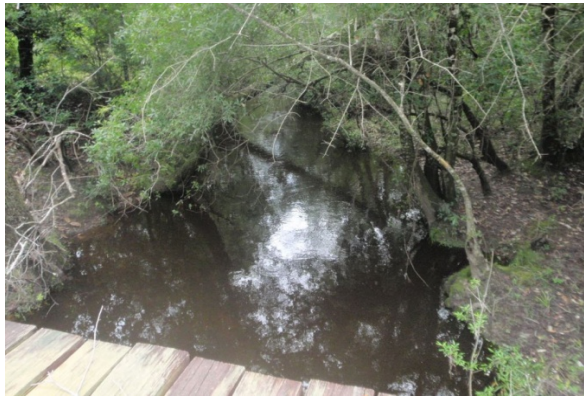
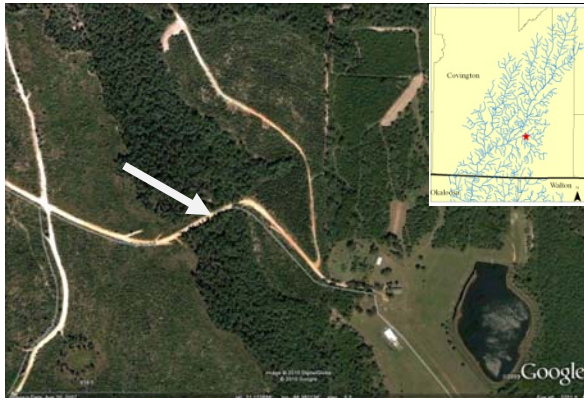
Crossing Structure: DS		US																																																																					
<table border="1"> <thead> <tr> <th>Risk Factor</th> <th>Ranking</th> <th>Score</th> </tr> </thead> <tbody> <tr><td>US Channel Morph</td><td>B</td><td>5</td></tr> <tr><td>DS Channel Morph</td><td>B</td><td>5</td></tr> <tr><td>DS Bank Alteration</td><td>NATURAL</td><td>5</td></tr> <tr><td>Upstream Skew Angle</td><td><5°</td><td>5</td></tr> <tr><td>Crossing fill condition</td><td>Poor/Bare soil</td><td>1</td></tr> <tr><td>Inlet/Outlet Condition</td><td>No Impairment</td><td>5</td></tr> <tr><td>Road Approach Material</td><td>All Sand/Clay</td><td>3</td></tr> <tr><td>Potential Eroded Volume Mean</td><td>21-40 y³</td><td>3</td></tr> <tr><td>Approach Slope Mean</td><td><2%</td><td>5</td></tr> <tr><td>Soil K Factor</td><td><0.20</td><td>5</td></tr> <tr><td>Upstream Rt Outlet</td><td>Vegetated</td><td>1</td></tr> <tr><td>Upstream Lt Outlet</td><td>Bare soil</td><td>0</td></tr> <tr><td>Upstream Rt Ditch</td><td>Bare soil</td><td>0</td></tr> <tr><td>Upstream Lt Ditch</td><td>Bare soil</td><td>0</td></tr> <tr><td>Downstream Rt Outlet</td><td>Bare soil</td><td>0</td></tr> <tr><td>Downstream Lt Outlet</td><td>Bare soil</td><td>0</td></tr> <tr><td>Downstream Rt Ditch</td><td>Bare soil</td><td>0</td></tr> <tr><td>Downstream Lt Ditch</td><td>Bare soil</td><td>0</td></tr> <tr><td>Outlet Total</td><td>Partially Improved Outlet System</td><td>3</td></tr> <tr><td>Ditches Total</td><td>Unimproved Drainage System</td><td>1</td></tr> <tr><td>SRI Total</td><td>Low Risk</td><td>46</td></tr> </tbody> </table>		Risk Factor	Ranking	Score	US Channel Morph	B	5	DS Channel Morph	B	5	DS Bank Alteration	NATURAL	5	Upstream Skew Angle	<5°	5	Crossing fill condition	Poor/Bare soil	1	Inlet/Outlet Condition	No Impairment	5	Road Approach Material	All Sand/Clay	3	Potential Eroded Volume Mean	21-40 y ³	3	Approach Slope Mean	<2%	5	Soil K Factor	<0.20	5	Upstream Rt Outlet	Vegetated	1	Upstream Lt Outlet	Bare soil	0	Upstream Rt Ditch	Bare soil	0	Upstream Lt Ditch	Bare soil	0	Downstream Rt Outlet	Bare soil	0	Downstream Lt Outlet	Bare soil	0	Downstream Rt Ditch	Bare soil	0	Downstream Lt Ditch	Bare soil	0	Outlet Total	Partially Improved Outlet System	3	Ditches Total	Unimproved Drainage System	1	SRI Total	Low Risk	46

Notes: Semi-private road. Dead end, does not appear to receive a lot of traffic.
