Unnamed tributary		wa-0716-r-006	Sedimentation Risk Index <b>34</b>																																																																		
<u>Common:</u> 3.9mi NE of Mossy Head <u>Drainage:</u> Shoal River GPS: 30.762719, -86.252690 <u>Land owner:</u> Richard & Barbara Harrison-DS, Marjorie McLaughlin-US		<u>County:</u> Walton <u>PLSS(T-R-S):</u> 3N-20-16-28060 <u>Parcel No.:</u> 16.0310; 015.0170 <u>Road Name:</u> Amaryllis Ln

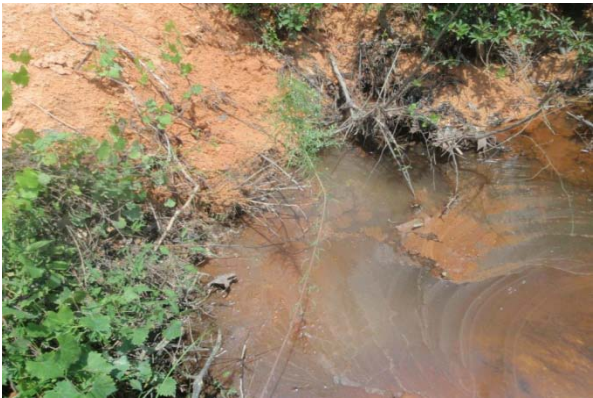
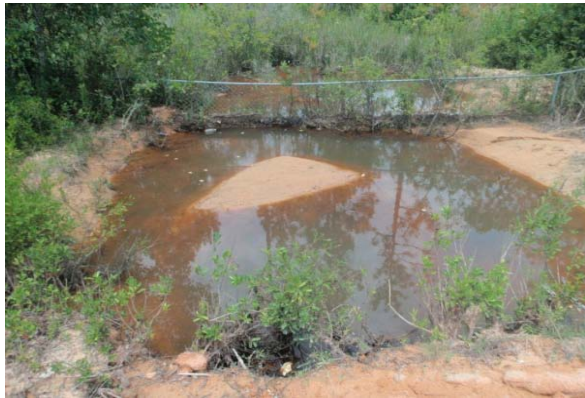
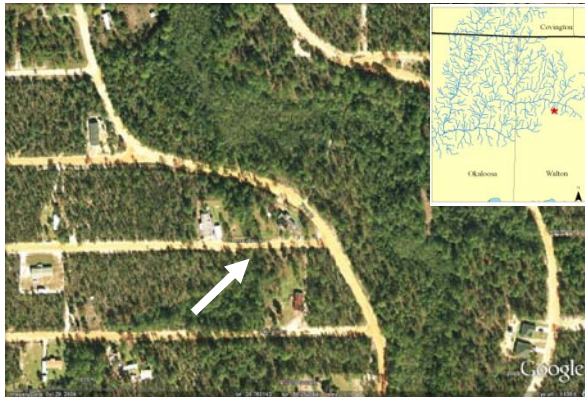
Crossing Structure: US		DS																																																																			
<table border="1"> <thead> <tr> <th>Risk Factor</th> <th>Ranking</th> <th>Score</th> </tr> </thead> <tbody> <tr><td>US Channel Morph</td><td>WETLAND</td><td>5</td></tr> <tr><td>DS Channel Morph</td><td>PONDED</td><td>1</td></tr> <tr><td>DS Bank Alteration</td><td>HIGH</td><td>1</td></tr> <tr><td>Upstream Skew Angle</td><td>&lt;5°</td><td>5</td></tr> <tr><td>Crossing fill condition</td><td>Poor/Bare soil</td><td>1</td></tr> <tr><td>Inlet/Outlet Condition</td><td>Blocked</td><td>1</td></tr> <tr><td>Road Approach Material</td><td>All Sand/Clay</td><td>3</td></tr> <tr><td>Potential Eroded Volume Mean</td><td>&lt;21 y<sup>3</sup></td><td>5</td></tr> <tr><td>Approach Slope Mean</td><td>2.1-4%</td><td>3</td></tr> <tr><td>Soil K Factor</td><td>&lt;0.20</td><td>5</td></tr> <tr><td>Upstream Rt Outlet</td><td>Bare soil</td><td>0</td></tr> <tr><td>Upstream Lt Outlet</td><td>Vegetated</td><td>1</td></tr> <tr><td>Upstream Rt Ditch</td><td>Bare soil</td><td>0</td></tr> <tr><td>Upstream Lt Ditch</td><td>Bare soil</td><td>0</td></tr> <tr><td>Downstream Rt Outlet</td><td>Bare soil</td><td>0</td></tr> <tr><td>Downstream Lt Outlet</td><td>Bare soil</td><td>0</td></tr> <tr><td>Downstream Rt Ditch</td><td>Bare soil</td><td>0</td></tr> <tr><td>Downstream Lt Ditch</td><td>Bare soil</td><td>0</td></tr> <tr><td>Outlet Total</td><td>Partially Improved Outlet System</td><td>3</td></tr> <tr><td>Ditches Total</td><td>Unimproved Drainage System</td><td>1</td></tr> <tr><td><b>SRI Total</b></td><td><b>High Risk</b></td><td><b>34</b></td></tr> </tbody> </table>		Risk Factor	Ranking	Score	US Channel Morph	WETLAND	5	DS Channel Morph	PONDED	1	DS Bank Alteration	HIGH	1	Upstream Skew Angle	<5°	5	Crossing fill condition	Poor/Bare soil	1	Inlet/Outlet Condition	Blocked	1	Road Approach Material	All Sand/Clay	3	Potential Eroded Volume Mean	<21 y <sup>3</sup>	5	Approach Slope Mean	2.1-4%	3	Soil K Factor	<0.20	5	Upstream Rt Outlet	Bare soil	0	Upstream Lt Outlet	Vegetated	1	Upstream Rt Ditch	Bare soil	0	Upstream Lt Ditch	Bare soil	0	Downstream Rt Outlet	Bare soil	0	Downstream Lt Outlet	Bare soil	0	Downstream Rt Ditch	Bare soil	0	Downstream Lt Ditch	Bare soil	0	Outlet Total	Partially Improved Outlet System	3	Ditches Total	Unimproved Drainage System	1	<b>SRI Total</b>	<b>High Risk</b>	<b>34</b>

Notes: Buried crossing structure- unknown. Fence across DS.
