Unnamed tributary		co-0810-r-006	Sedimentation Risk Index <b>38</b>
<u>Common:</u>	8.8mi N of Laurel Hill	<u>County:</u>	Covington
<u>Drainage:</u>	Yellow River	<u>PLSS (T-R-S):</u>	1N-15E-1
<u>Land owner:</u>	Kermit George	<u>Parcel No.:</u>	1
		<u>Road Name:</u>	Bass Rd

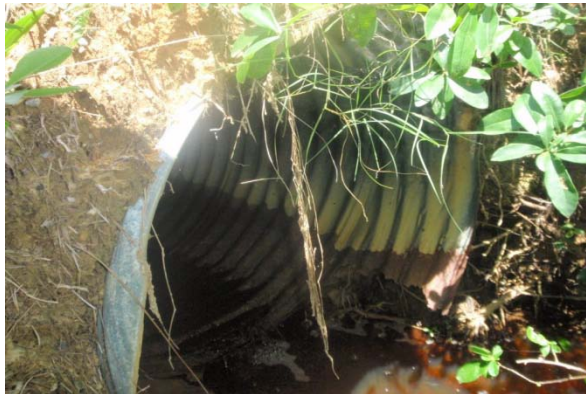
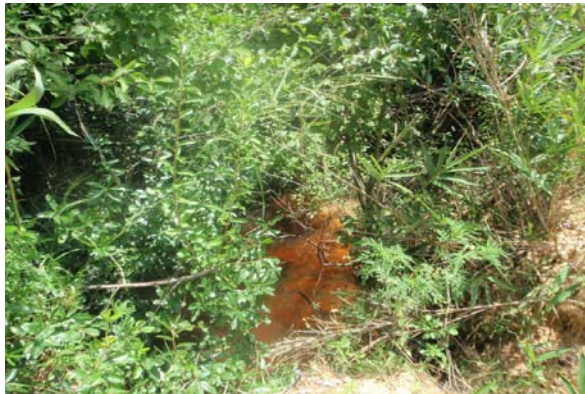
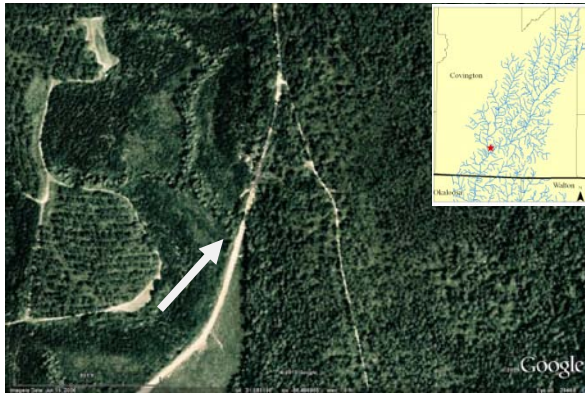
Crossing Structure: DS		DS	
<b>Risk Factor</b>	<b>Ranking</b>	<b>Score</b>	
US Channel Morph	DA	3	
DS Channel Morph	C	5	
DS Bank Alteration	HIGH	1	
Upstream Skew Angle	5-30°	3	
Crossing fill condition	Poor/Bare soil	1	
Inlet/Outlet Condition	No Impairment	5	
Road Approach Material	All Sand/Clay	3	
Potential Eroded Volume Mean	<21 y <sup>3</sup>	5	
Approach Slope Mean	2.1-4%	3	
Soil K Factor	<0.20	5	
Upstream Rt Outlet	Bare soil	0	
Upstream Lt Outlet	Bare soil	0	
Upstream Rt Ditch	Bare soil	0	
Upstream Lt Ditch	Bare soil	0	
Downstream Rt Outlet	Bare soil	0	
Downstream Lt Outlet	Bare soil	0	
Downstream Rt Ditch	Synthetic	1	
Downstream Lt Ditch	Bare soil	0

Notes: Road actively eroding over culvert.
